ACCOTINK CREEK STREAM STABILITY ASSESSMENT AND PRIORITIZATION PLAN

FINAL REPORT

City of Fairfax, Virginia

October 22, 2007

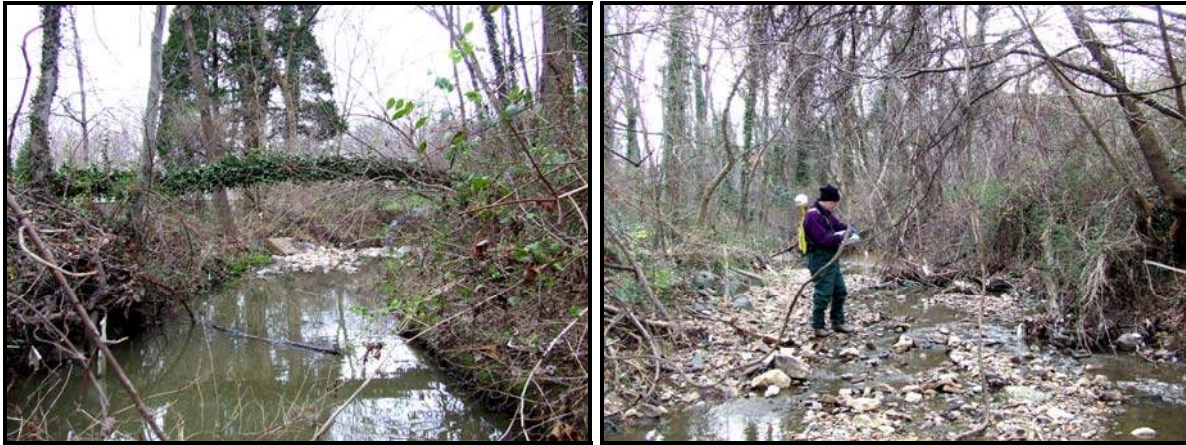
Site No.: SR1-003
Site Score: 51.0, “Extreme”
Location: Behind Main Street Green Condos

The reach is just upstream of condo community. There appears to be only one commercial property that would be impacted. Recent bank repairs were attempted on the east side of the channel. The stream is heavily incised with high banks. There is one sanitary sewer crossing.

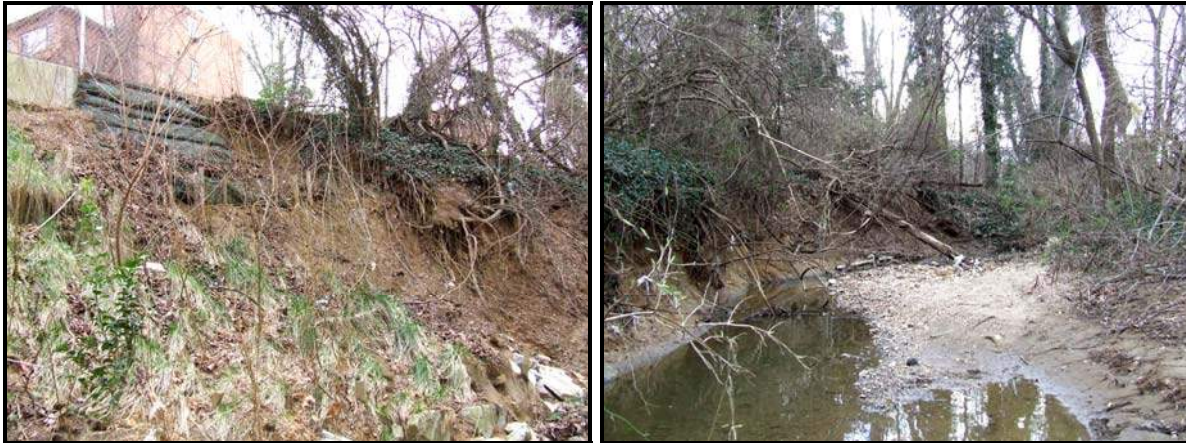
Site No.: SR1-004
Site Score: 58.0, “Extreme”
Location: Behind Main Street Green Condos

Three commercial properties border this reach. This reach is a very tight and narrow corridor and extremely incised. The sanitary sewer appears to parallel the stream along this reach. Recent sanitary work was performed by the City at Main Street.

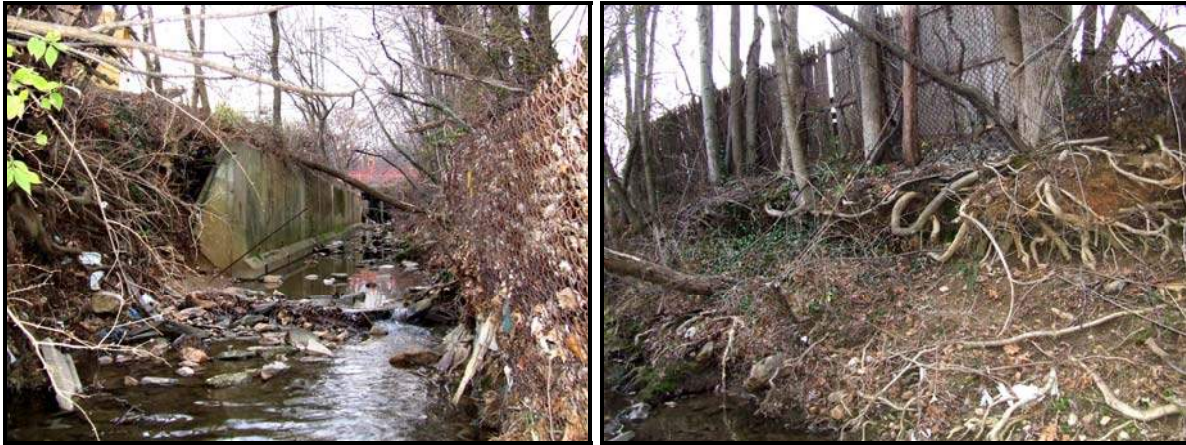
Site No.: SR1-005
Site Score: 58.0, “Extreme”
Location: Railroad Ave., north of Main Street

The reach is just upstream of SR1-004, towards Main Street. It is differentiated from SR1-004 due to a long concrete retaining wall. The west bank is actively eroding but constrained by the automobile dealer parking lot. The stream channel is very incised.

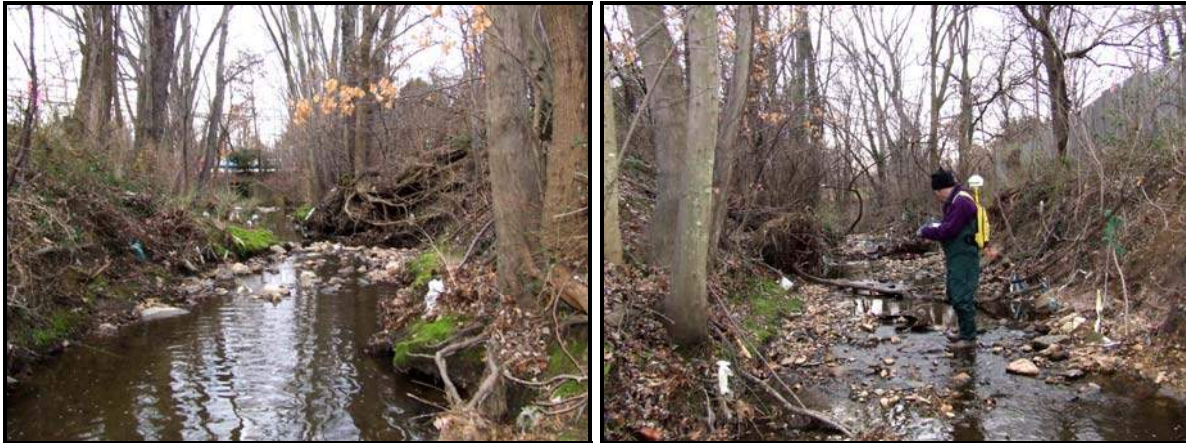
Location: City of Fairfax Cemetery, from Judicial Dr. to Main St.

There is limited bank erosion due to the backwater condition at the Main Street culvert. This is a short reach (500 ft. \pm) that is deeply incised. The stream abuts three commercial properties on Main Street (north) and the cemetery on the south bank. The sanitary sewer line parallels the stream and crosses it at least once.

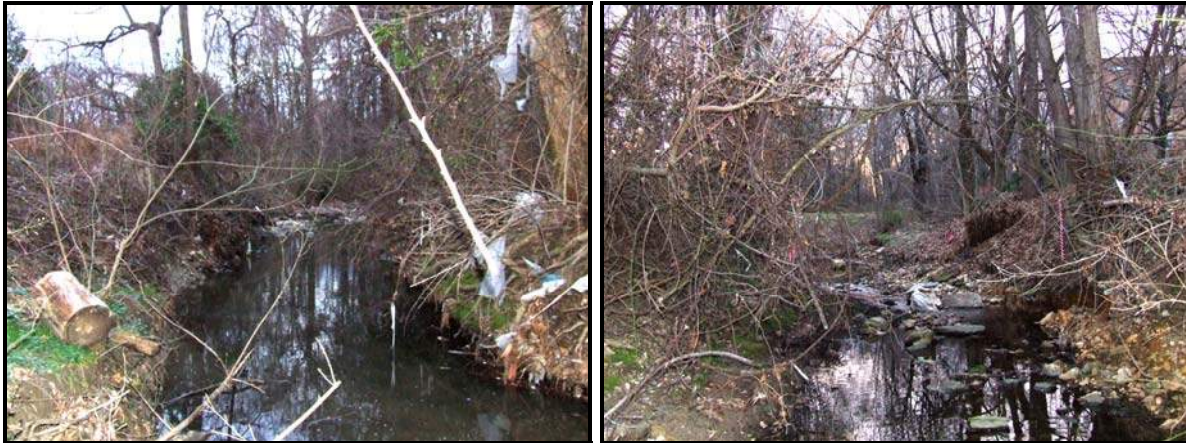
Site No.: SR1-007
Site Score: 54.5, “Extreme”
Location: Behind Fairfax Nursing Center, spans to Judicial Dr.

This reach is just downstream of SR1-008. It is deeply incised, most likely from a backwater condition at the Judicial Drive culvert. The reach spans four properties of the medical complex. There is new construction occurring at the lower end of the reach on the north side of the stream.

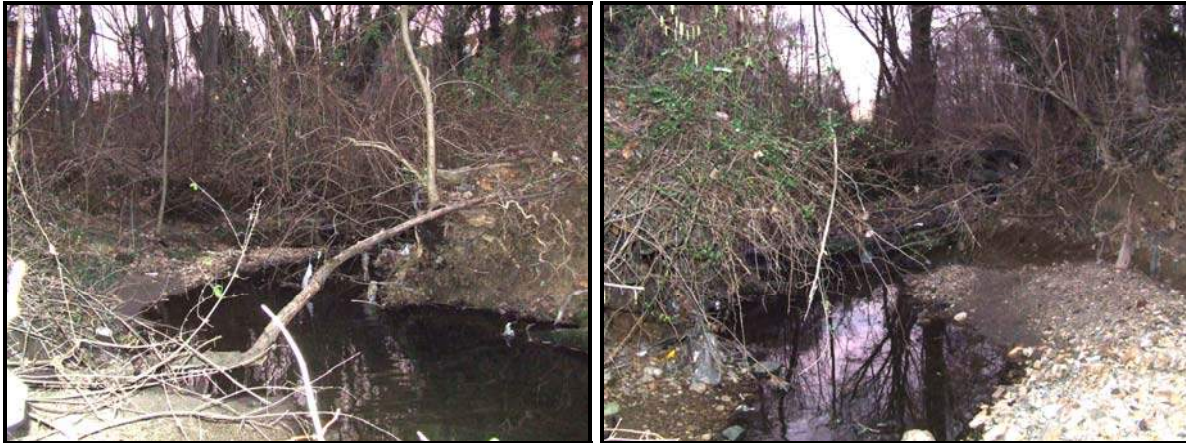
Location: Autumn Woods, behind Crest St. and Autumn Ct.

This reach primarily spans one property (Fairfax Medical Center). The sanitary sewer is located on both sides of stream channel. It is deeply incised with a foot bridge from the nursing center located at the mid-point of the approximately 1,000 ft. reach.

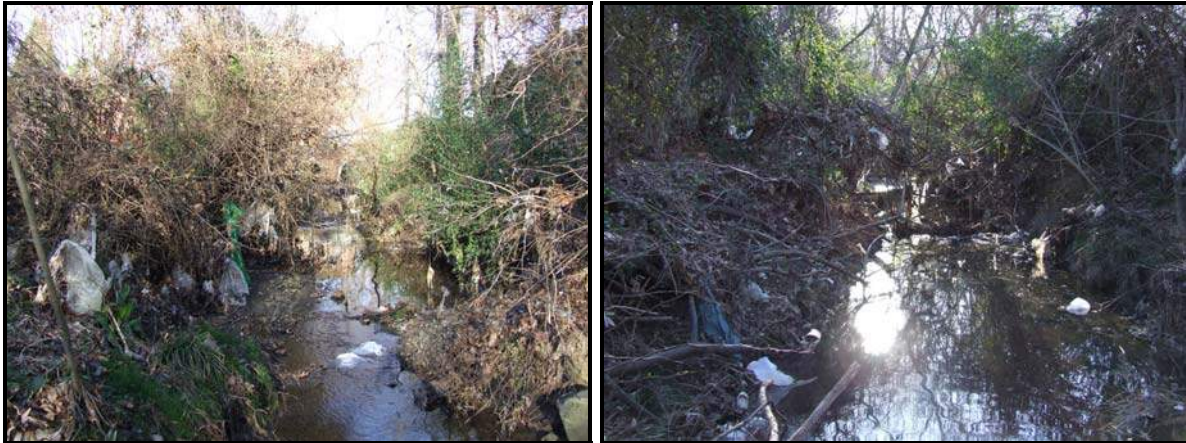
Site No.: SR1-010
Site Score: 40.5, "Very High"
Location: Autumn Woods, from Hallman St. to Poplar St.

This is the first reach of the southern tributary to be above ground. There is erosion from a storm drain outfall. A park-like walkway to the south side of the channel allows adequate space for work. The sanitary sewer is offset approximately 50 feet from the channel.

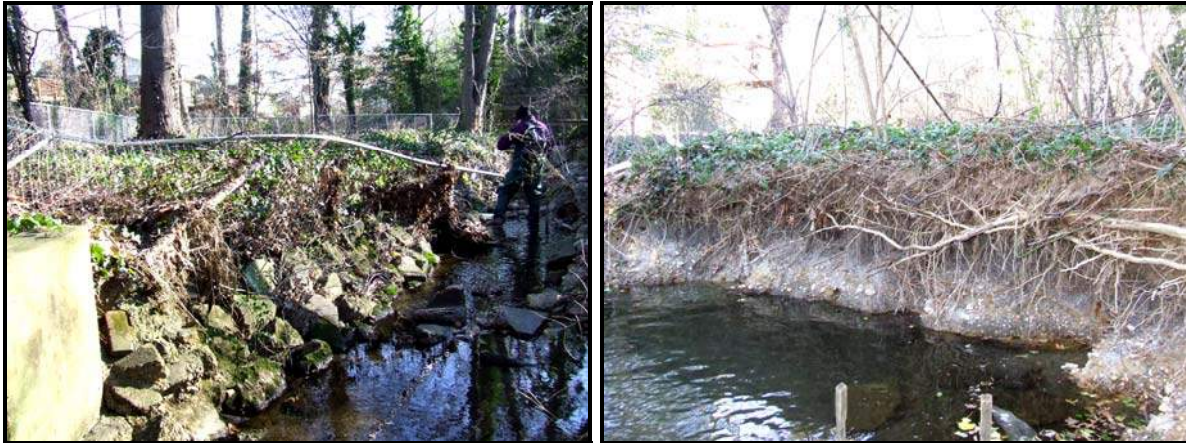
Site No.: SR2-002
Site Score: 46.5, “Extreme”
Location: behind Springmann Dr., from Keith Ave. to Railroad Ave.

Approximately 24 residential homes are impacted from severe erosion on the rear of their properties. The stream channel is highly impacted, with random ad-hoc bank revetment located throughout the reach. Midway through the reach, there is a large bamboo stand, which is followed by a tortuous meander. The sanitary sewer crosses the stream at least twice. This reach is very narrow.

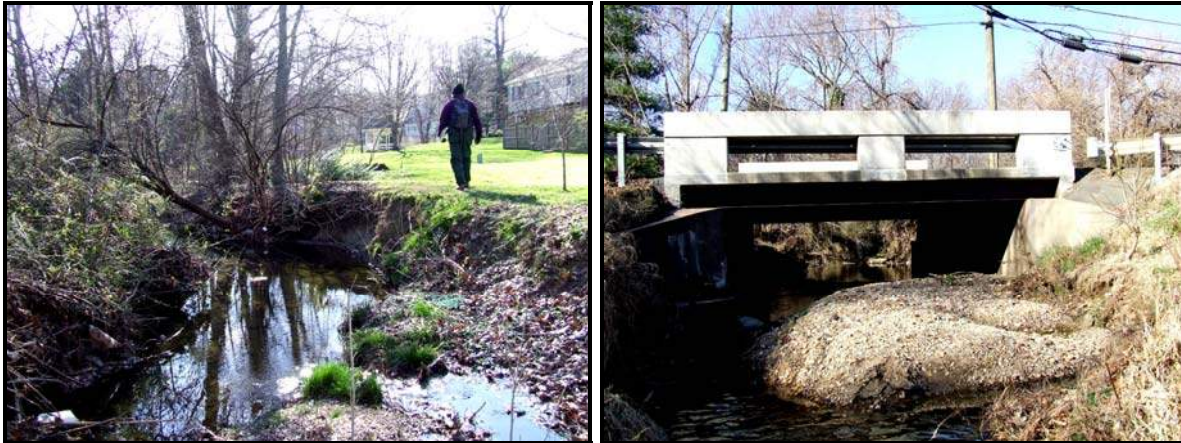
Location: North of Tusico Ct., from the gap in Center St. to Chain Bridge Rd.

This reach extends to the confluence with SR1 and appears to impact only two parcels with no structures on them. The sanitary sewer parallels the stream to south. Downstream, the bridge at Chainbridge Road creates a backwater condition.

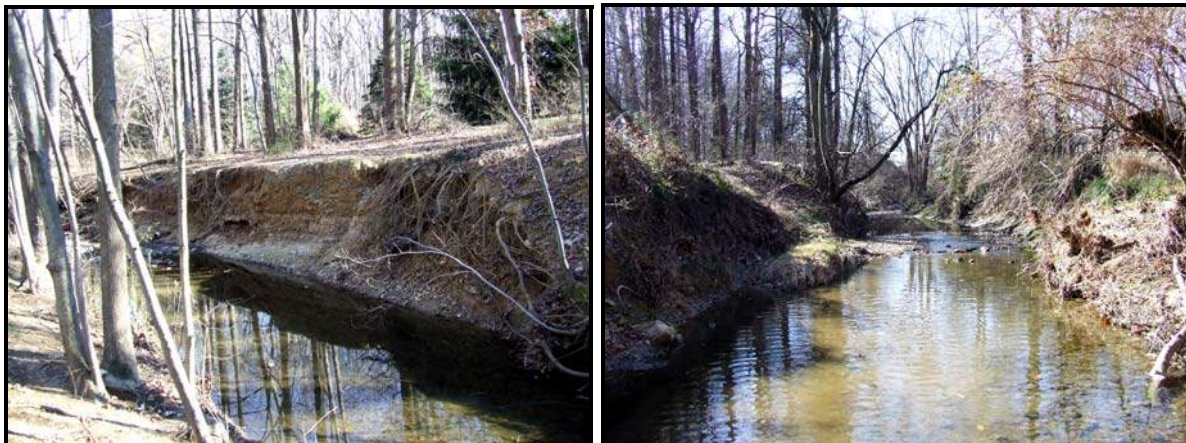
Site No.: SR3-002
Site Score: 59.5, "Extreme"
Location: Jean St., along E Calvin Van Dyck Park

Up to 9 private properties are potentially affected due to erosion on the west side of the reach. Layton Hall and St. Leos School are on the east side of the reach. The surroundings are primarily residential, with the sanitary sewer running parallel to the stream on the east side. SR3-001 is in better condition than this reach due to recent restoration efforts. This reach is overwidened and has high banks

The three yellow highlighted reaches (SR3-002, NR2-002, AND NR2-003) should be considered the top priority reaches. We recommend that work performed in SR3-002 include full restoration due to the extensive nature of the impacts on the stream. The accessibility of the project coupled with the facts that the upstream reach has been previously restored and the reach is on publicly-owned land makes this area a very good candidate for restoration. The lower portion of the reach (600 LF) is the most impacted, so it is recommended that light restoration be concentrated at the tight meander bend located in this area. NR2-002 is a lengthy (1500 LF) reach between Plantation Parkway and Stafford Drive. This area is a priority for the City as it has been an area historically impacted by downed trees, debris, and flooding. Again, this area is accessible and publicly-owned with high citizen concerns, which makes it another candidate for full restoration. Light restoration is recommended to focus on the tight meander bend located approximately 500 LF upstream from Stafford Drive. Lastly, NR2-003 exhibits excessive lateral migration tendencies and citizen concerns about fallen trees have surfaced. As with NR2-002, this is a good candidate for both comprehensive restoration or spot fixes at tight meander bends.

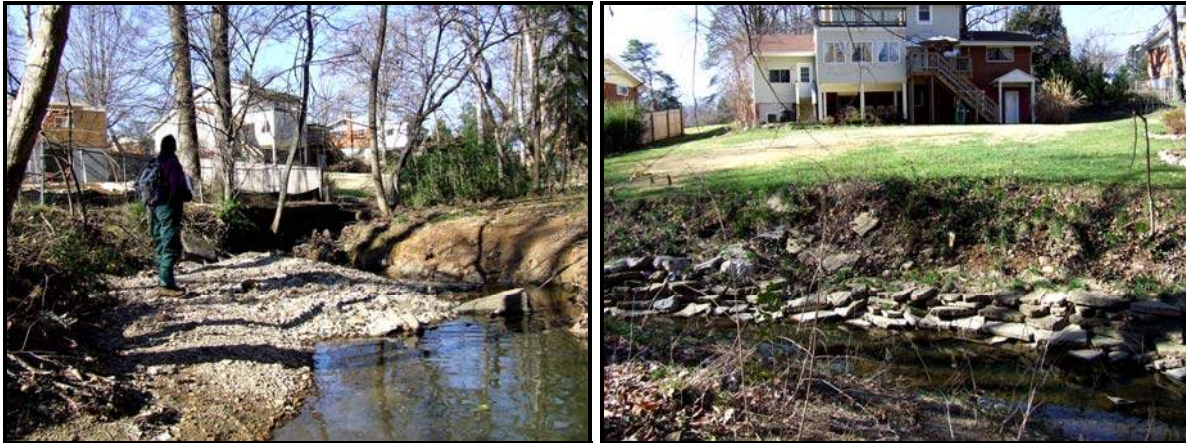
Site No.: SR3-004
Site Score: 43.5, “Very High”
Location: Spring Lake Terrace, from Dale Dr. and Jean St. to a court on Spring Lake Terrace

The stream reach is similar to SR2-002. This is a residential area, with 11 residential lots bordering the reach. The sanitary sewer is to the west of the stream channel. It is a very narrow corridor with random bank revetment that utilizes anything, from broken concrete to gabion mattresses.
