**JOHN C. WOOD HOUSE  
FAIRFAX, VIRGINIA**

**MODIFIED HISTORIC STRUCTURE REPORT**

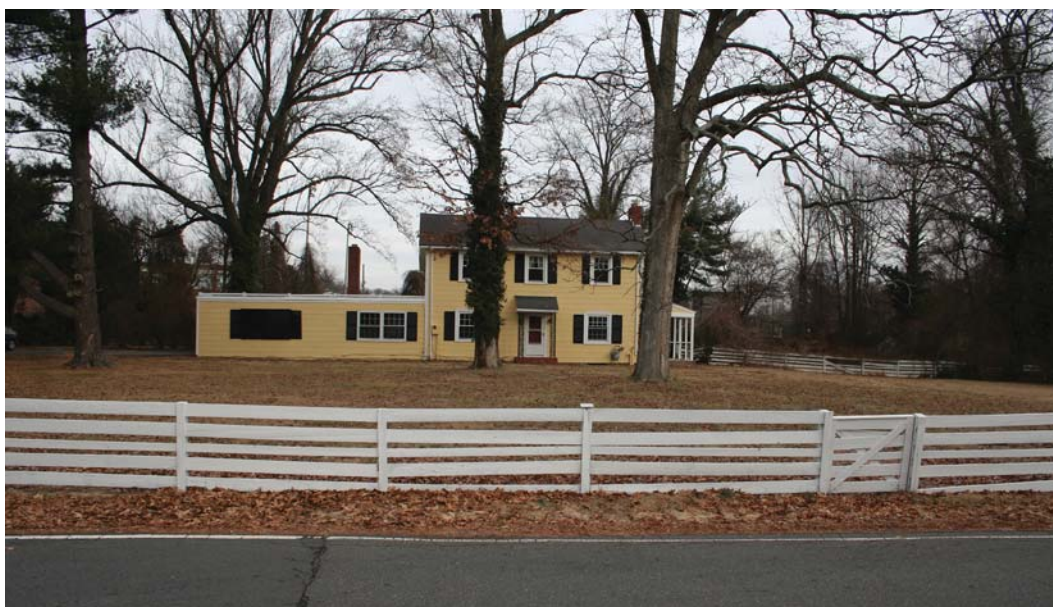
*View of South Facade*

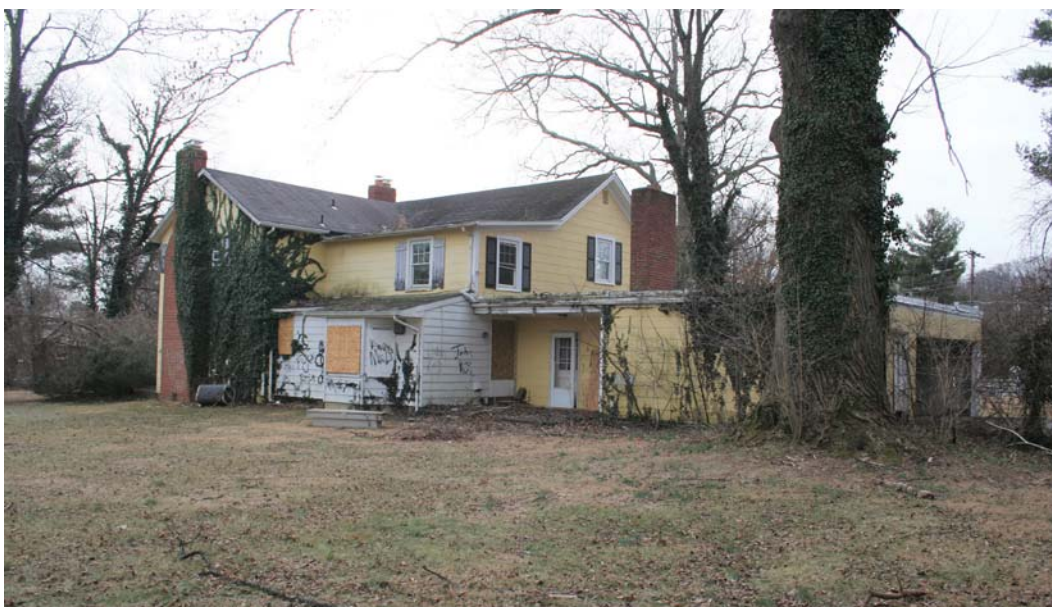
*View of North Facade, looking Southeast*

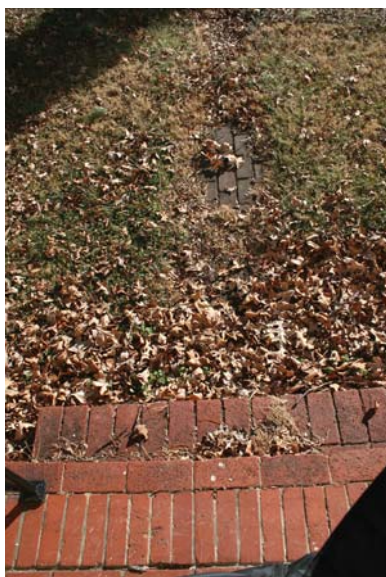
*View of front stairs and walkway*

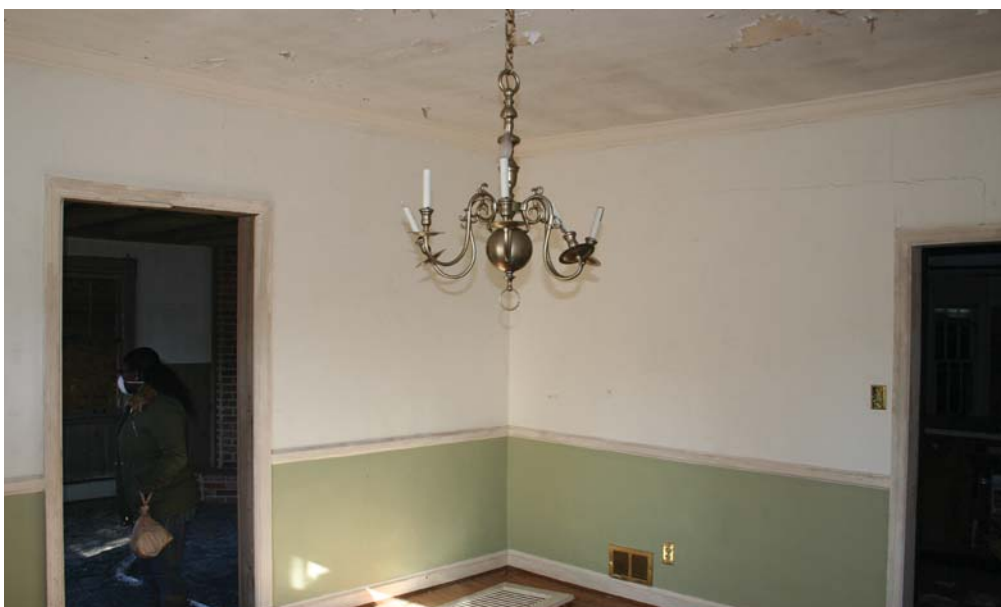
*View of Dining Room looking northwest*

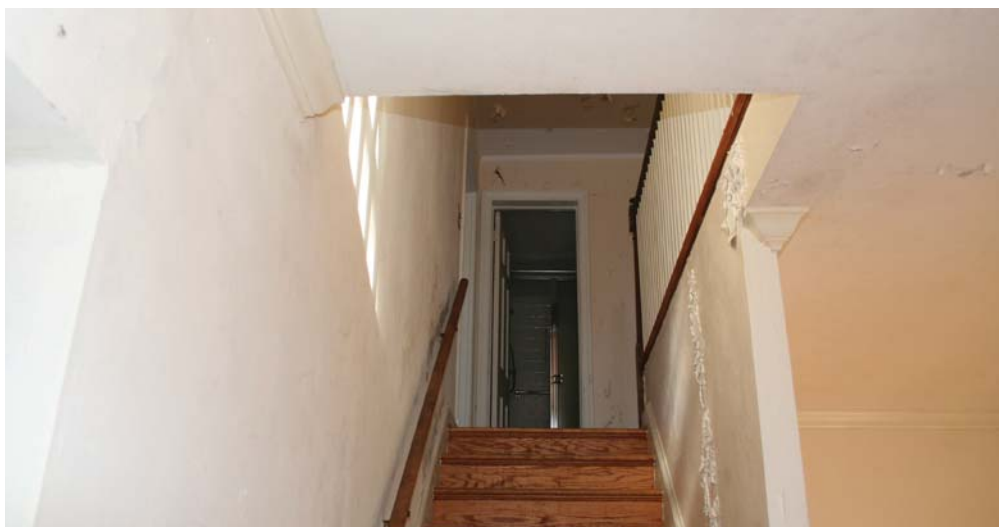
*View looking up the stairs to the second floor*

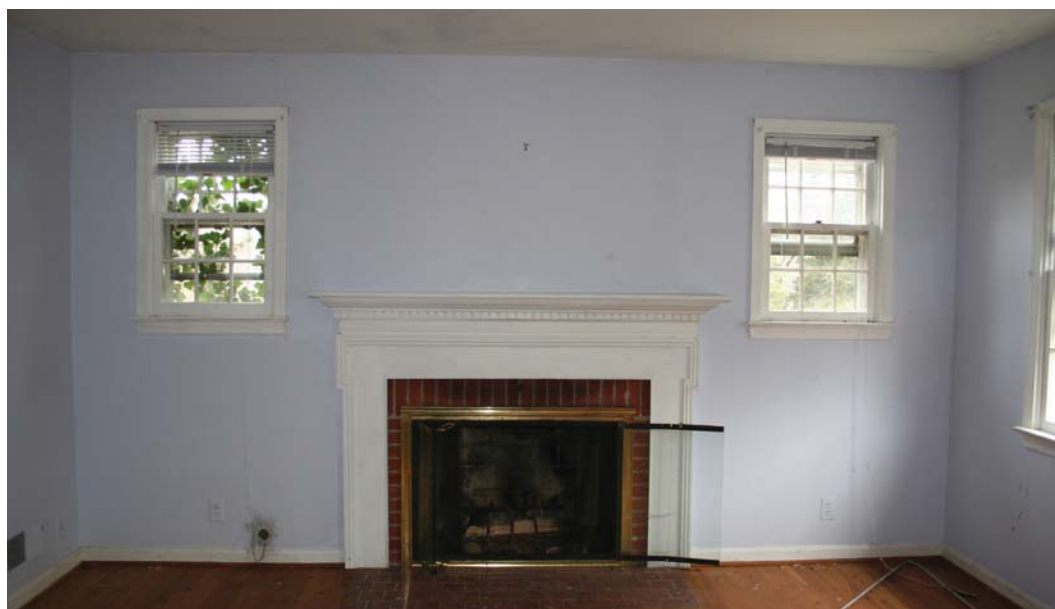
*View of Master bedroom looking north*

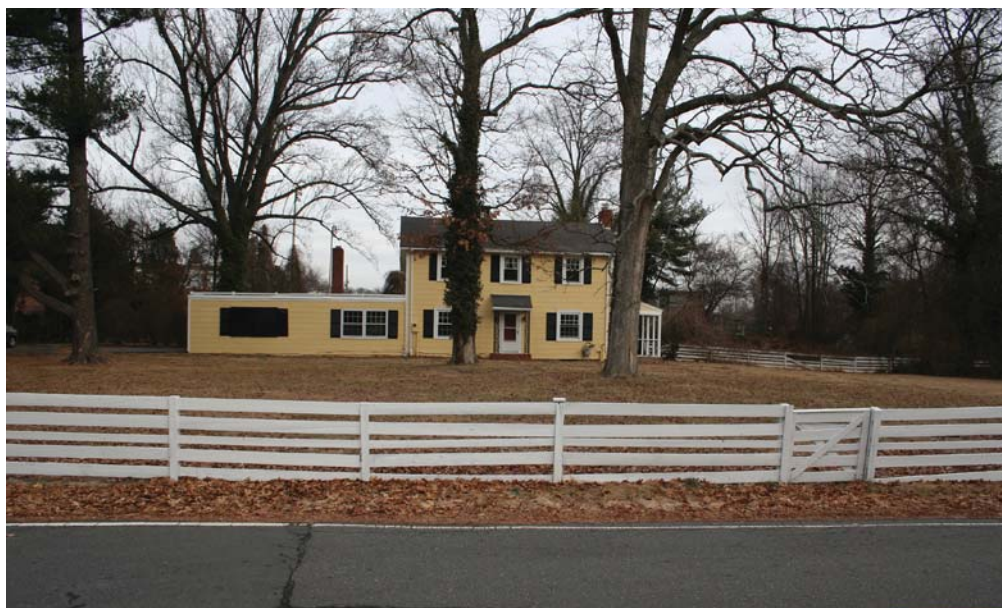
*View of mature trees on the site*

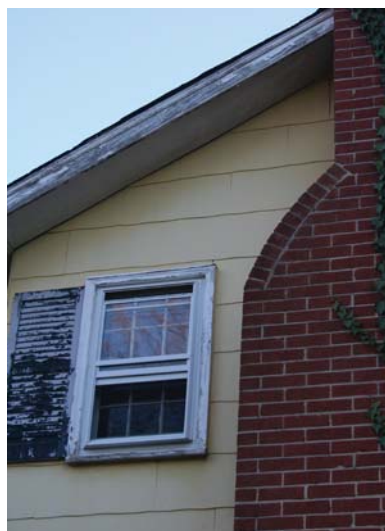
*View of storm window on 1970 addition, 2nd floor, north facade*

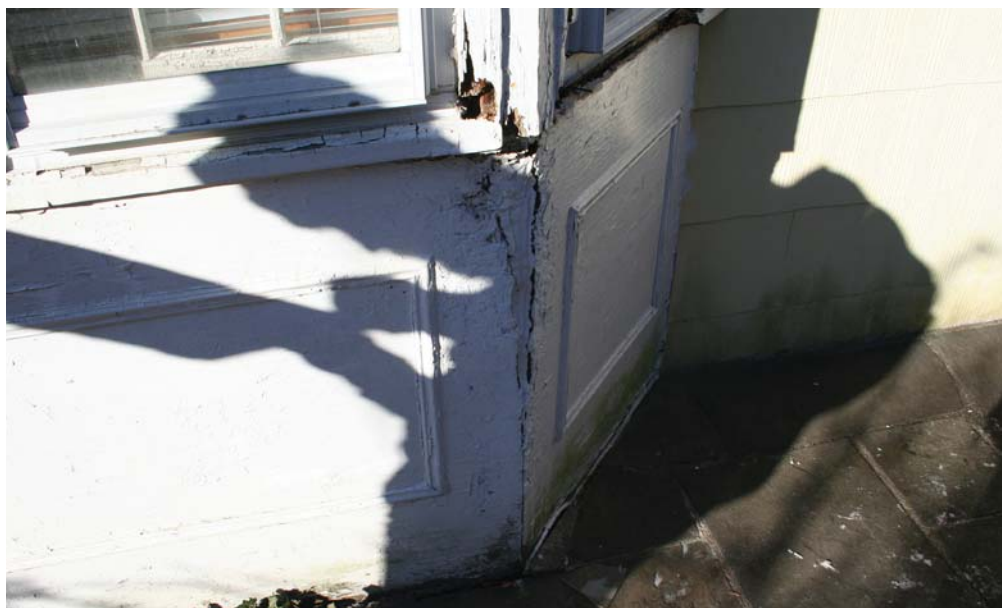
*View of wood rot & attempted repair under bay window on the east facade*

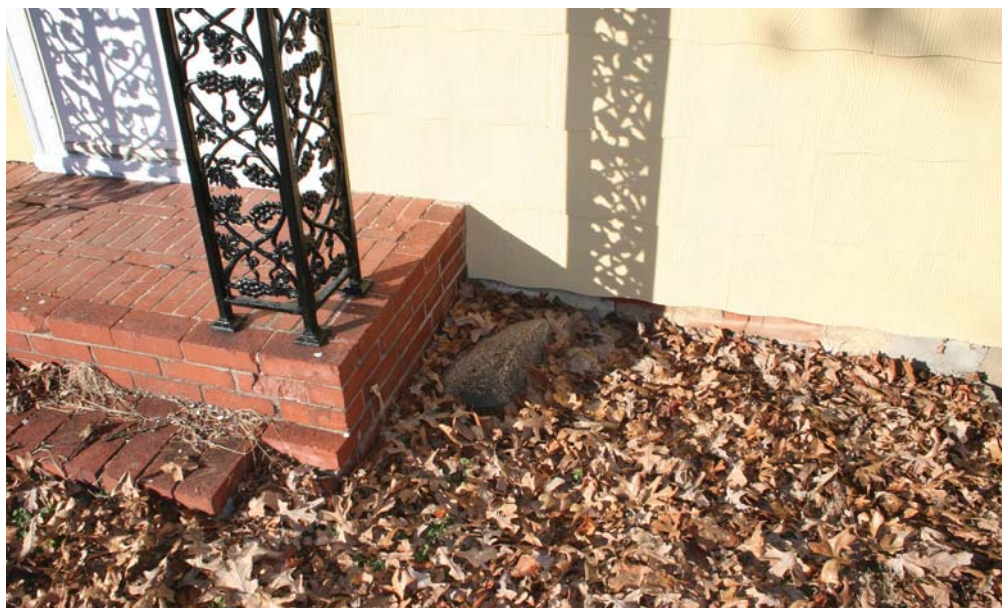
*View of front brick steps, note missing corner*

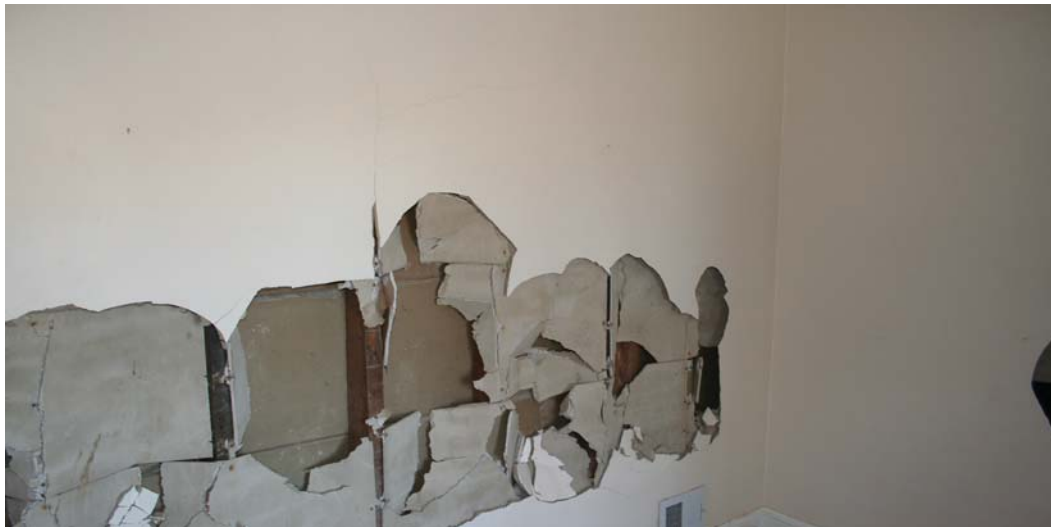
*View of damaged drywall in Bedroom 3*

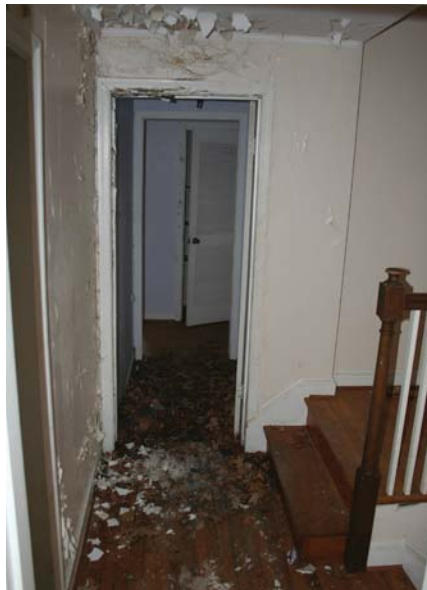
*View of damaged finishes in Second Floor Hallway*

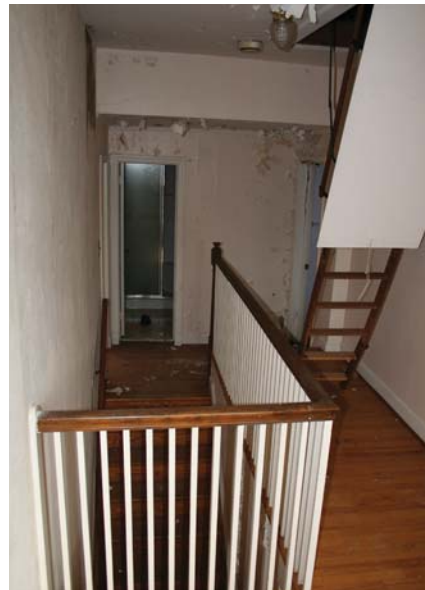
*View of damaged finishes and attic access in Second Floor hallway*

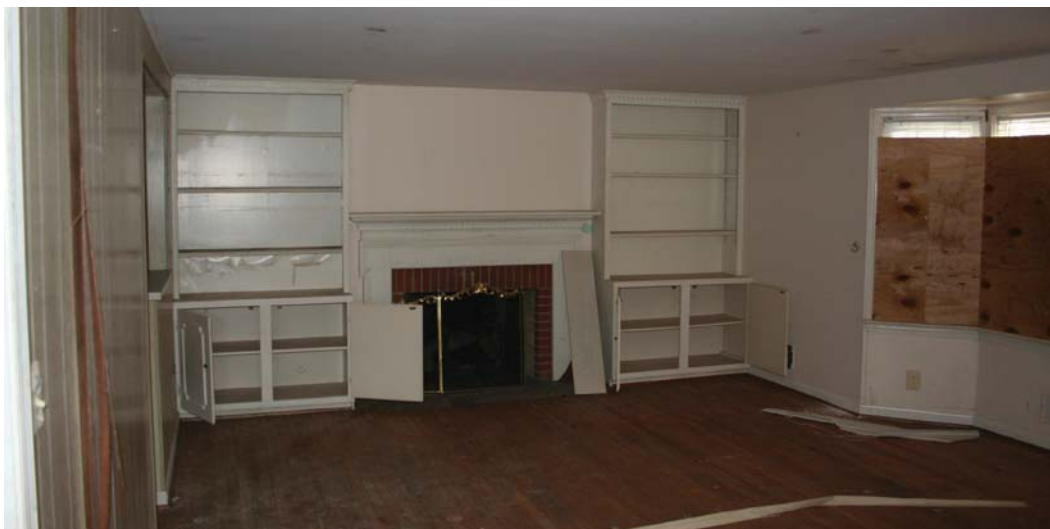
*View of Family Room looking north*

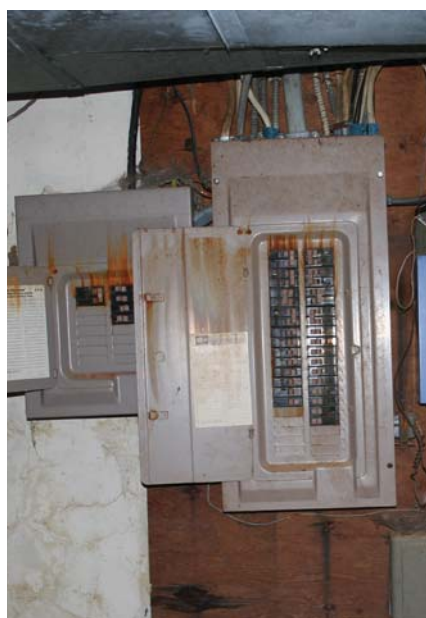
*View of rusted electric panel*

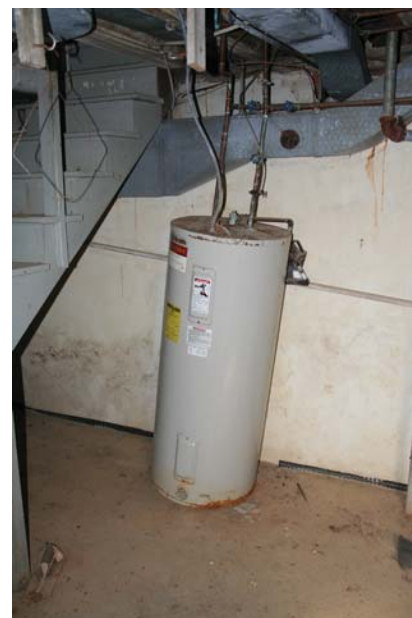
*View of basement water heater*

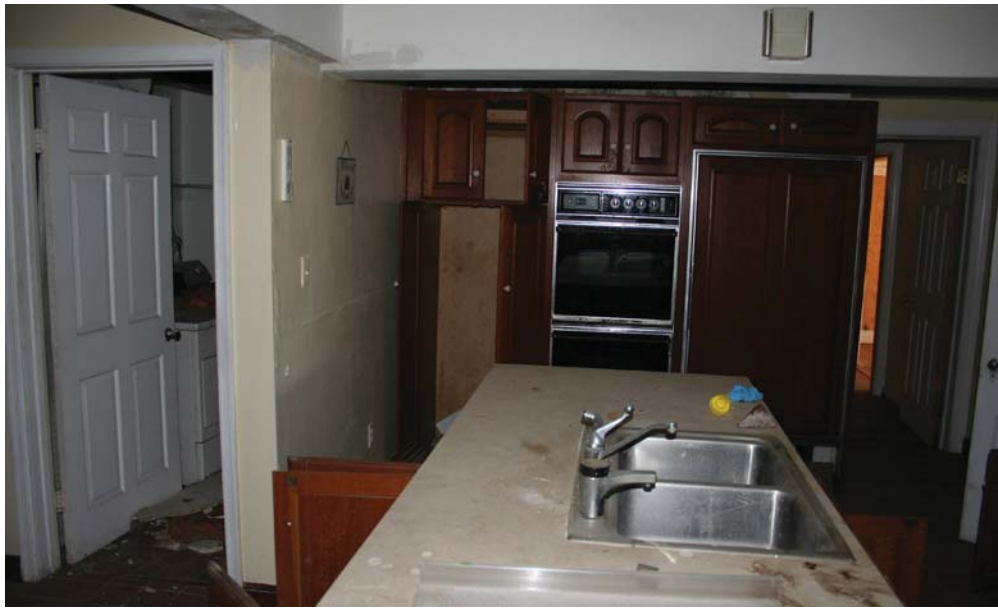
*View of kitchen & laundry room looking east*

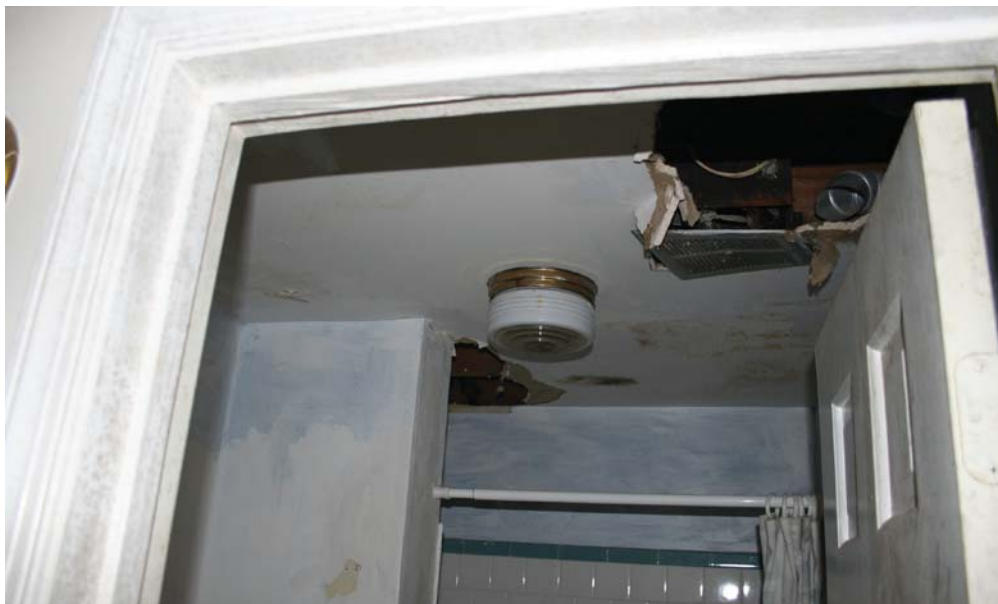
*View of ceiling damage in 1st floor bathroom*

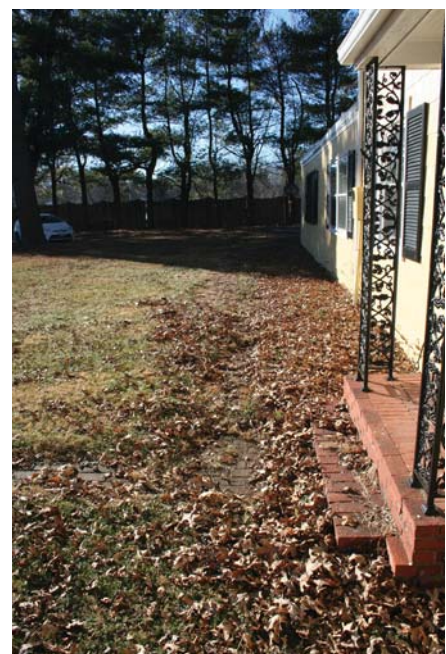
*View of front walkway*

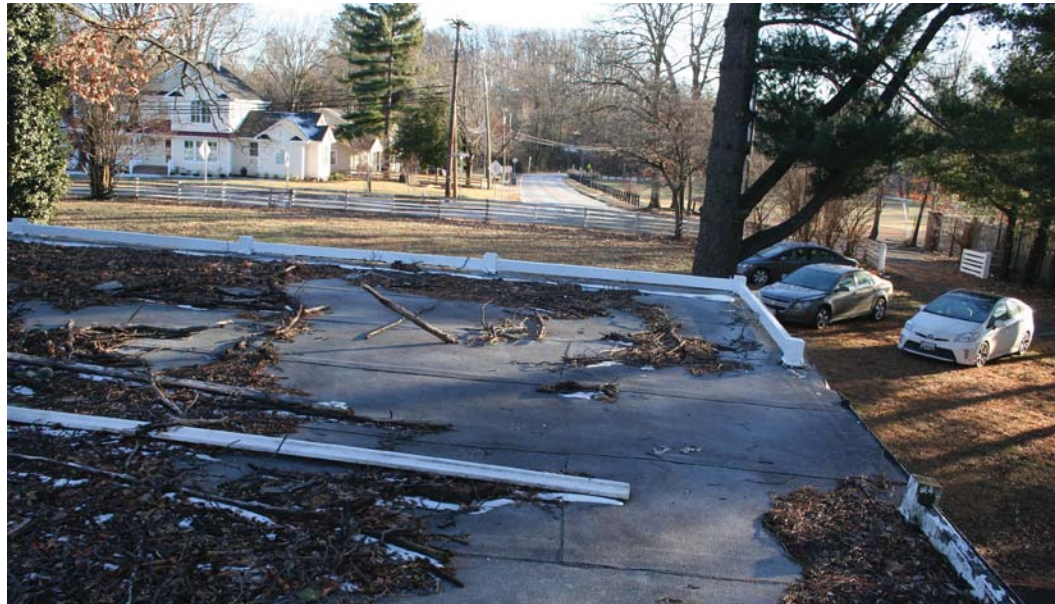
*View ontop of garage looking South towards Cedar Ave*

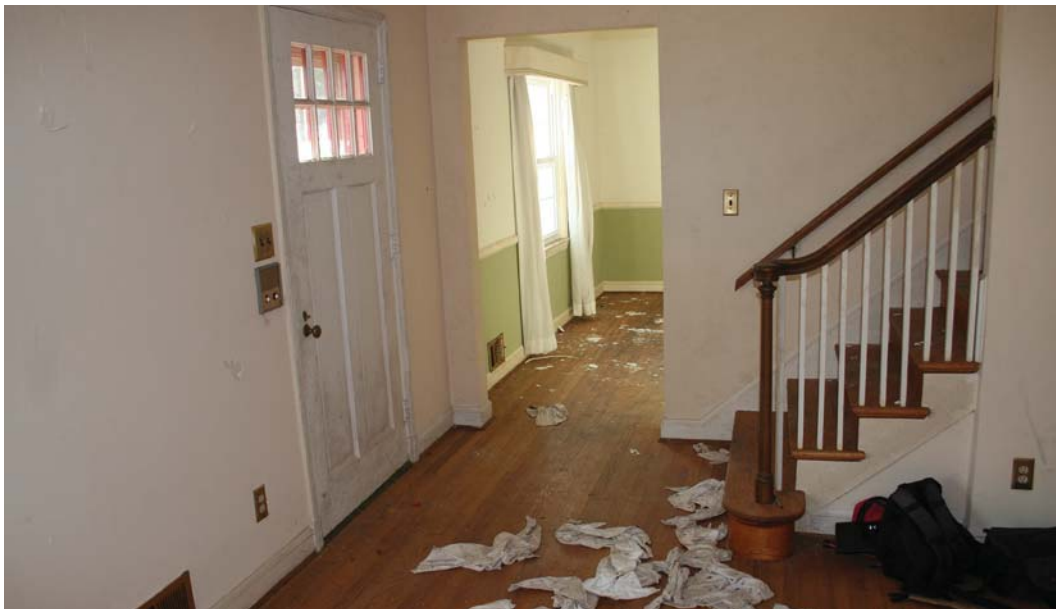
*View of front door and stairs to 2nd floor.*

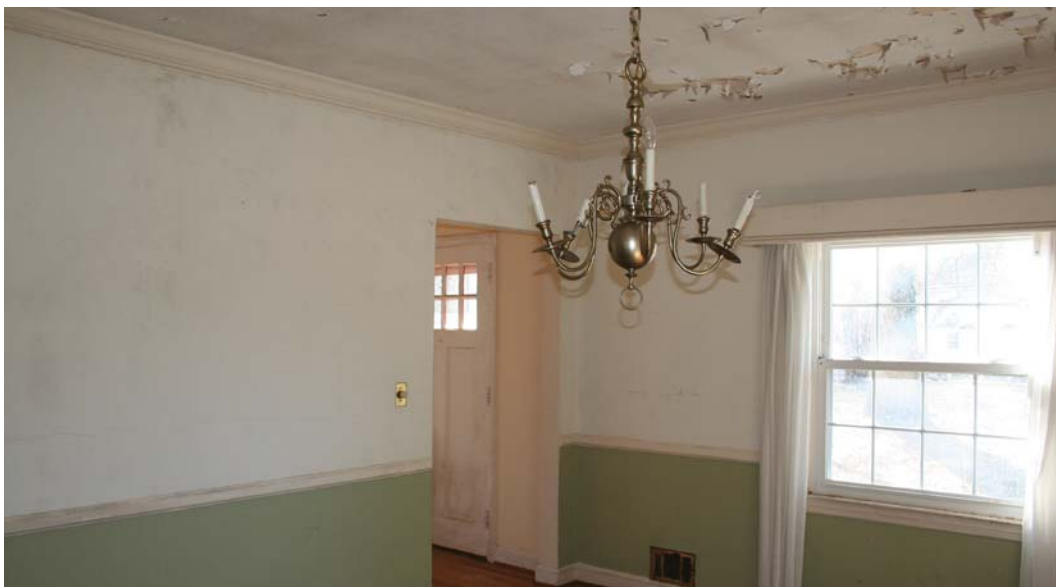
*View of Dining Room looking southeast*

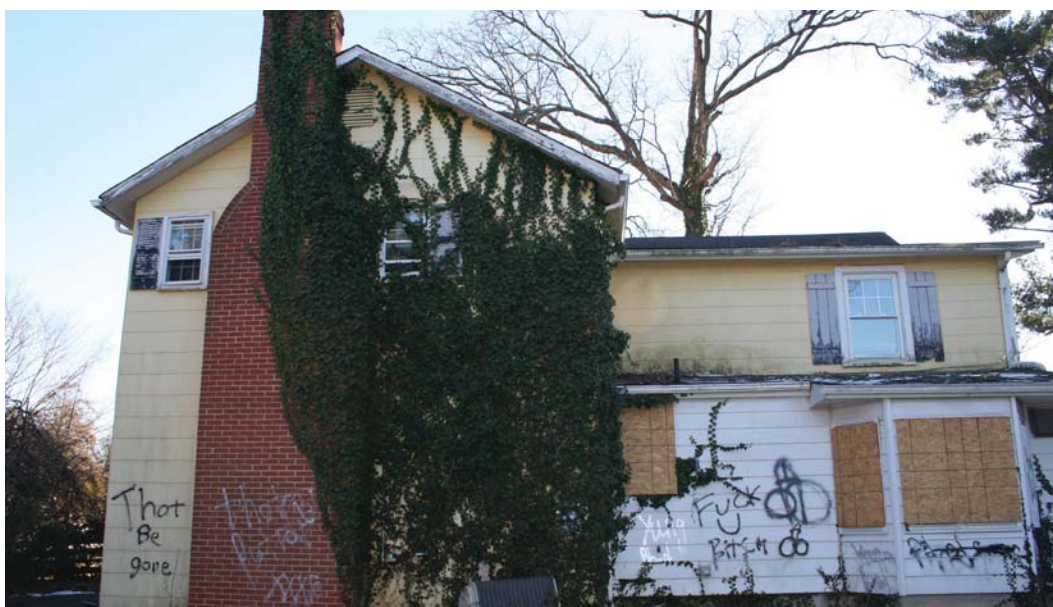
*View of North facade looking South*

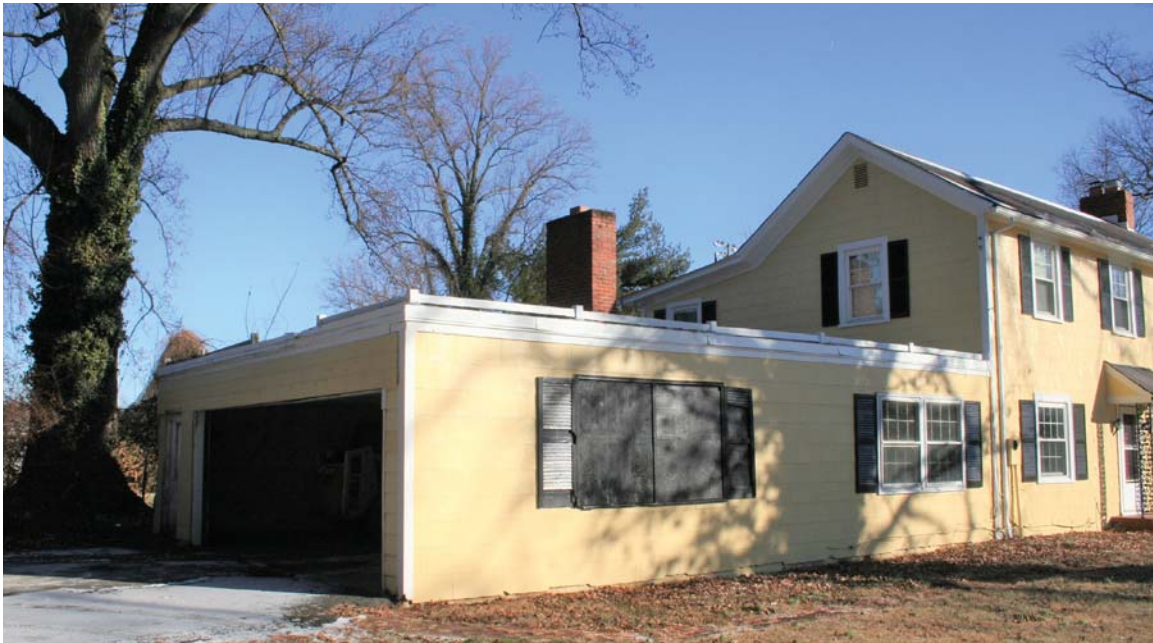
*View of garage looking northeast*

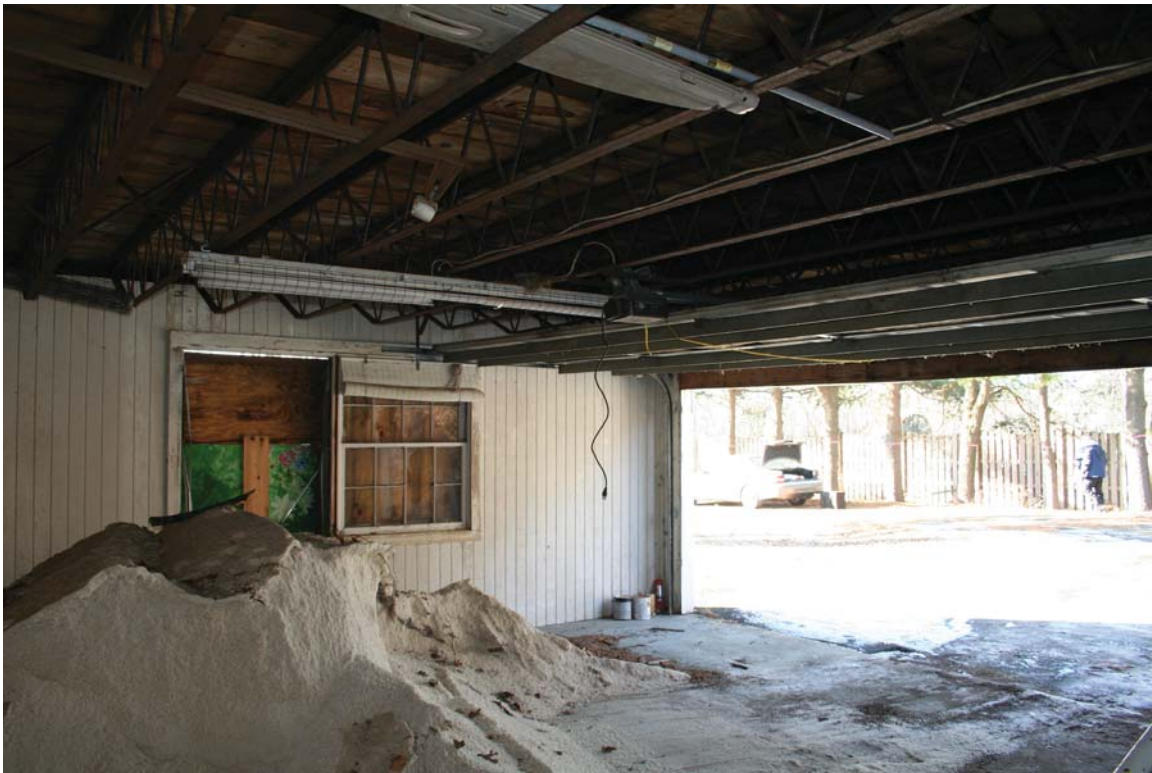
*View of garage interior looking southwest*

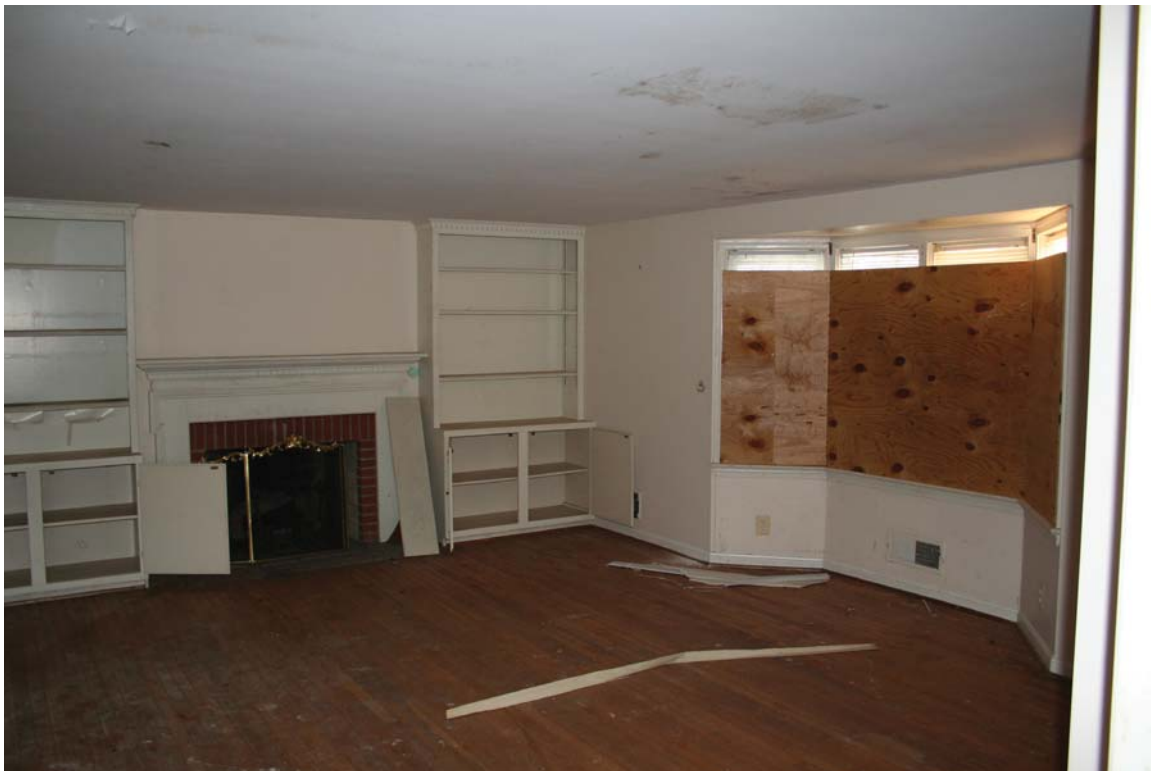
*View of Family Room looking northeast*

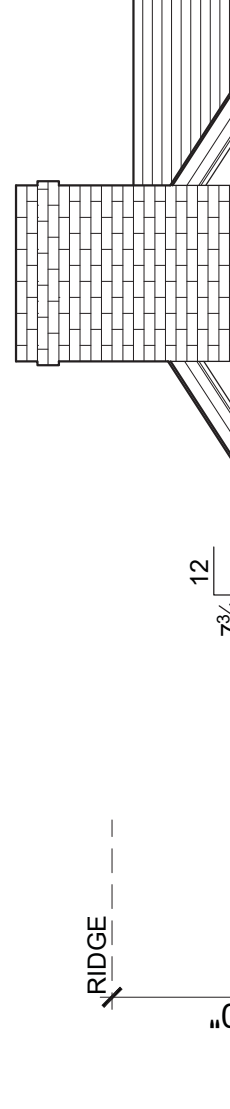
## APPENDIX 2: MSC CONDITION ASSESSMENT

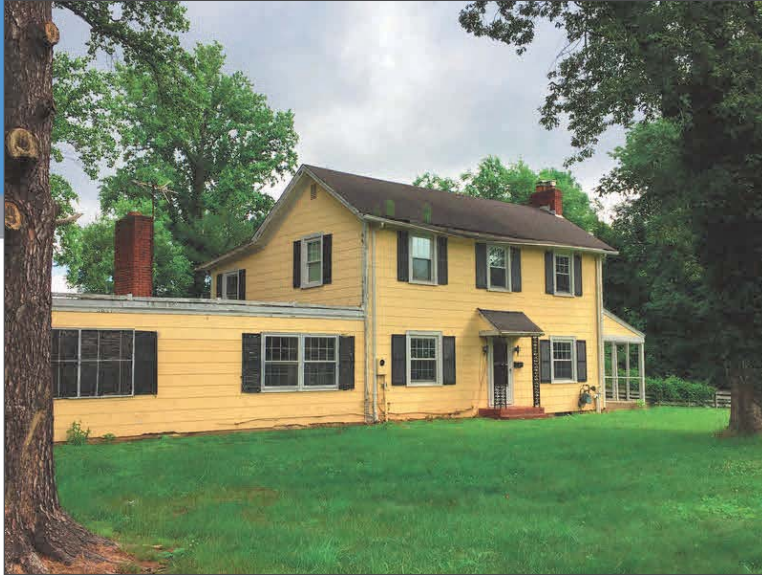
HAZARDOUS MATERIALS AND STRUCTURAL SURVEY

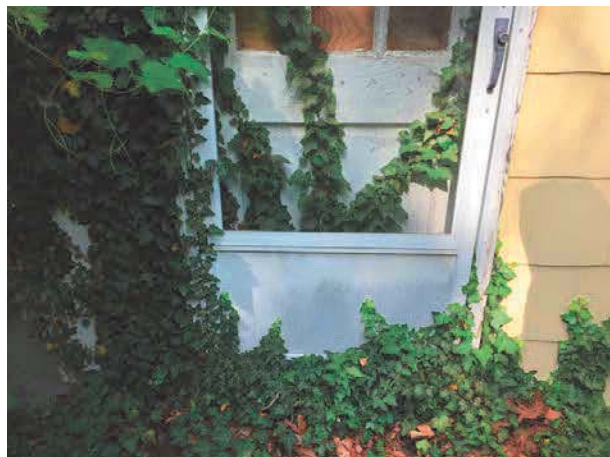
Growth on side door near porch

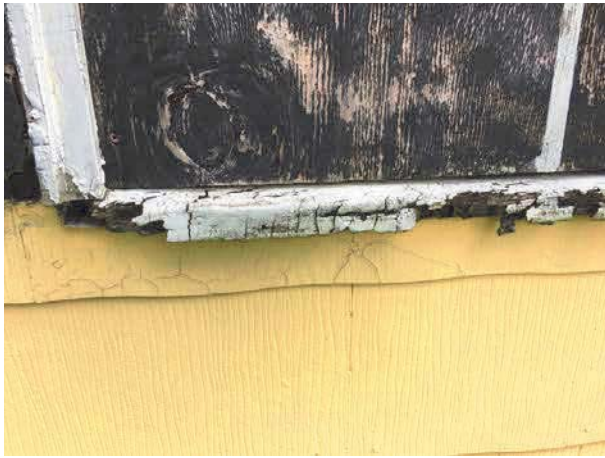
Window frame wood rot

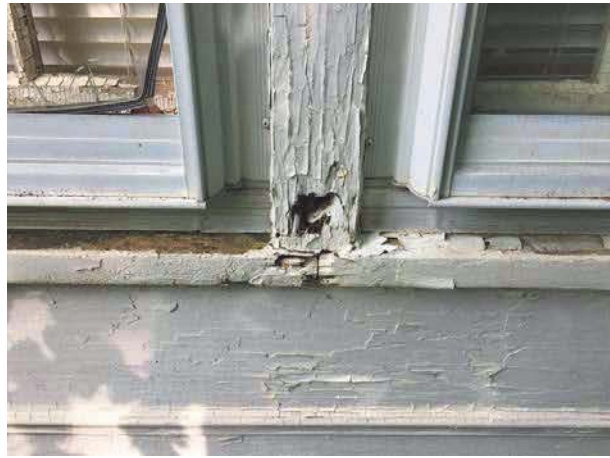
Window frame wood rot

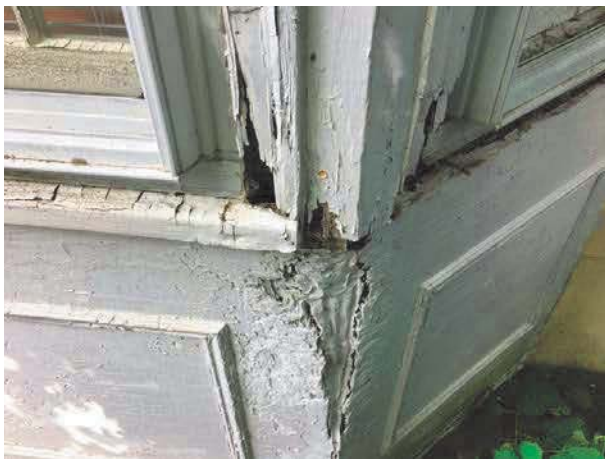
Window frame wood rot

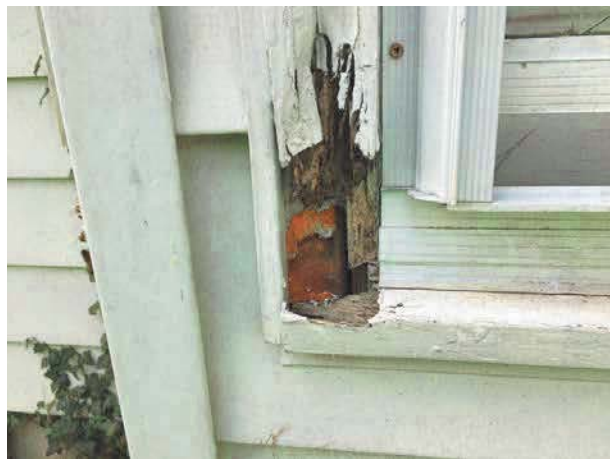
Window frame wood rot

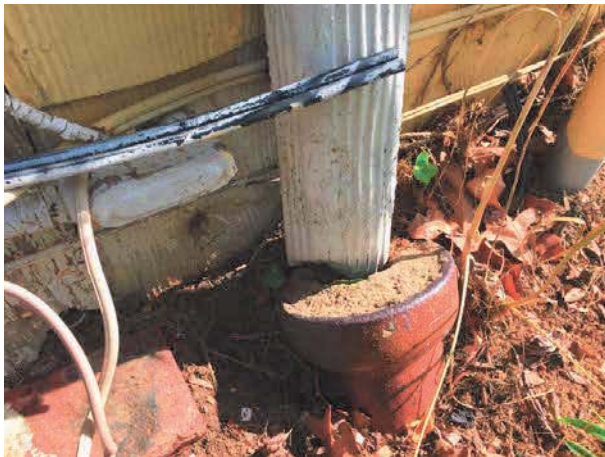
Downspout path blocked

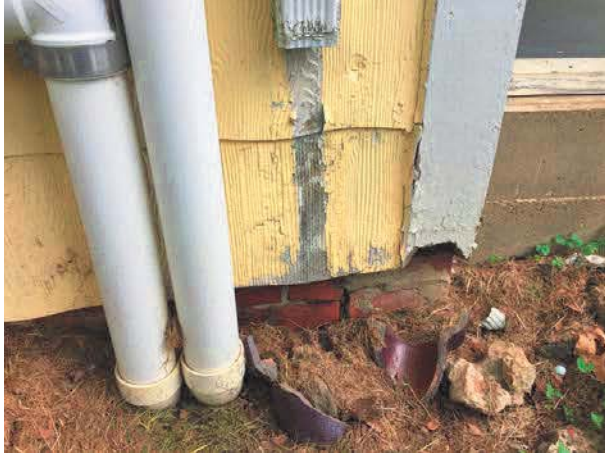
Downspout path blocked

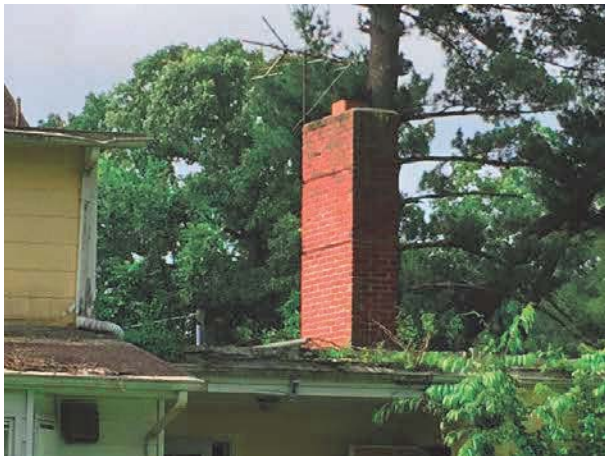
Gutters filled with debris

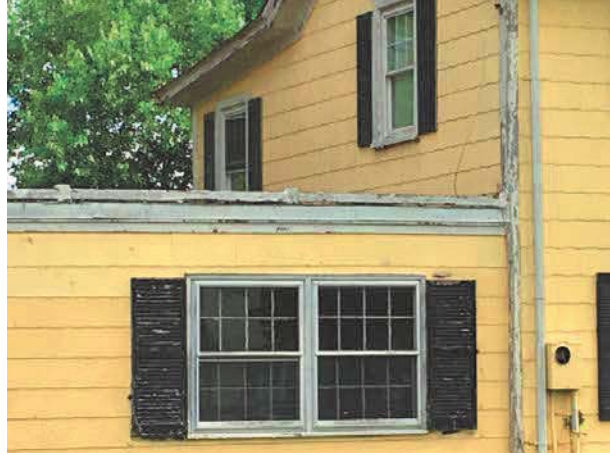
Gutters at the front

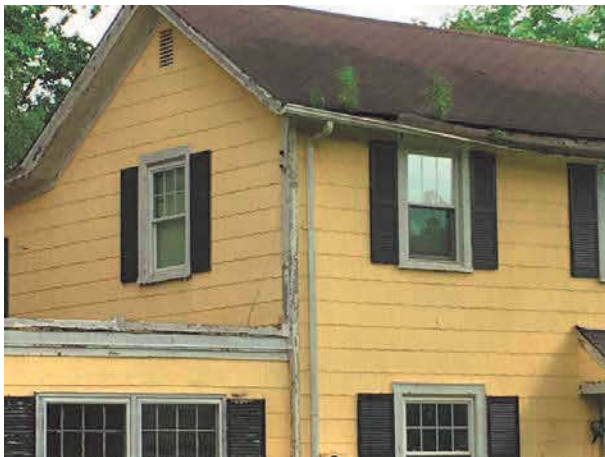
Typical roof condition

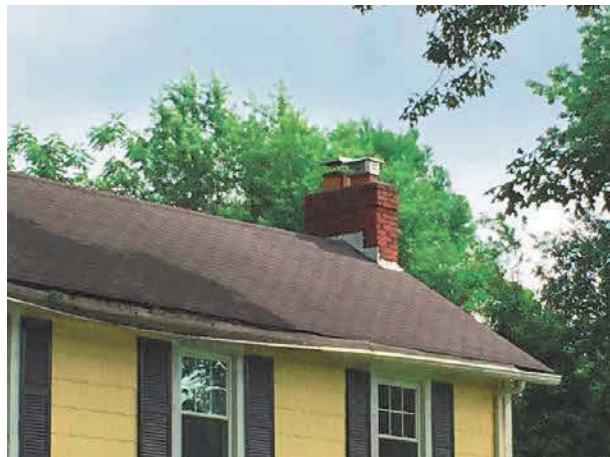
Typical roof condition

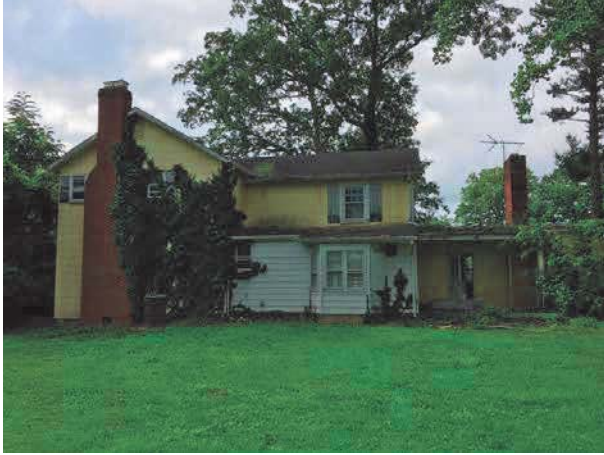
Flat roof at garage and laundry area

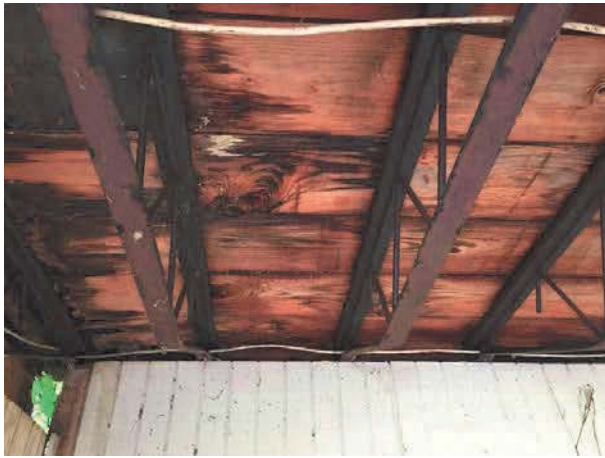
Wood roof water damaged

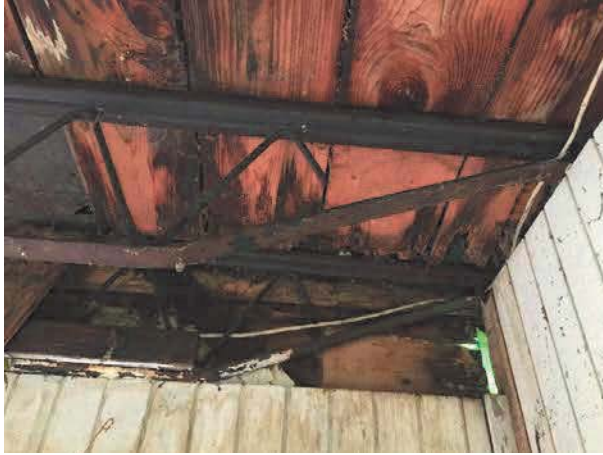
Steel surface rusted

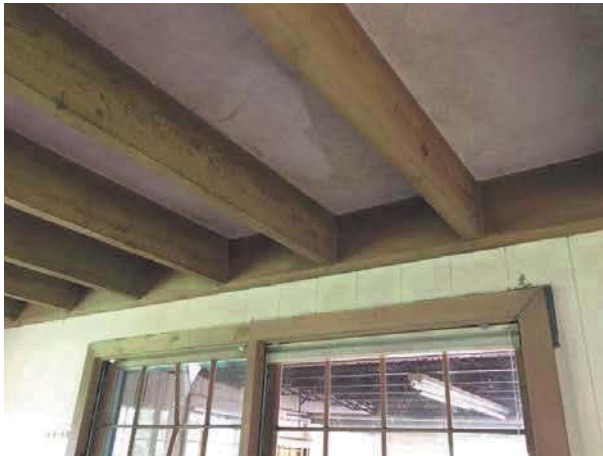
Exposed joists in room adjacent to garage

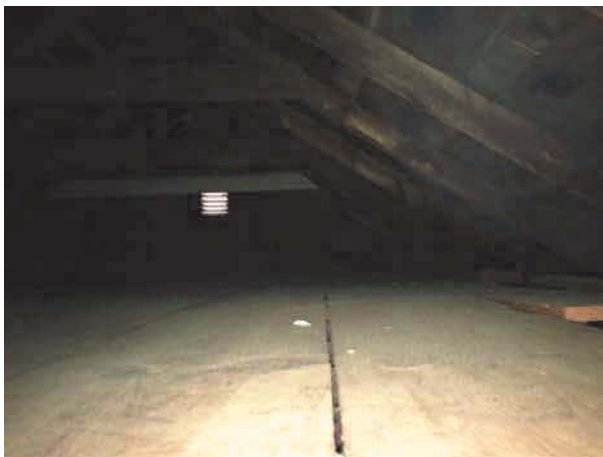
Rafter system supporting roof

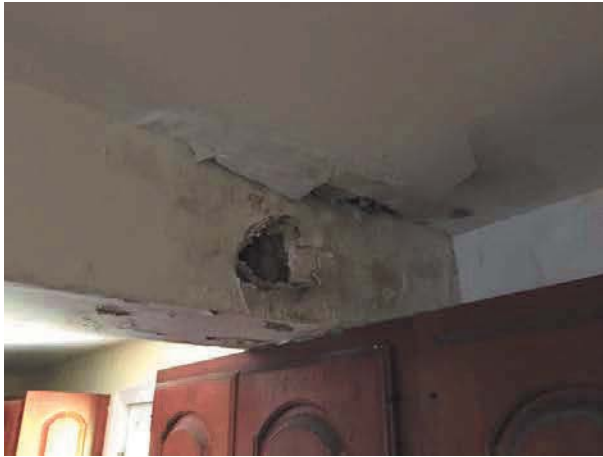
Water damaged drywall in kitchen

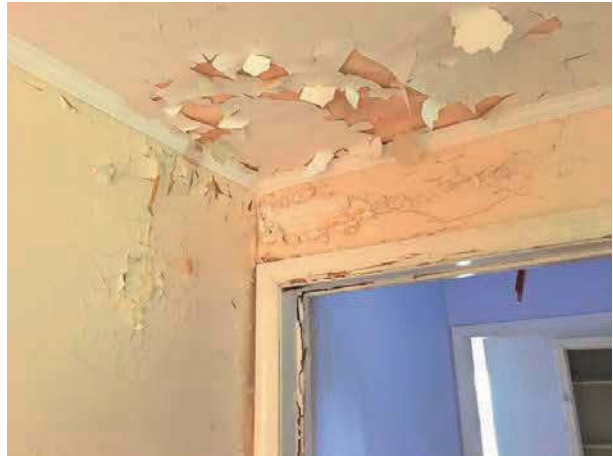
Ceiling paint peeling

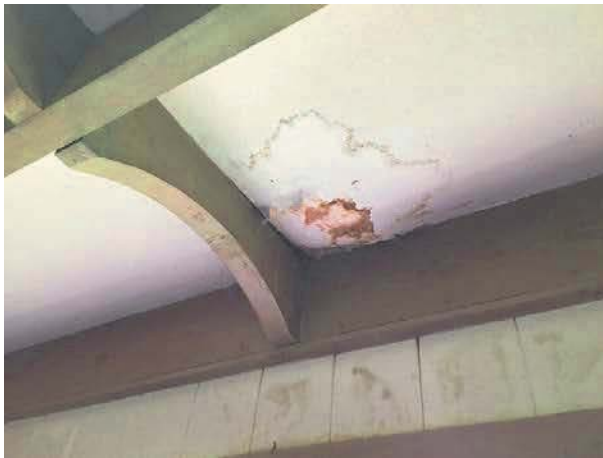
Water damage on ceiling in room adjacent to garage

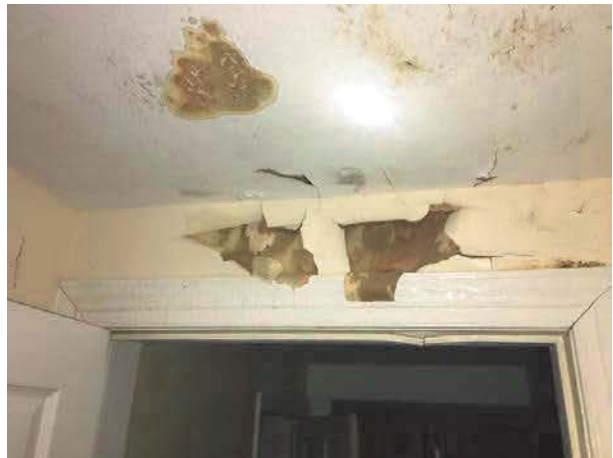
Paint peeling above door frame

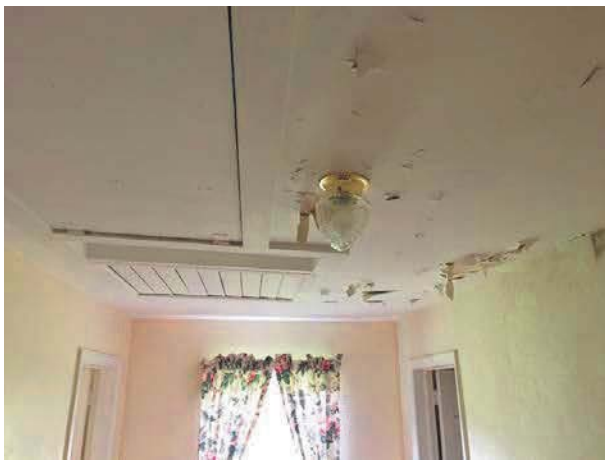
Second floor hallway ceiling sag

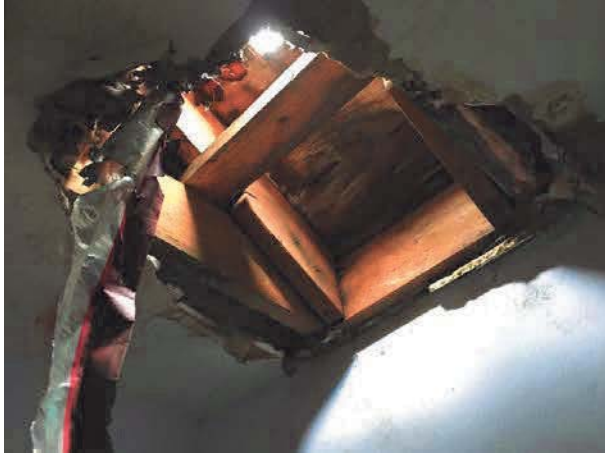
Hole penetrating from roof

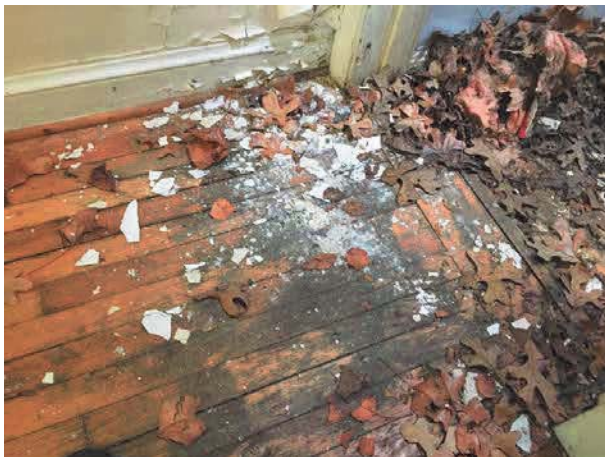
Debris fallen through hole creating possible water damage

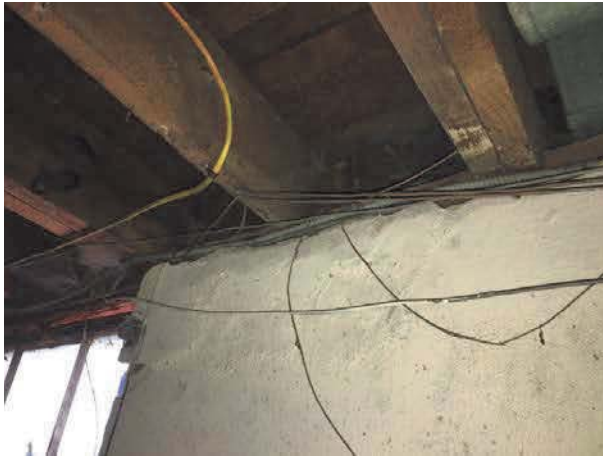
Organic growth penetrating from outside into basement

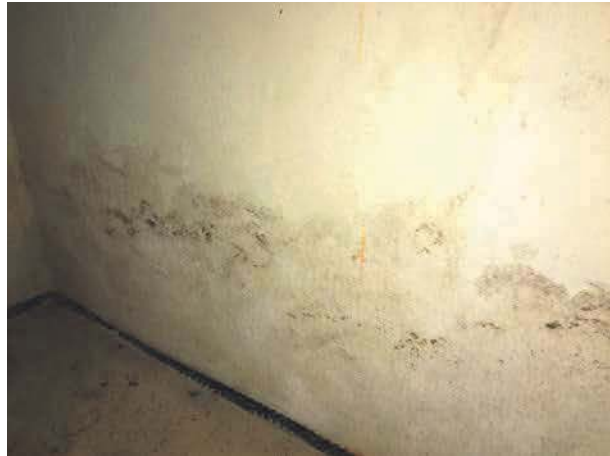
Water damage of the walls

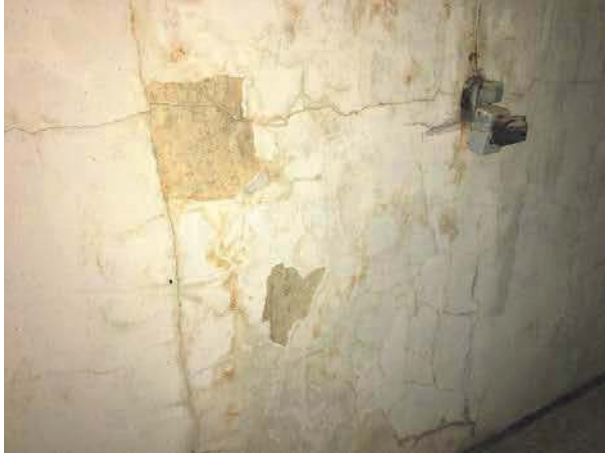
Cracks in the parged walls

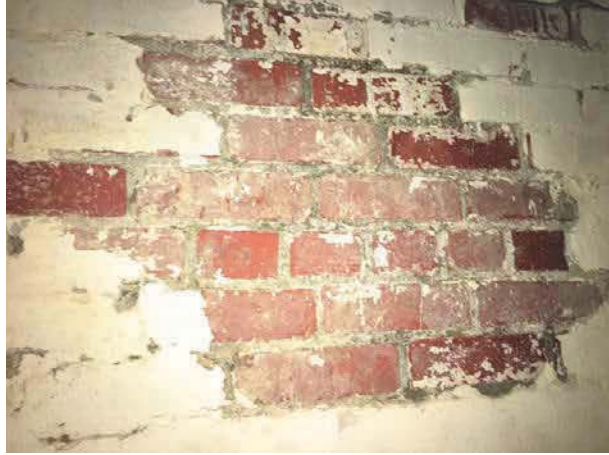
Exposed area of basement wall

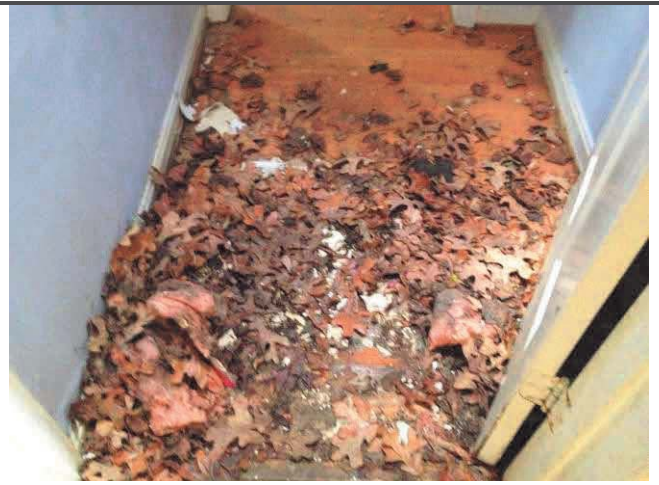
8. View of debris on the floor, partial hole in the floor from the roof leak.
