**JOHN C. WOOD HOUSE  
FAIRFAX, VIRGINIA**

**MODIFIED HISTORIC STRUCTURE REPORT**

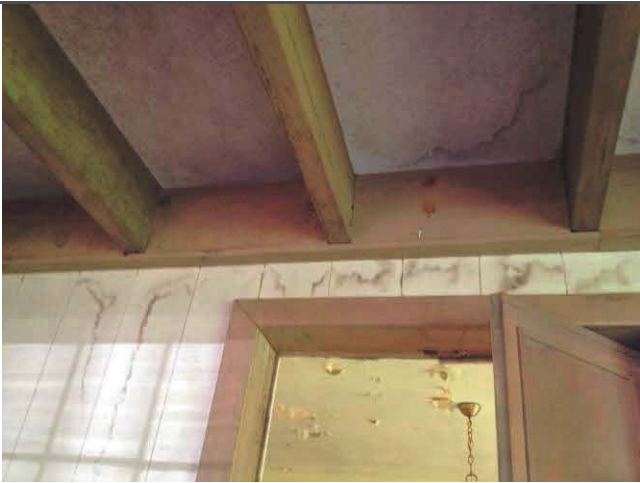
9. View of visible mold on the ceiling/walls in the den.

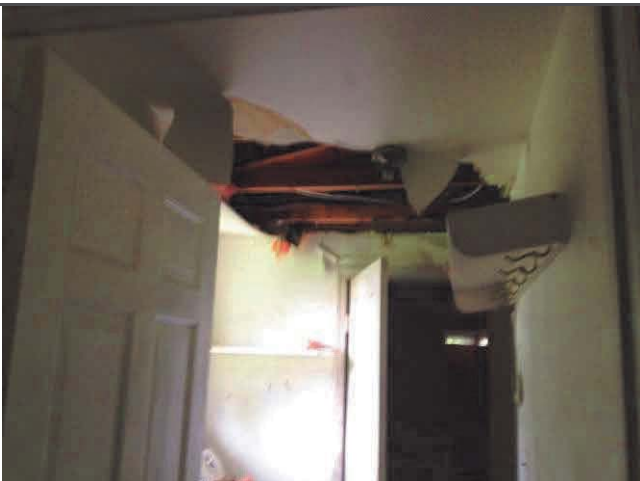
17. View of the ceiling damage from a roof leak in the laundry room/hall.

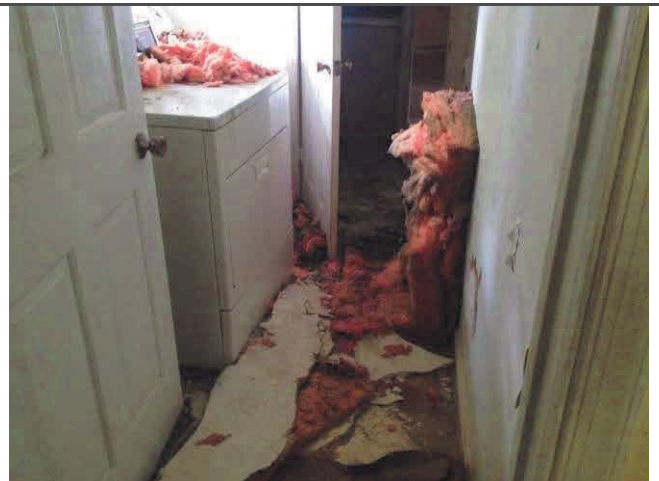
18. View of impacted materials from a roof leak in the laundry room/hall.

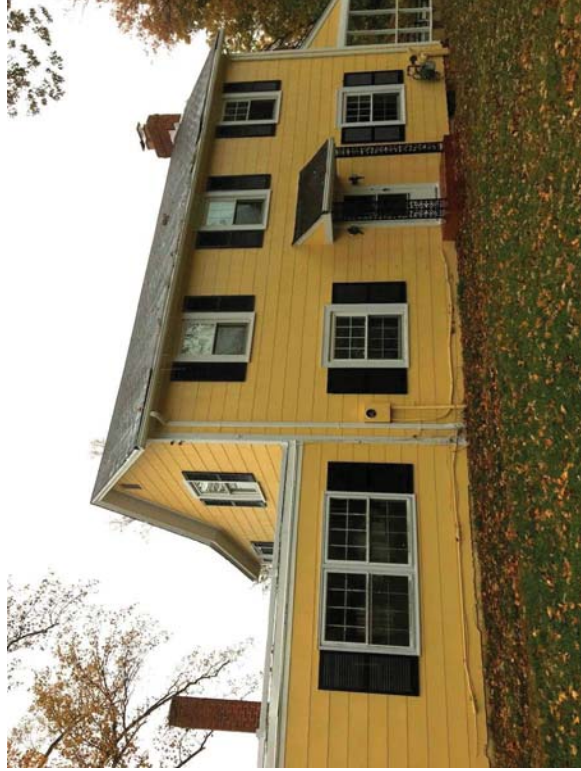
Front elevation / main entrance of property. South facing.

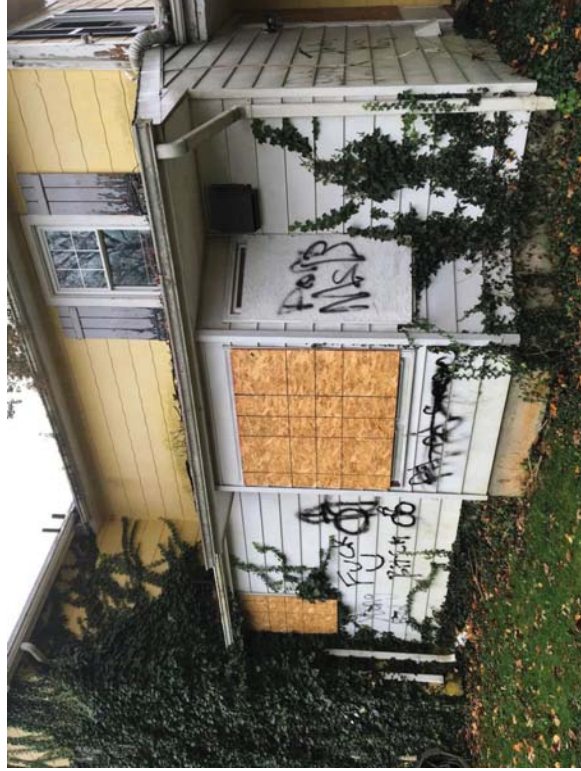
North elevation of property.

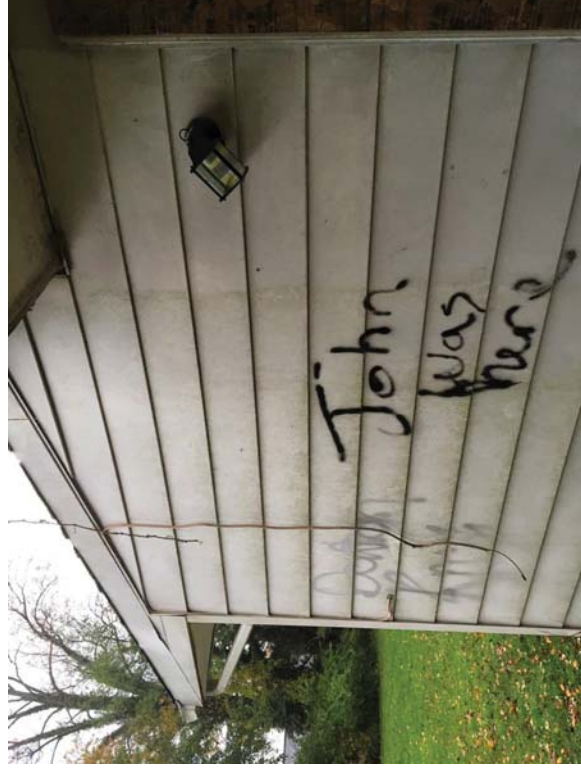
North elevation of property.

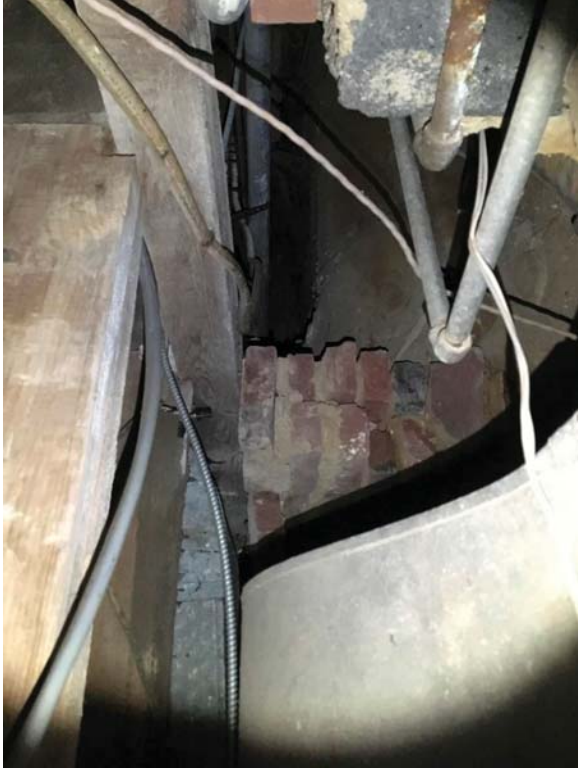
Crawl space under main portion of structure. Significant deterioration of masonry support.

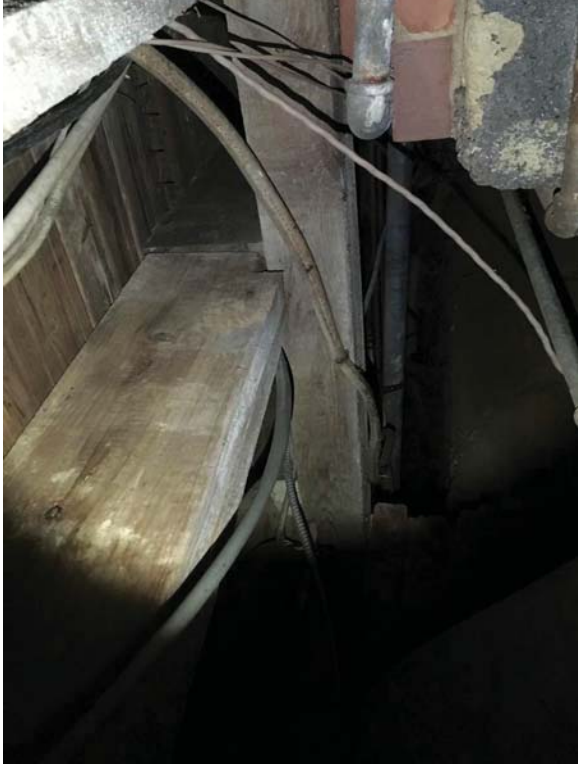
Displacement of floor beam. Beam appears undersized.

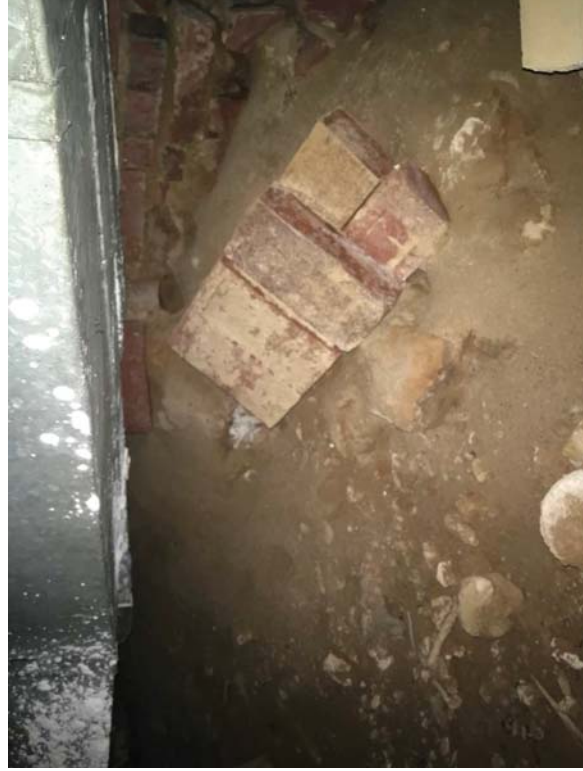
Partial collapse of masonry foundation.

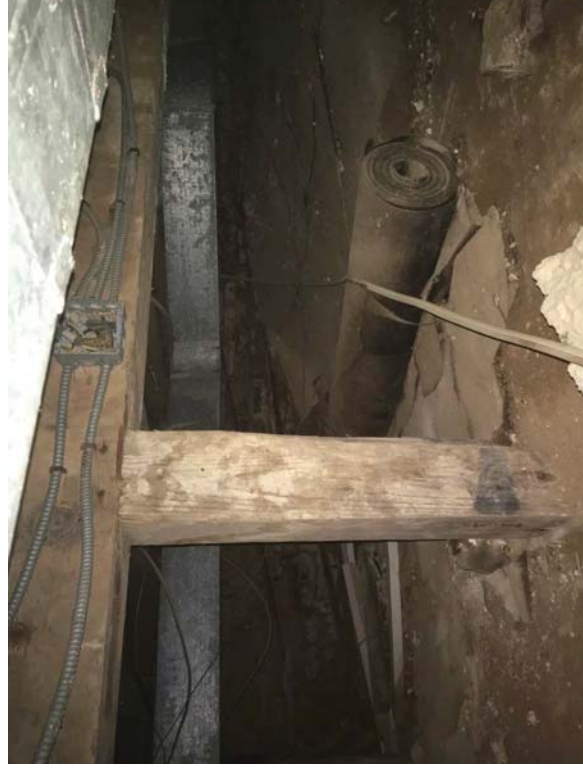
Wood post with crawl space, supporting floor. Wood deterioration.

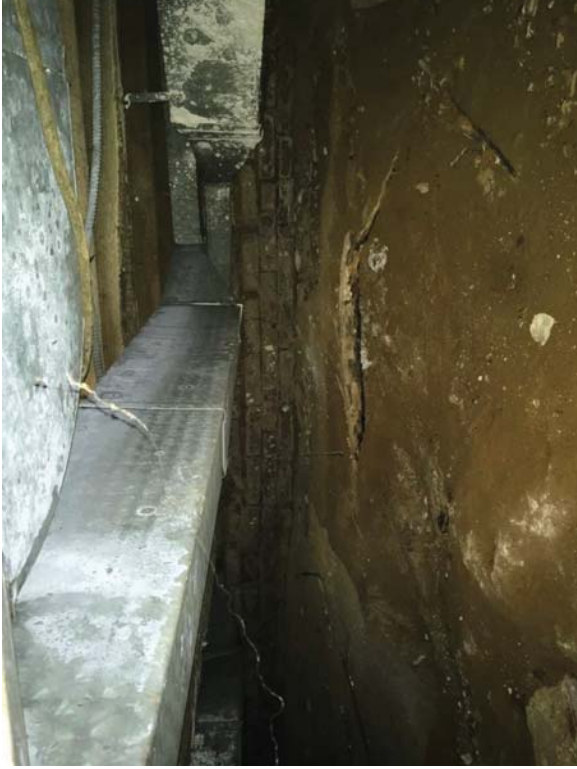
Crawl space under main portion of structure.

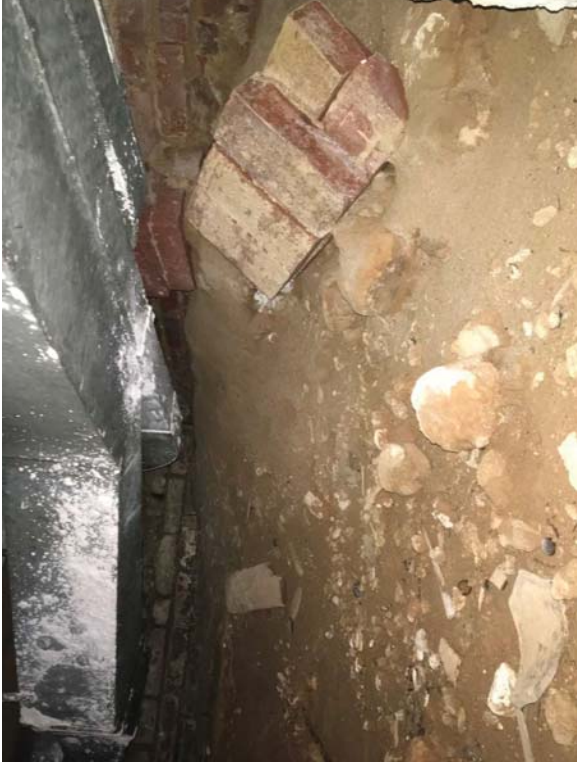
Partially collapsed masonry foundation.

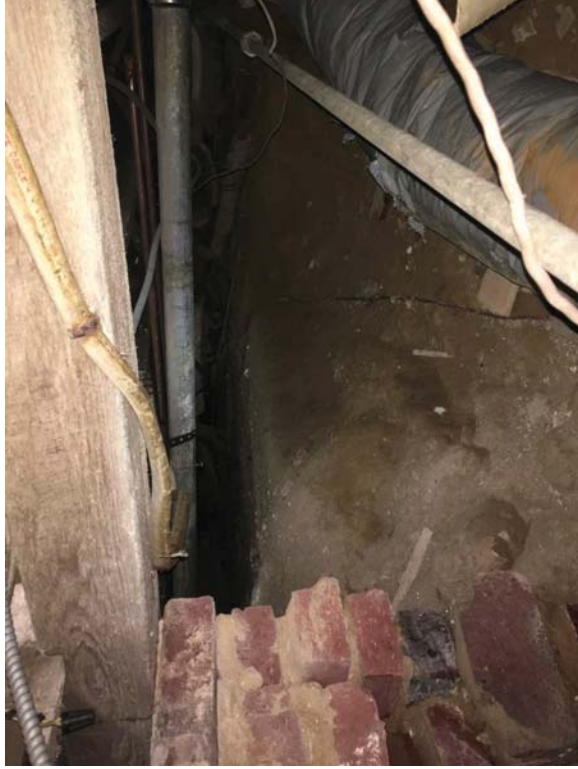
Significant deterioration of masonry foundation.

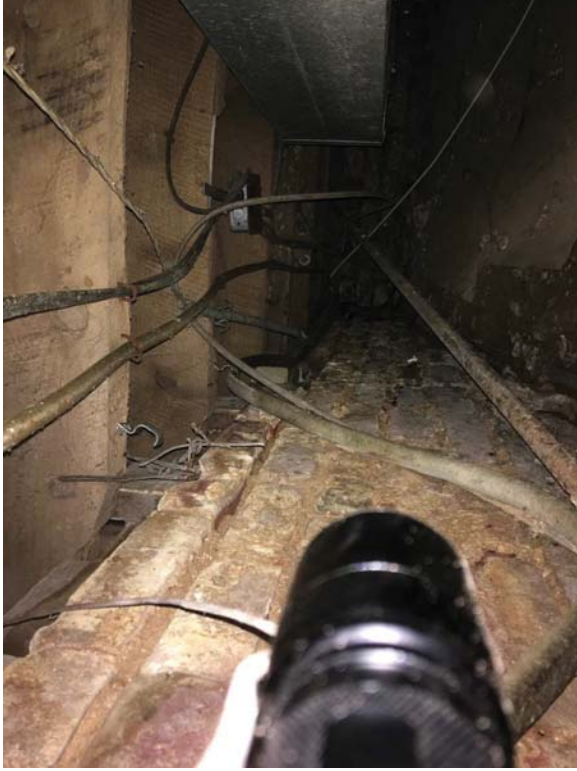
Significant deterioration of masonry foundation.

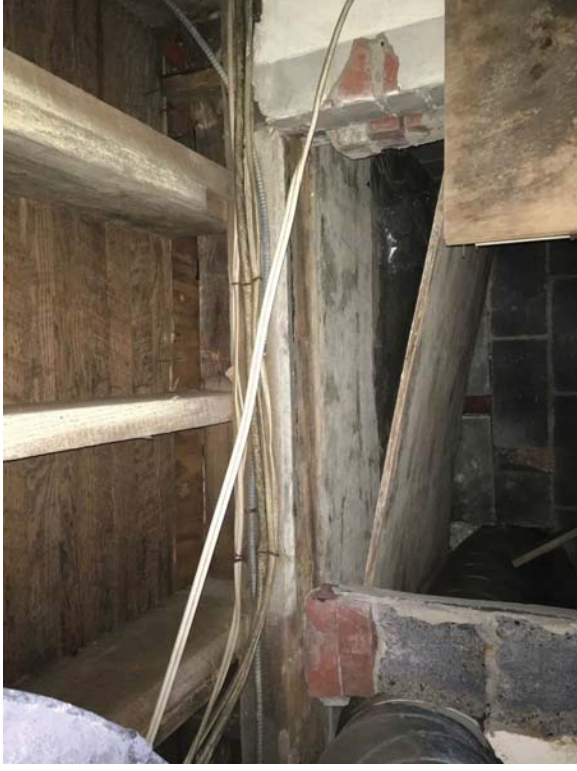
Floor support beam spanning opening.

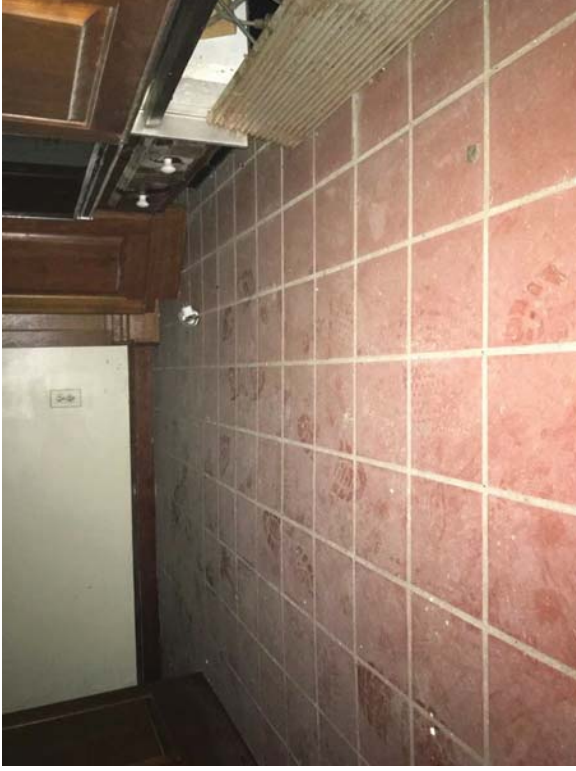
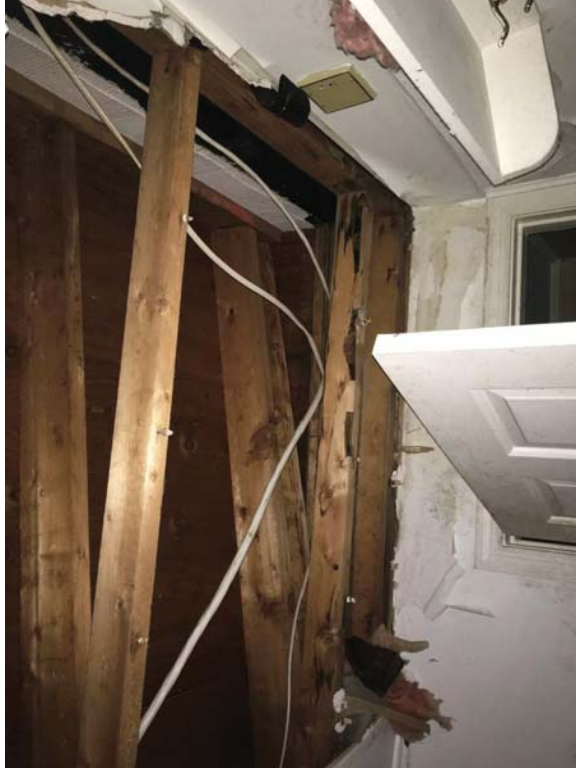
Collapsed ceiling observed on First Floor caused by water infiltration.

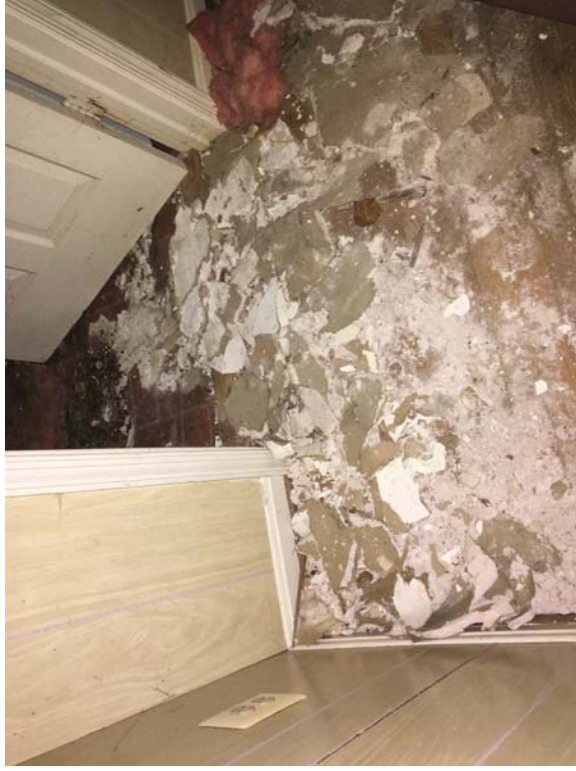
Collapsed ceiling debris on floor.

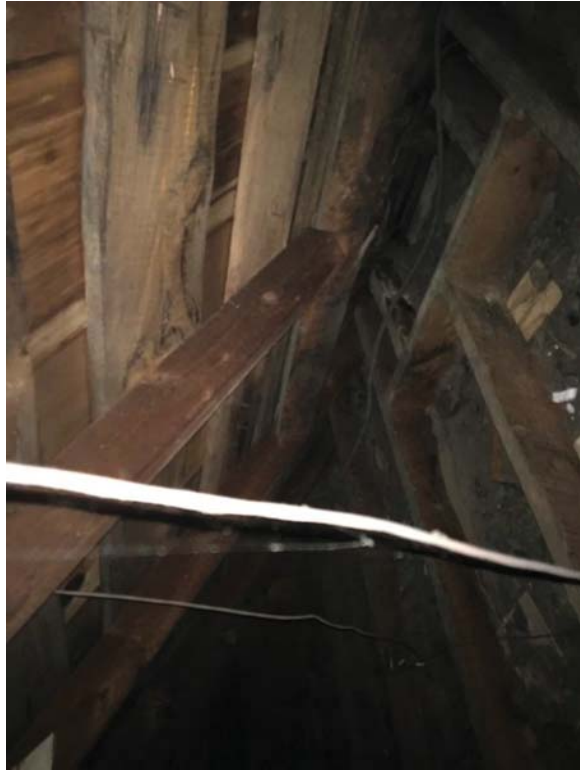
Water infiltration at roof framing. Partial failure of wood framing.

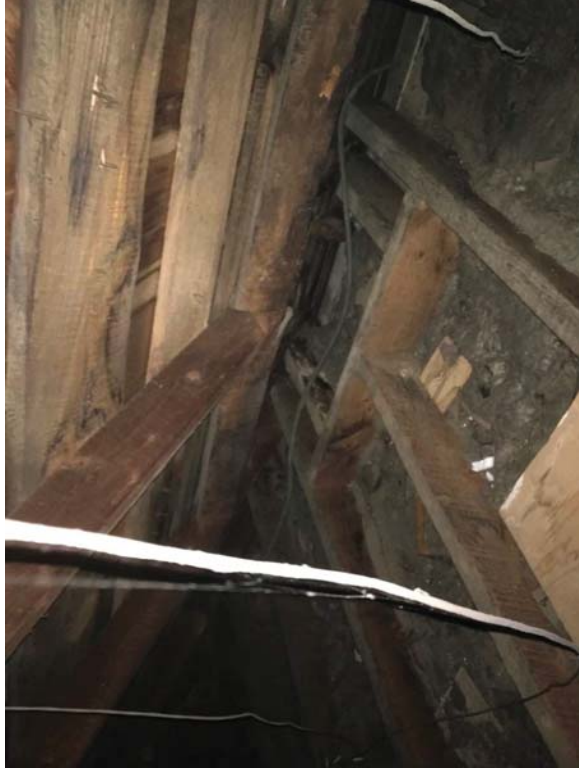
Partial failure of roof framing.

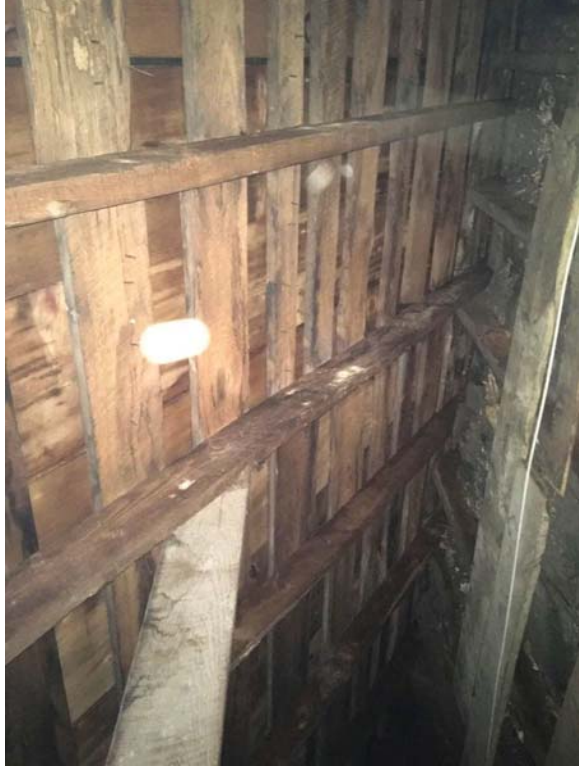
Base of roof rafters appear to have displaced outward. Wood framing appear bowed and twisted.

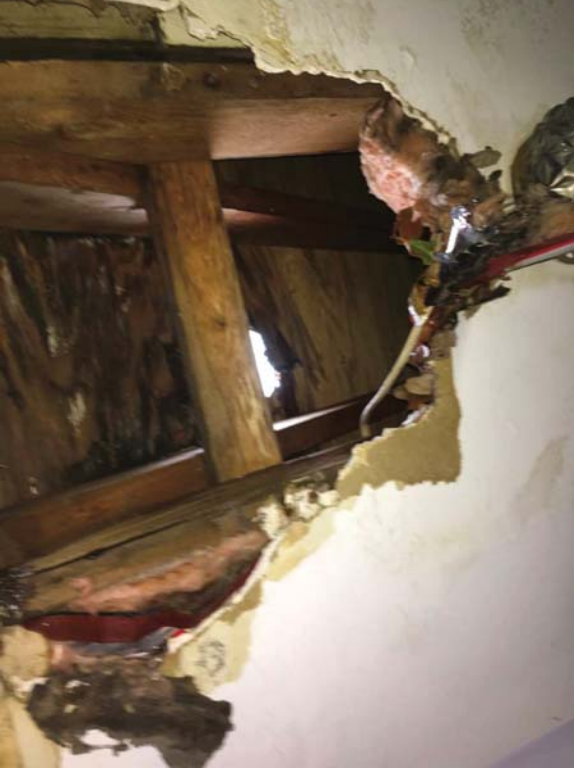
Partial collapse of roof structure.

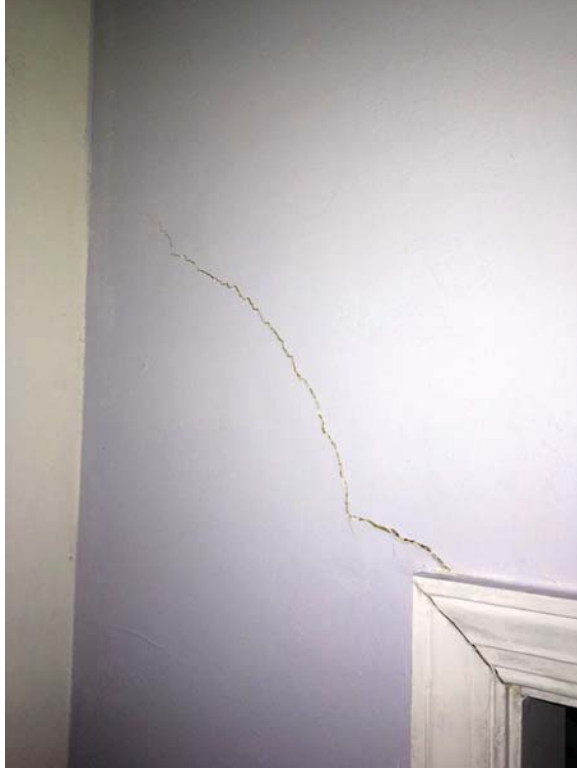
Typical diagonal cracking through wall finish at opening corners.

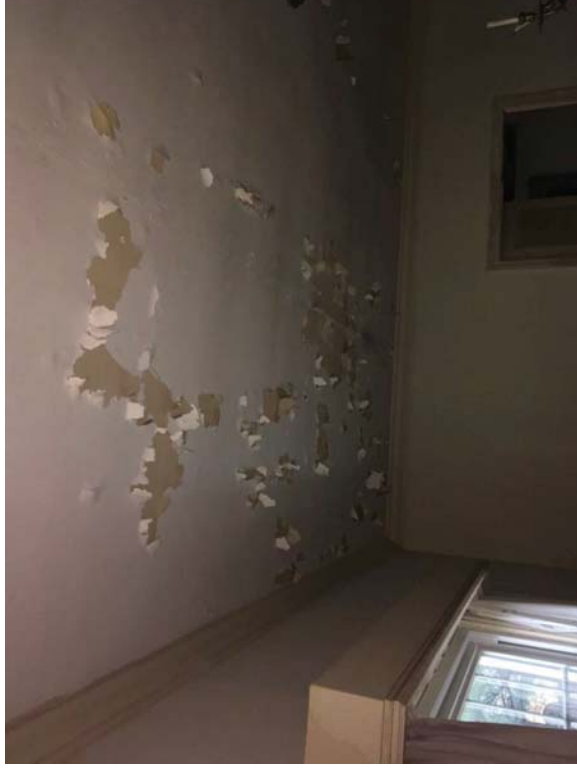
Peeling paint typical throughout building.

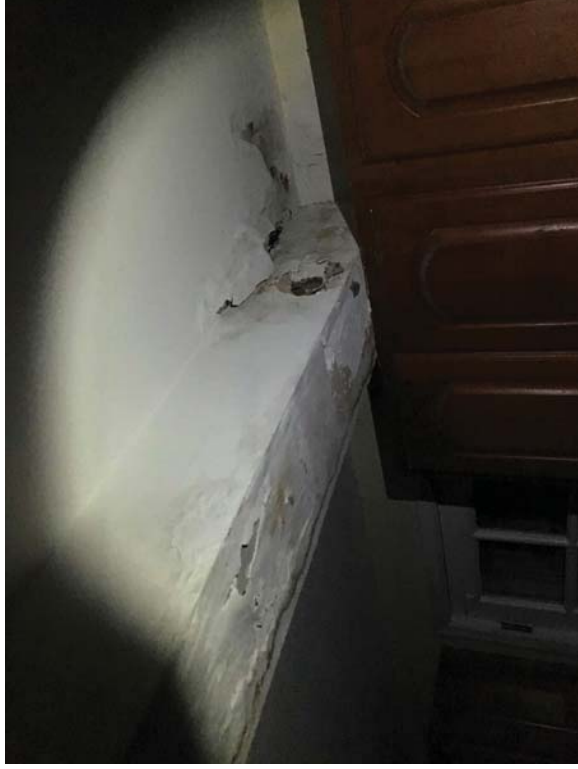
Water damage to finishes.
