PROJECT: Paul VI	PROJECT NUMBER: 17-124	PAGE: 1
REPORT DATE: 09-01-2017	REPORT NUMBER: 1	DATE OF SITE VISIT: 07-25-2017
TO: Patrick Rhodes – IDI Group		TIME OF SITE VISIT: 1:00 pm
		WEATHER/TEMP: SUNNY/85
<p>PROJECT: Paul VI - Condition Assessment Study of Original School Section</p> <p>LOCATION: 10675 Fairfax Blvd. Fairfax, VA</p> <p>SITE VISIT BY: D. Linton - LE</p> <p>PRESENT: P. Rhodes - IDI</p>		
<p>OBSERVATIONS/DISCUSSIONS: The following observations were made of the original 24,000 SF circa 1935 portion of the existing school building. All findings are based upon the visually accessible portions of the existing structure. The existing building is two stories above grade and appears to have been constructed with open web steel joists spanning to masonry bearing walls at the exterior and at the two corridor wall locations. A utility tunnel occurs below the first-floor corridor.</p> <p><u>Second Floor Level:</u></p> <p>The 2nd floor structure is framed with open web steel joists spanning front to back. See Photo #1. The joists are supported by the existing brick walls at the sides of the corridor and at the exterior walls. At some locations, the corridor walls are discontinuous

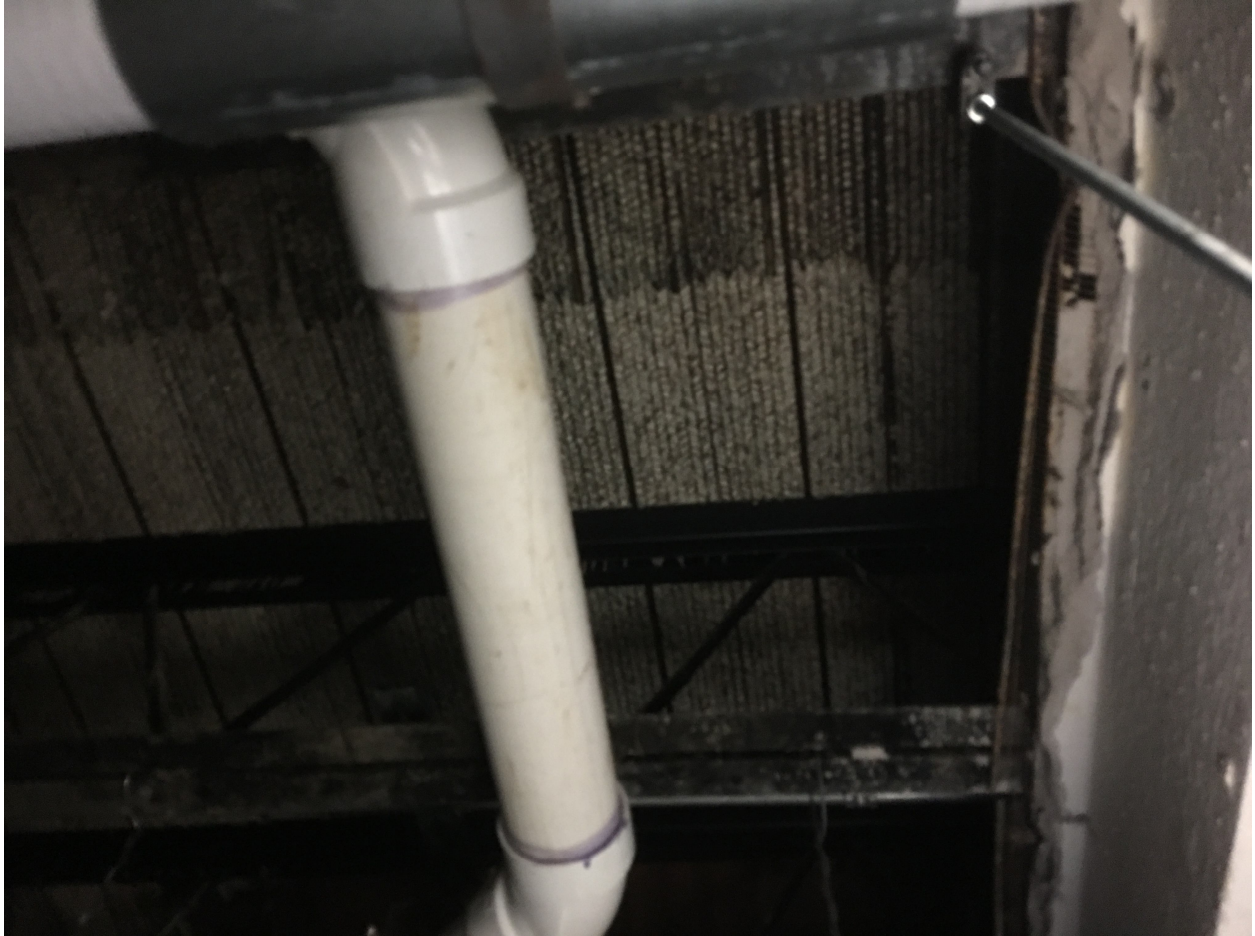
Photo #1: Underside of 2nd floor joists with metal lath decking

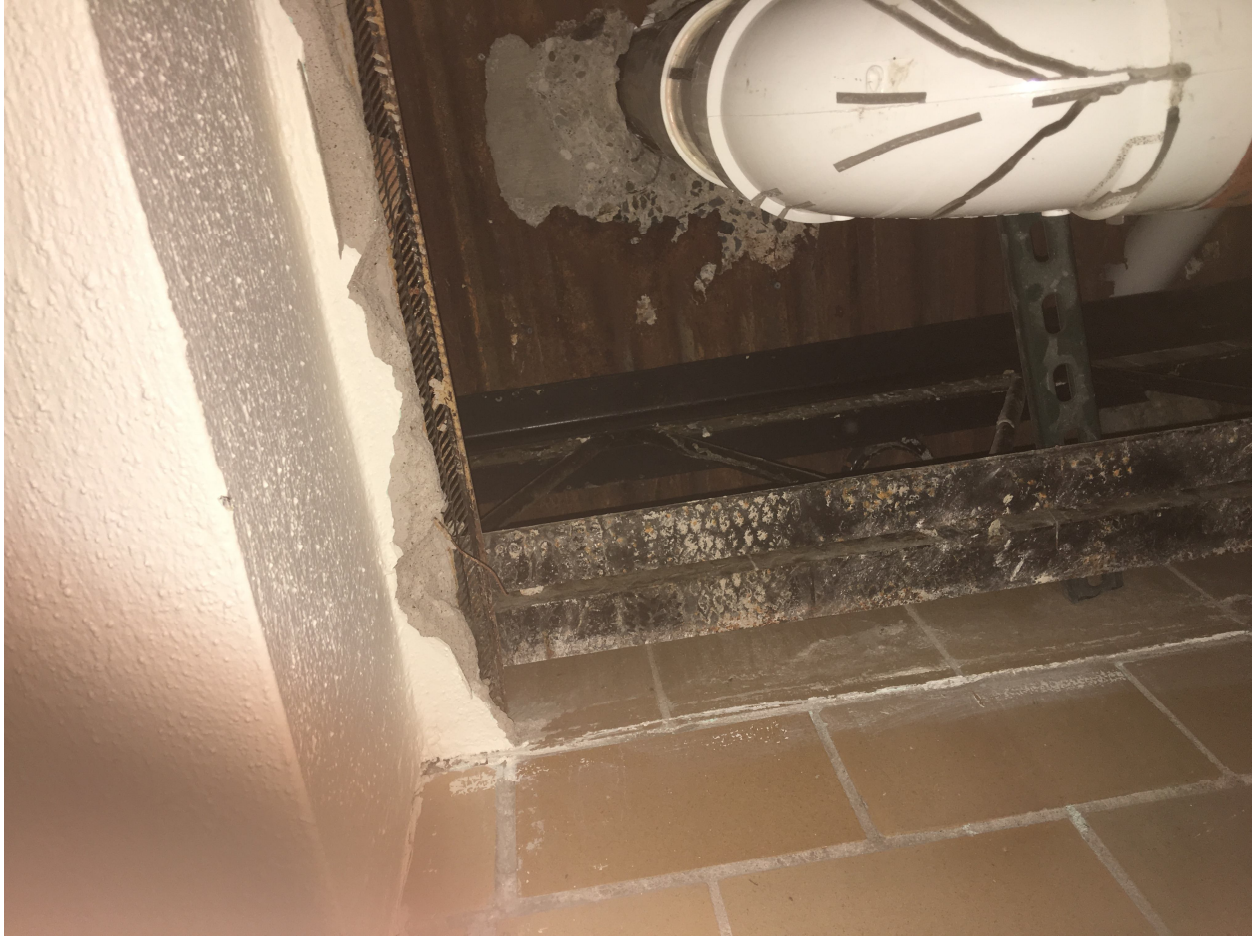
Photo #2: Underside of 2nd floor joists with steel form decking

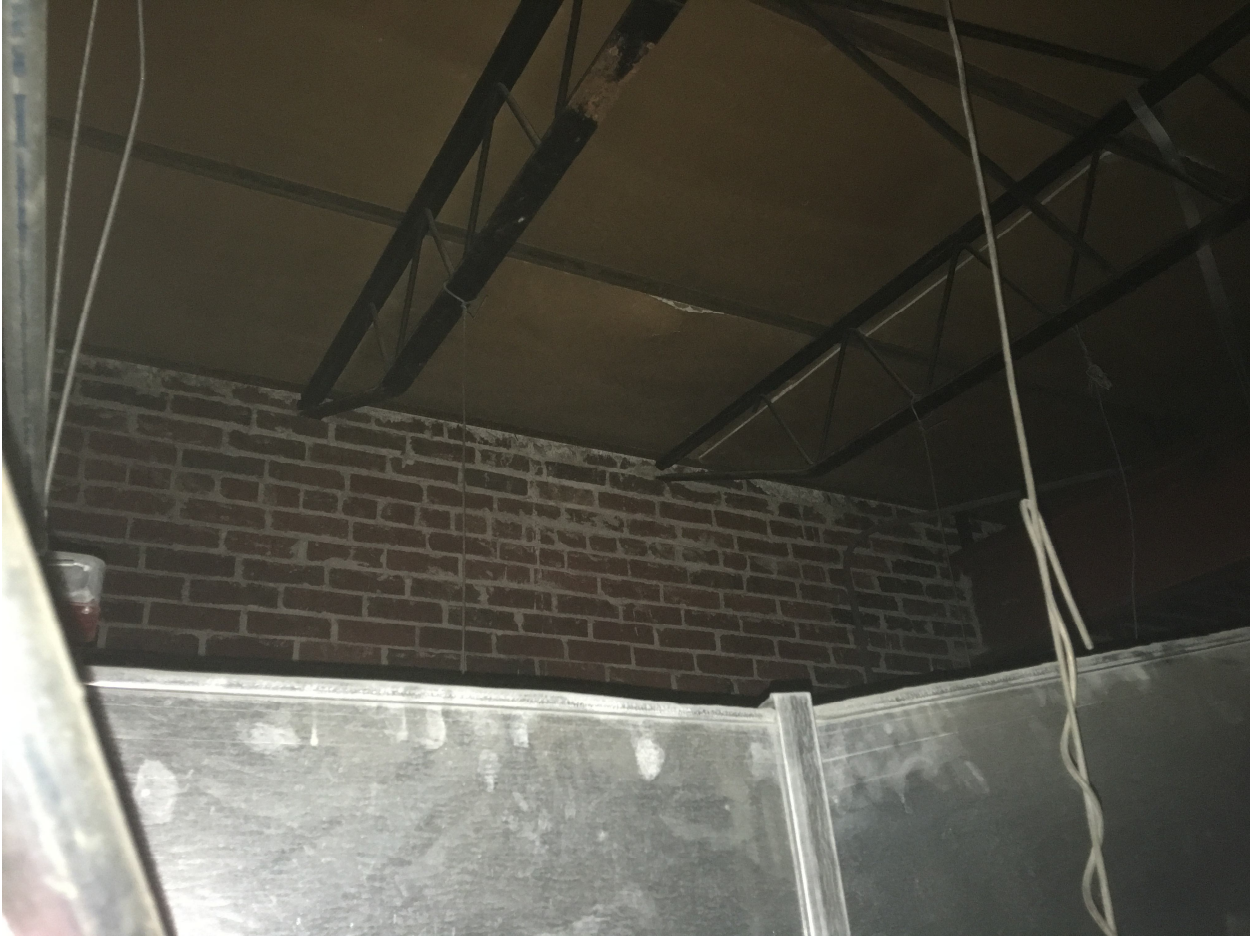
Photo #3: Roof joist bearing on interior brick wall.

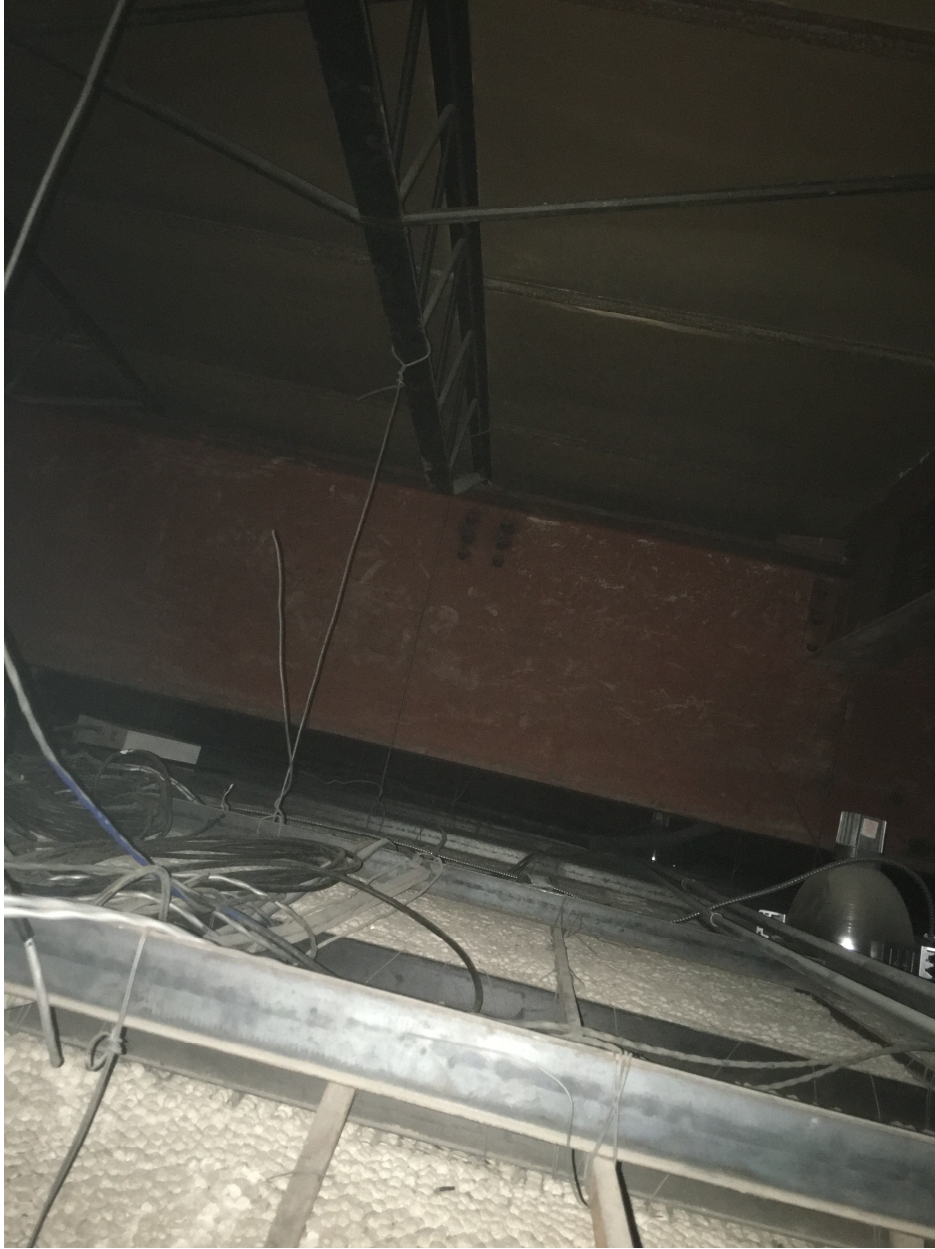
Photo #4: Steel beam supporting roof joists at corridor bearing line

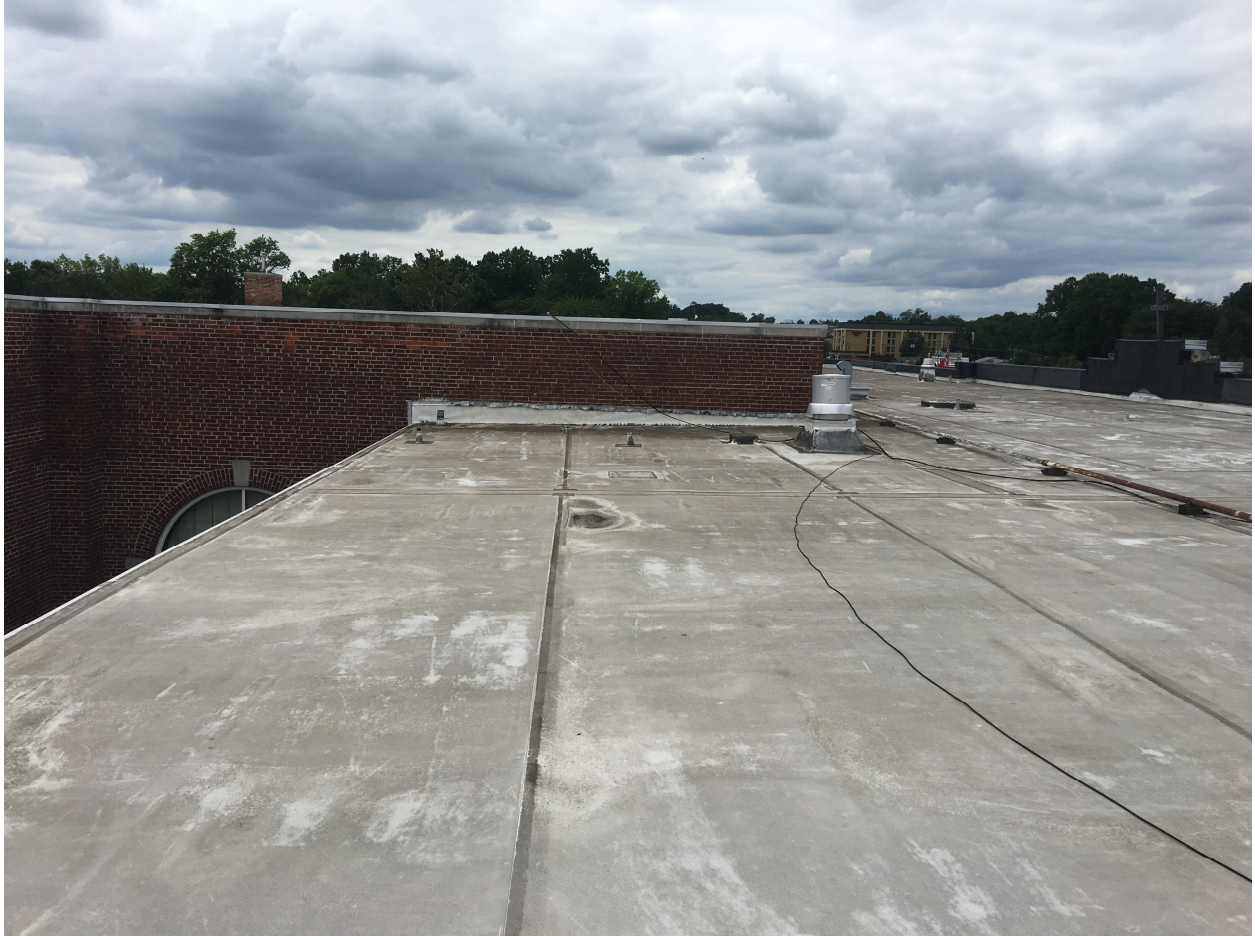
Photo #5: Parapet walls pop-up at Library and Cafeteria wings

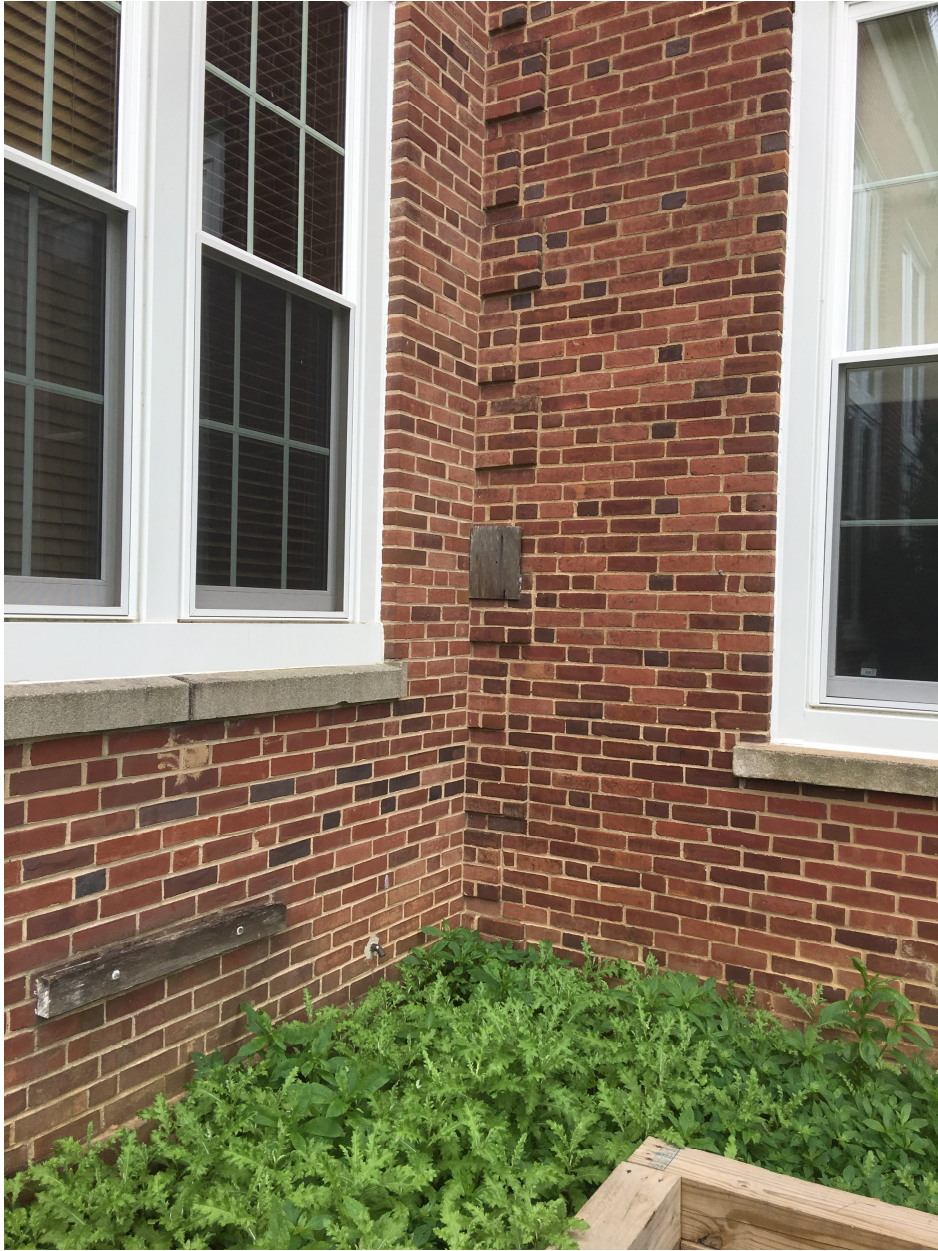
The exterior walls are composed of interlocking multi-wythe brick. Header courses are present every few feet to tie the wythes together. See Photo #6. It appears that the walls are (3) courses in thickness at the exterior and (2) courses thick at the interior bearing wall locations. Brick walls are also evident in the transverse direction of the building at the interior of the building between the classrooms. It was confirmed that these walls are non-load bearing but may be contributing to the lateral force resisting system of the building.

Photo #6: Front elevation at building corner

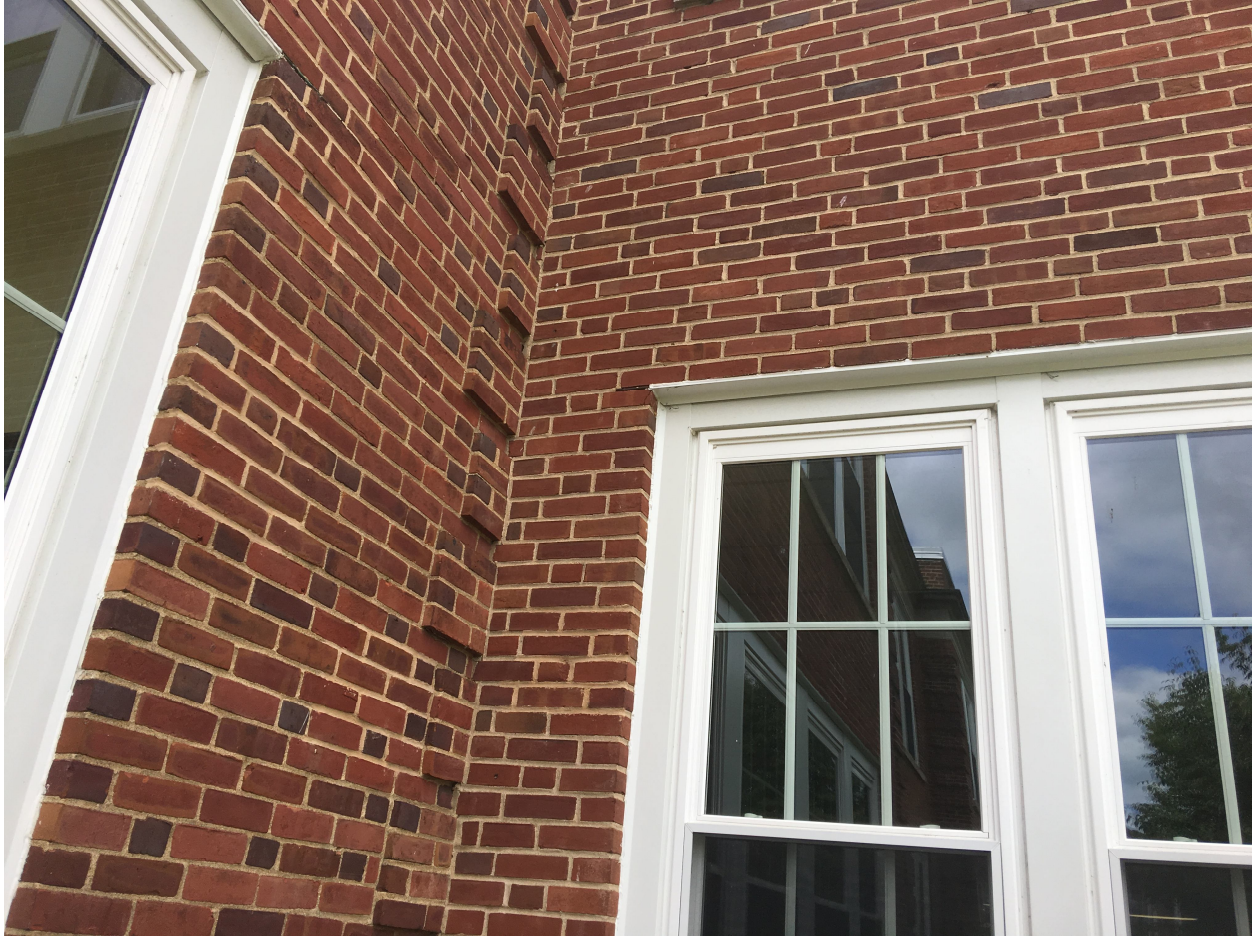
The only portion of the building where any signs of deterioration were observed was at isolated exterior mortar joint locations. The most consistent damage has occurred at the mortar joint locations at the jambs of the window openings where it appears that the steel angle lintel has rusted, causing volumetric expansion of the steel. This condition causes tensile stresses to develop in the adjacent mortar joints which cracks the mortar and causes the mortar joint to become loose and in some case open to the exterior. Subsequent additional brick damage is likely at these locations as additional water penetration can occur which leads to possible freeze-thaw damage. See Photo #7.

Photo #7: Open mortar joint at corner of window

The existing 1935 building structure is in a good condition and it can be readily adaptively reused for the proposed modifications. Minor mortar joint repointing work is needed at some locations and some minor lintel repair work is also needed. It appears that the 1935 original portion of the building is structurally independent of the adjacent building structures. The structure is in a solid structural condition and can be readily repurposed with little additional structural work. Some further, more detailed study will be needed in the areas where the classroom wing joins the adjacent building areas to confirm the full impact of the proposed demolition work.

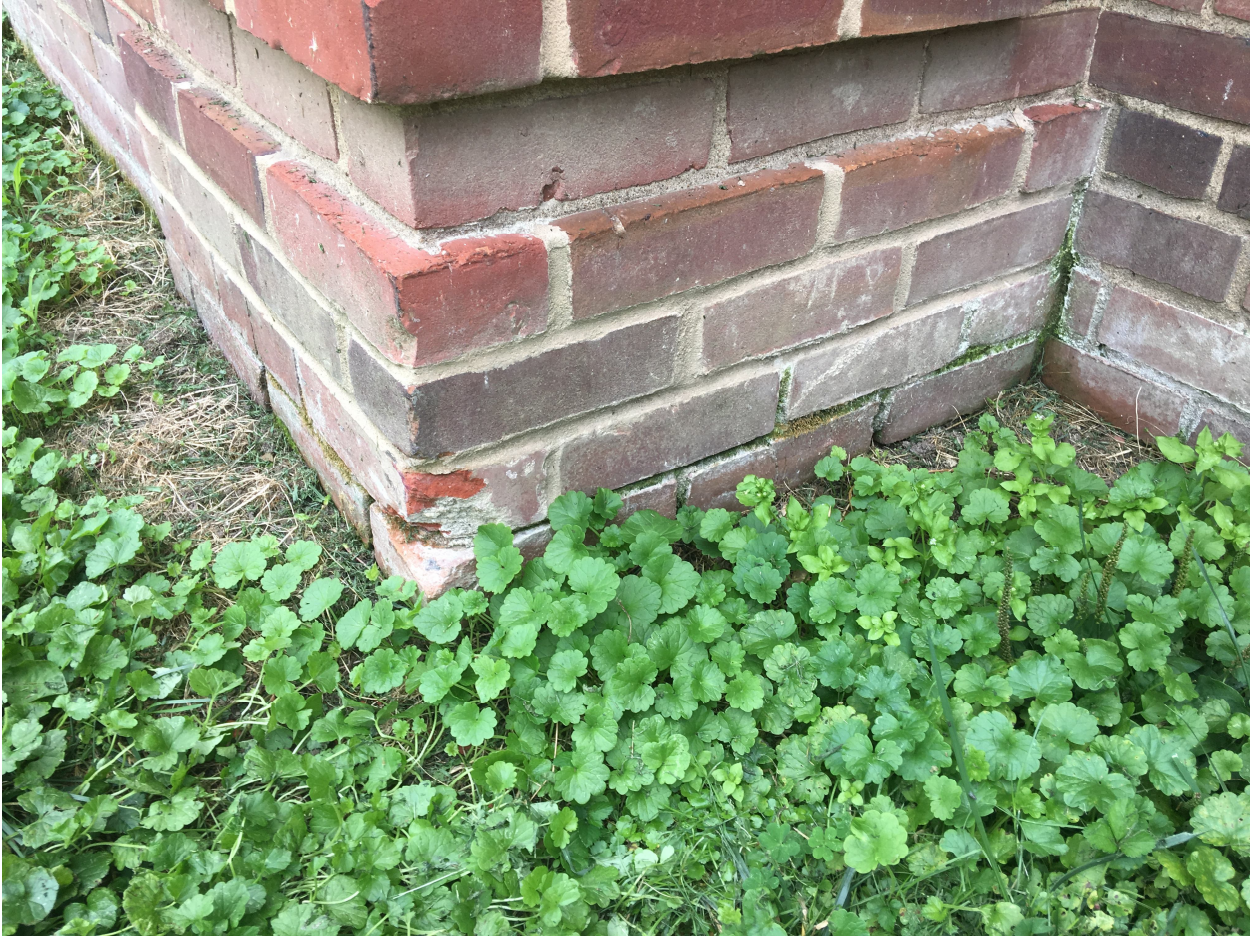
Other locations of isolated mortar joint damage where observed at the base of wall in the front façade of the building. See Photo #8.

Photo #8: Deteriorated mortar joints at base of exterior wall corner.
