November 10, 2017

Patrick J. Rhodes  
Vice President, Senior Project Manager  
The IDI Group Companies  
1700 N. Moore Street, Suite 2020  
Arlington, VA 22209

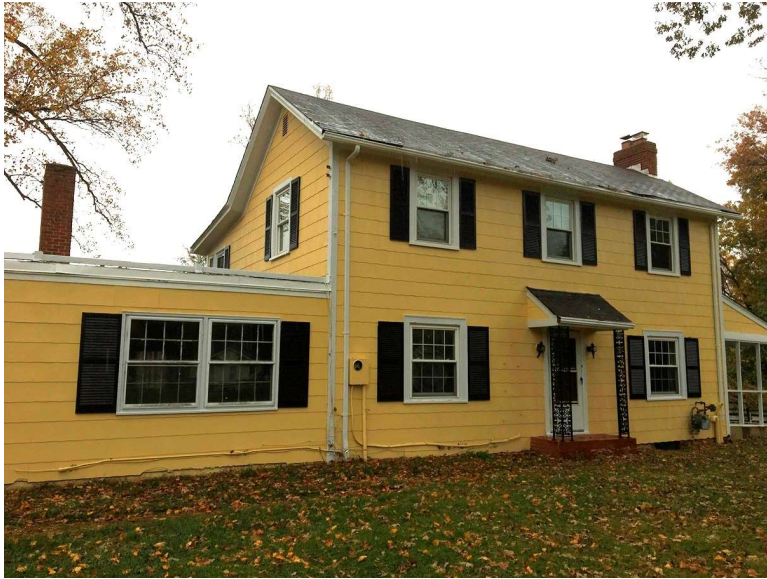
Front elevation / main entrance of property. South facing.

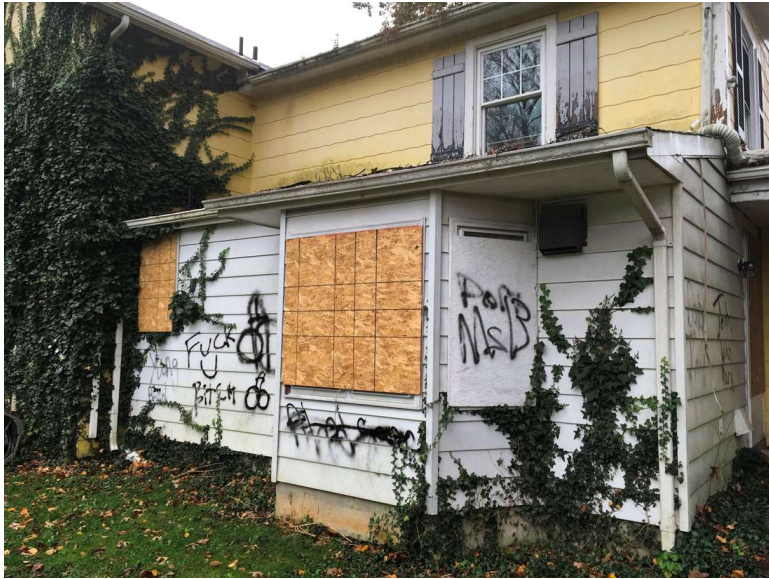
North elevation of property.

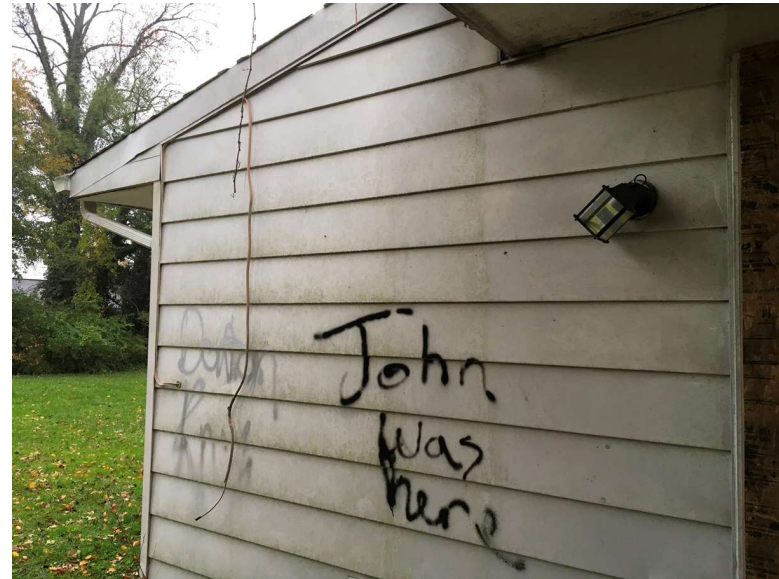
North elevation of property.

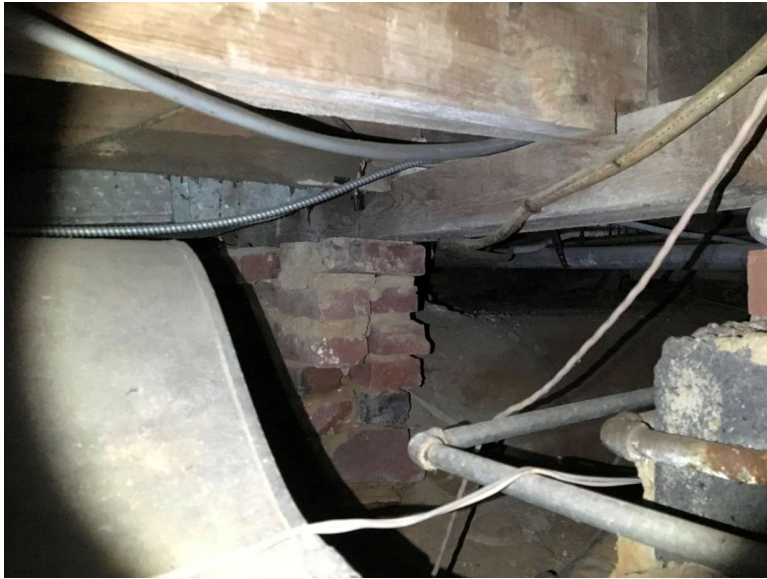
Crawl space under main portion of structure. Significant deterioration of masonry support.

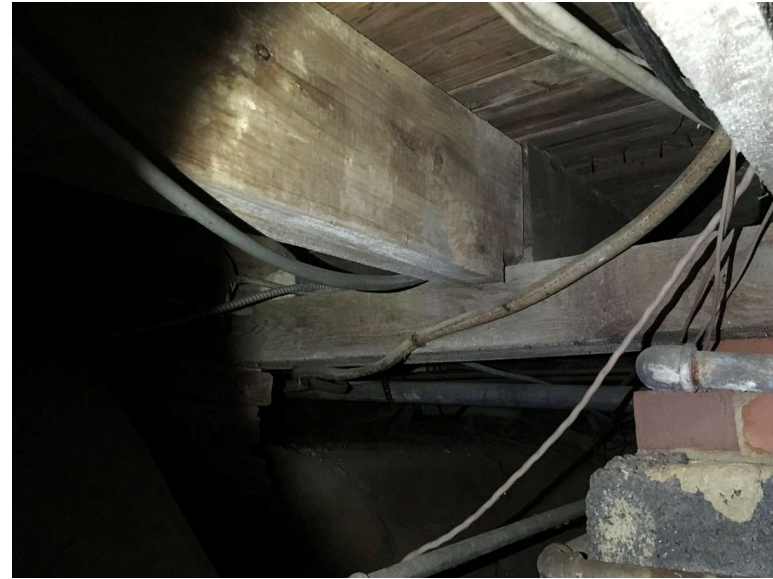
Displacement of floor beam. Beam appears undersized.

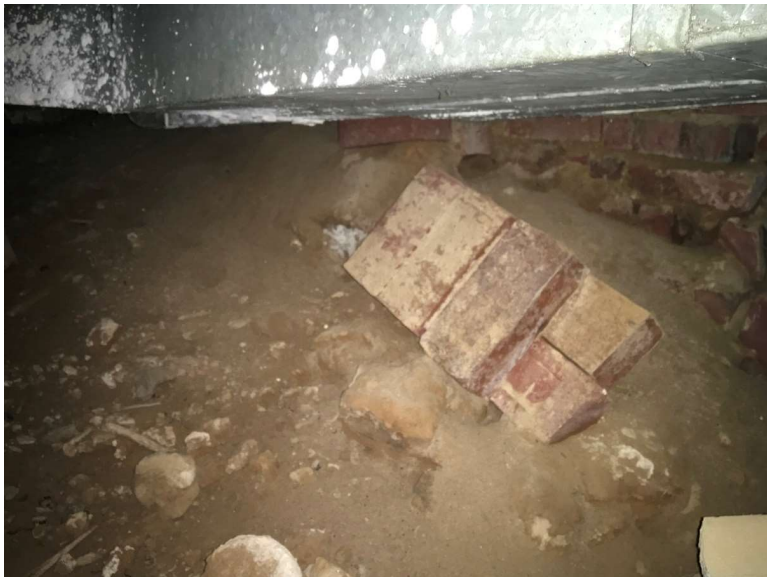
Partial collapse of masonry foundation.

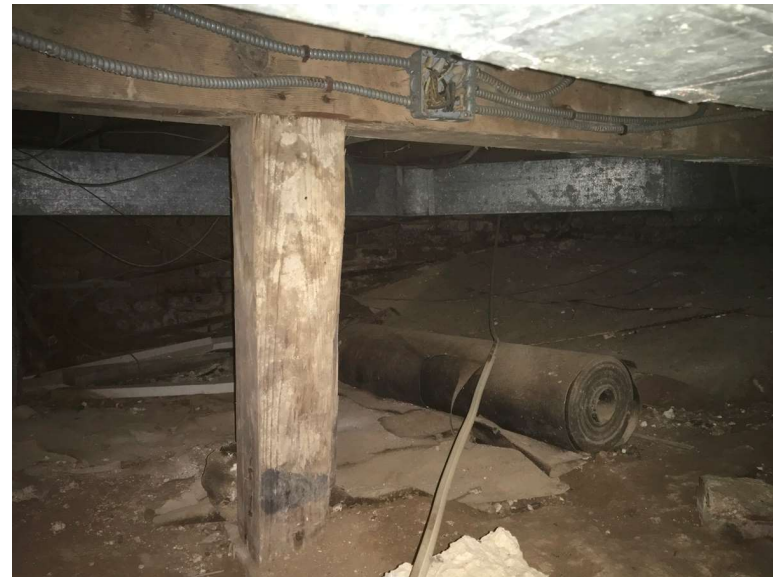
Wood post with crawl space, supporting floor. Wood deterioration.

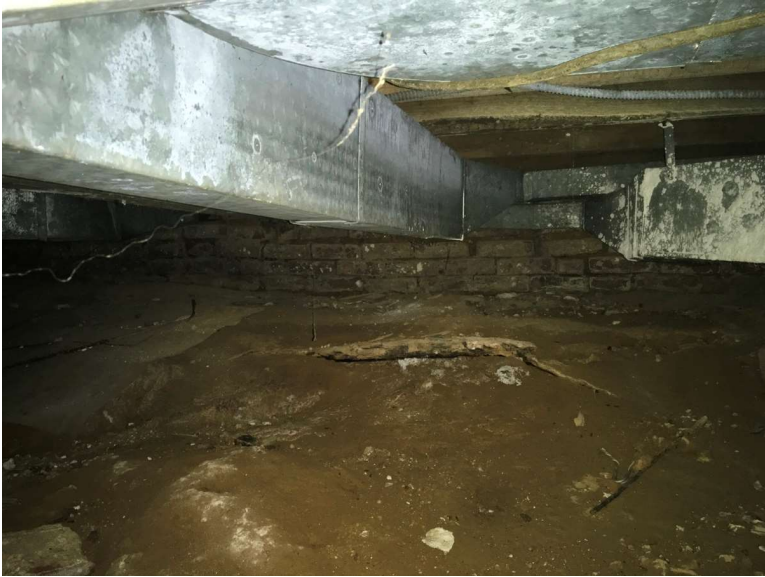
Crawl space under main portion of structure.

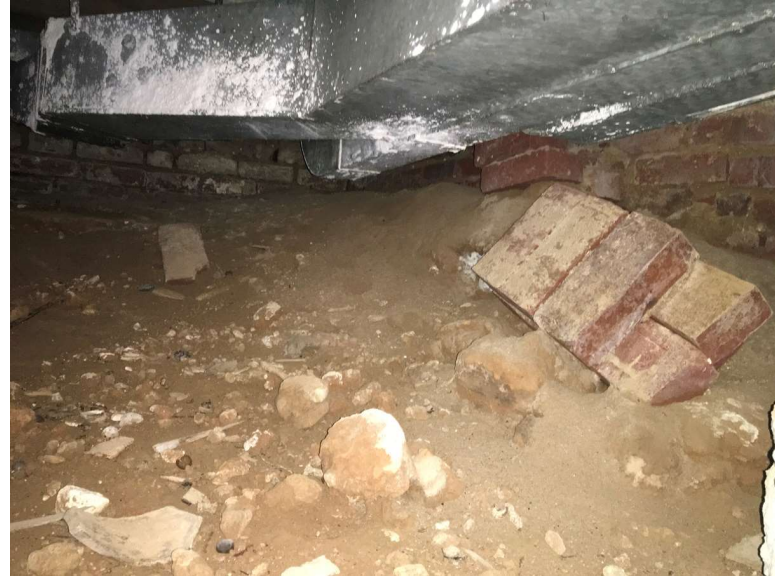
Partially collapsed masonry foundation.

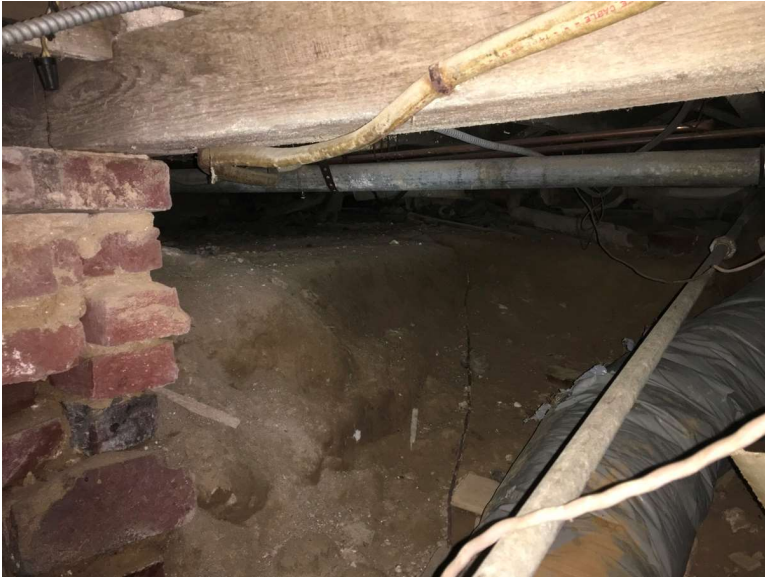
Significant deterioration of masonry foundation.

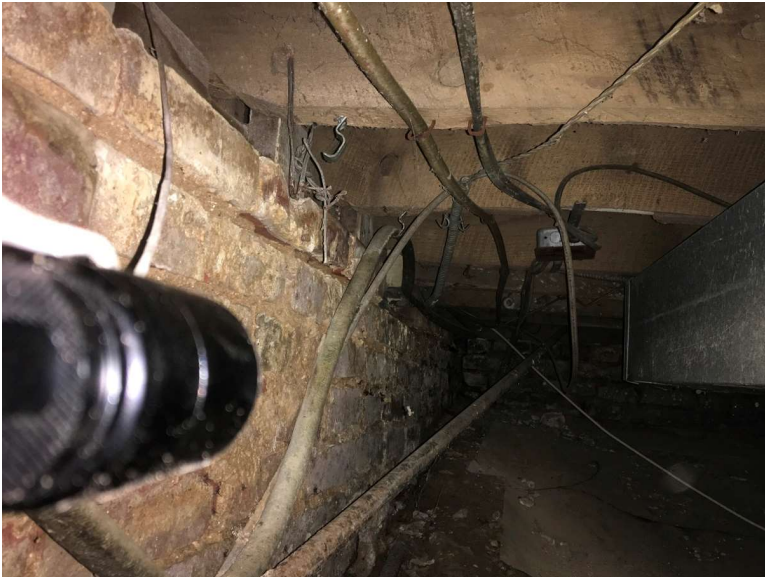
Significant deterioration of masonry foundation.

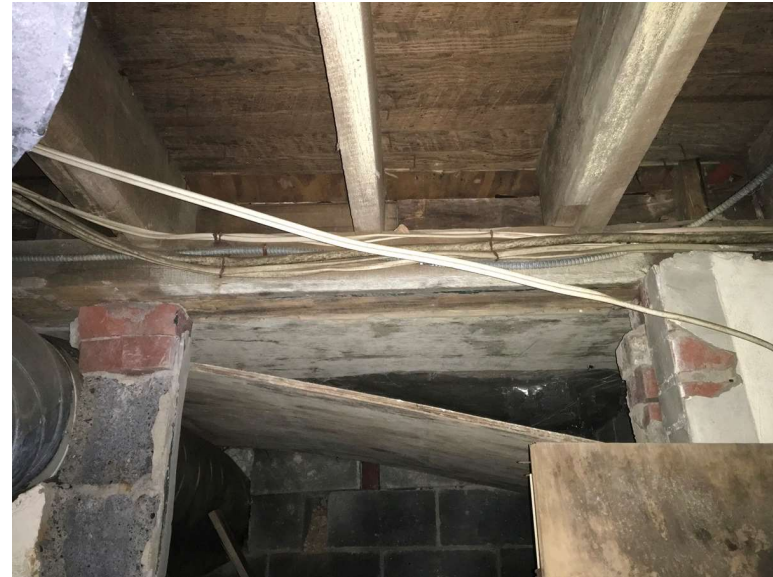
Floor support beam spanning opening.

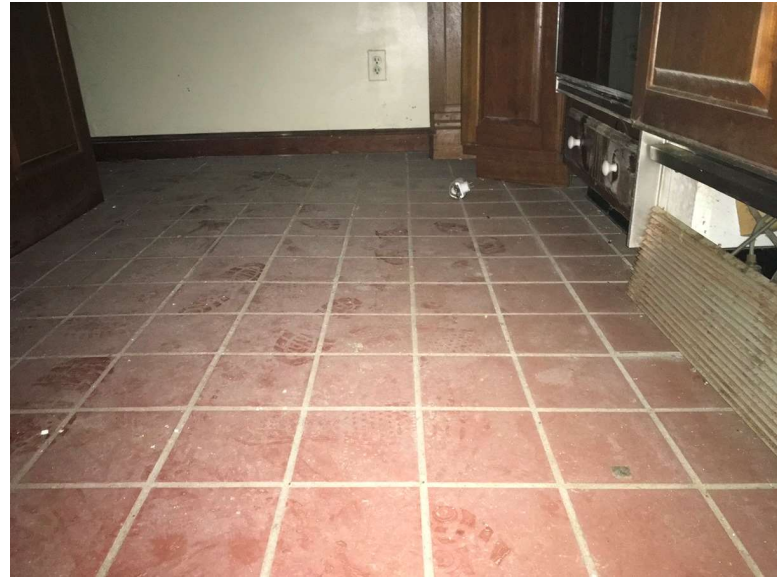
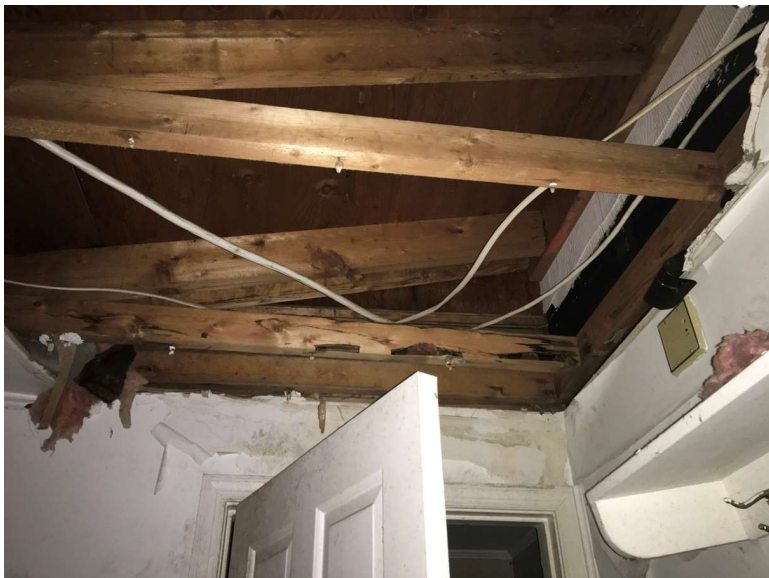
Collapsed ceiling observed on First Floor caused by water infiltration.

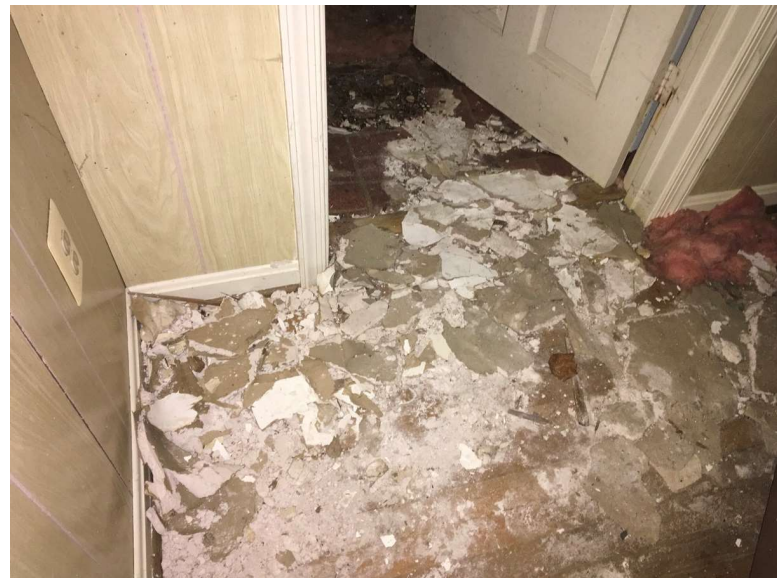
Collapsed ceiling debris on floor.

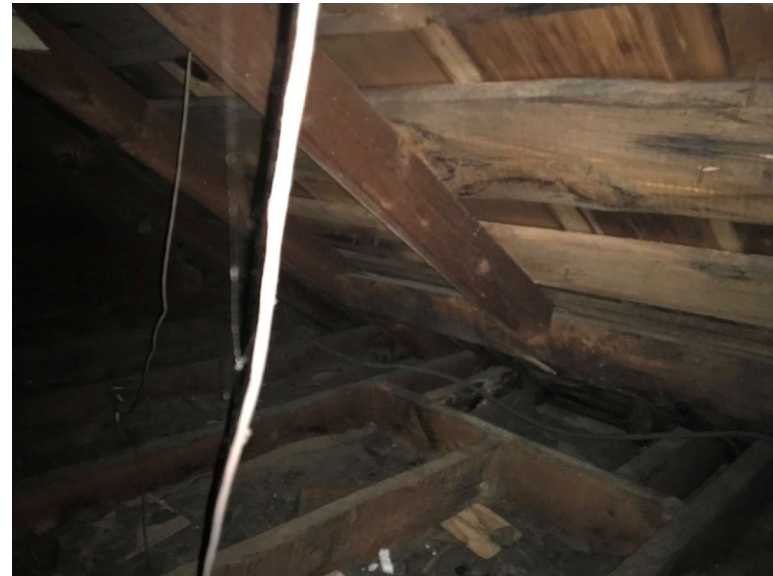
Water infiltration at roof framing. Partial failure of wood framing.

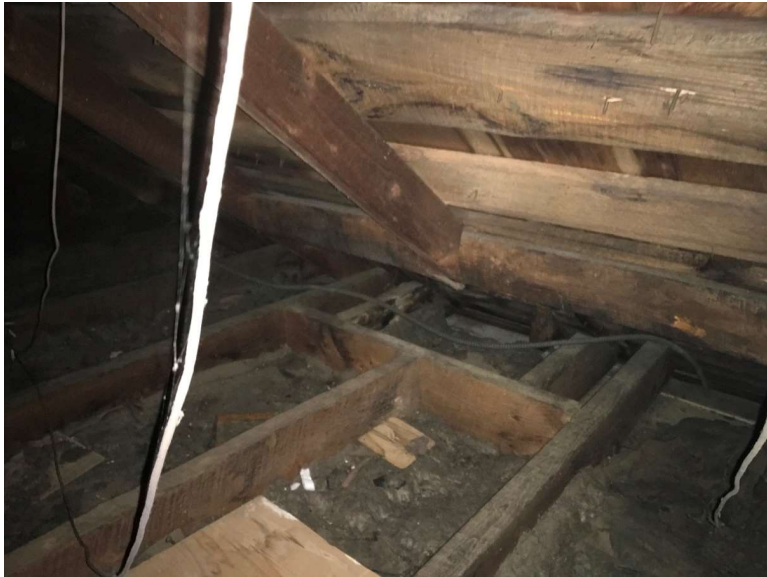
Partial failure of roof framing.

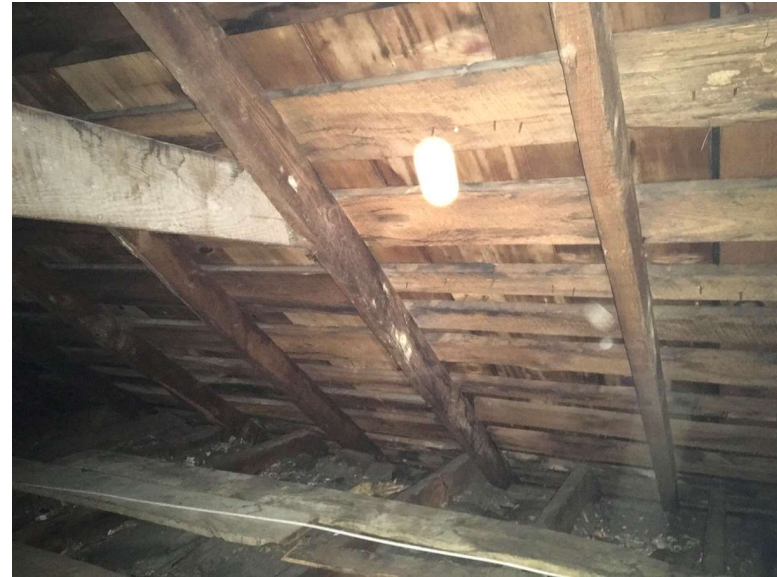
Base of roof rafters appear to have displaced outward. Wood framing appear bowed and twisted.

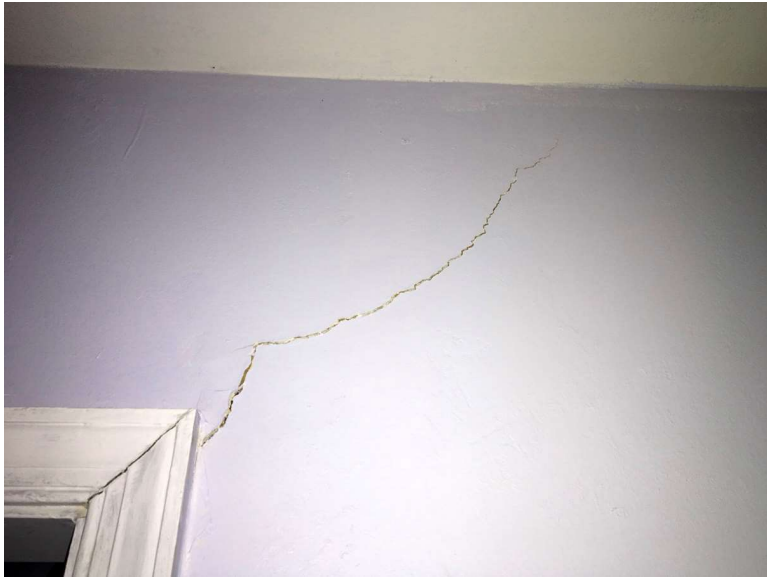
Typical diagonal cracking through wall finish at opening corners.

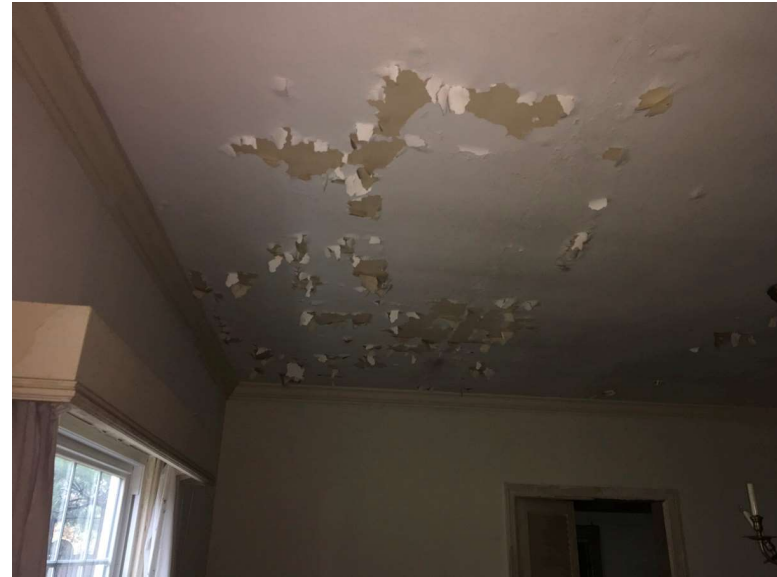
Peeling paint typical throughout building.

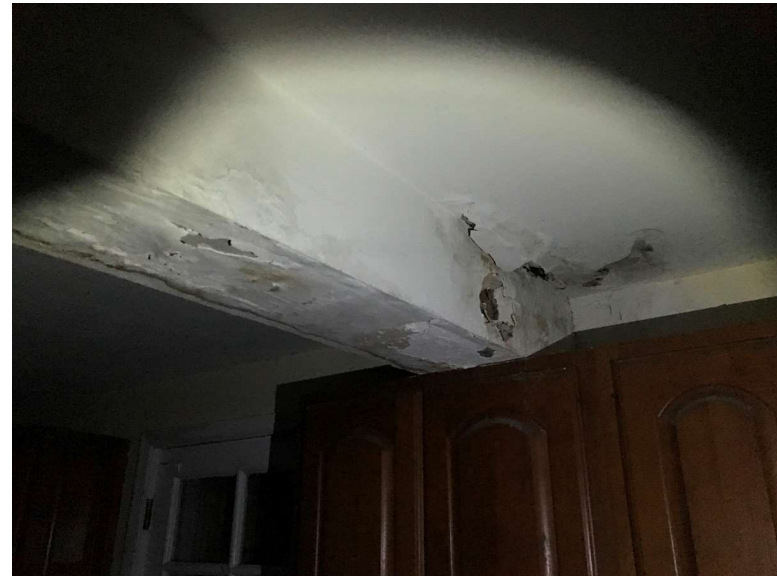
Water damage to finishes.

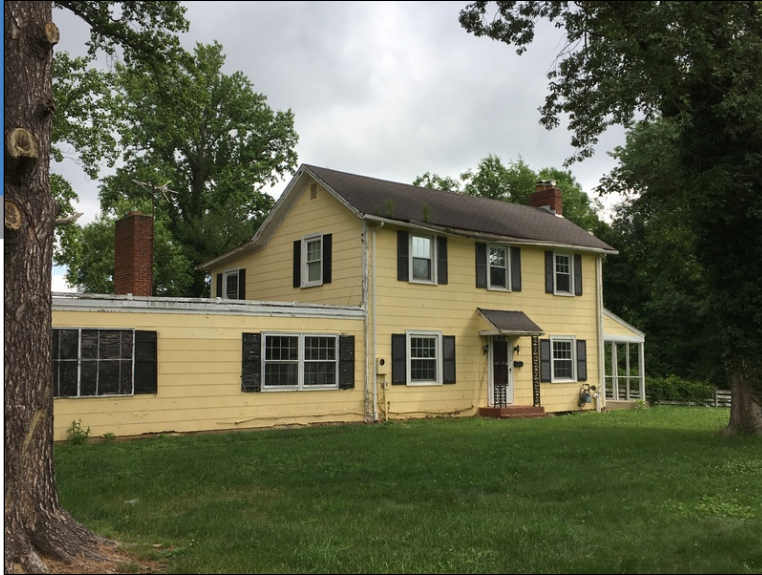
HAZARDOUS MATERIALS AND STRUCTURAL SURVEY

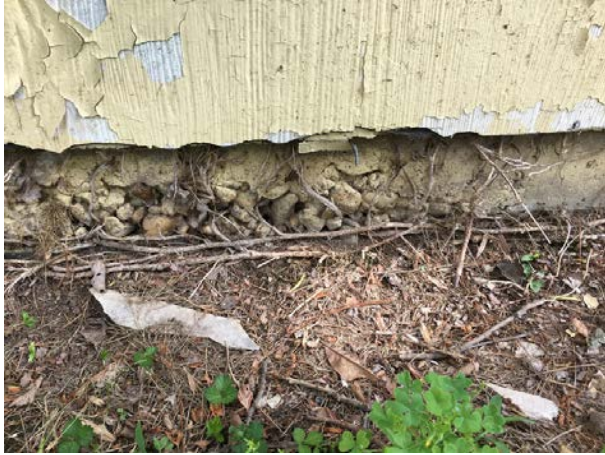
Organic grow into the wall

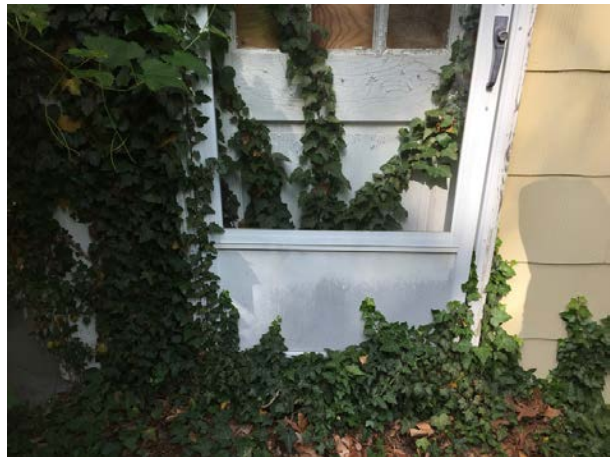
Growth on side door near porch

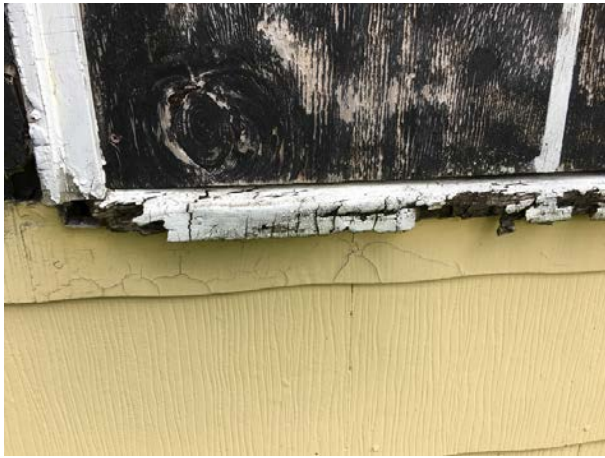
Window frame wood rot

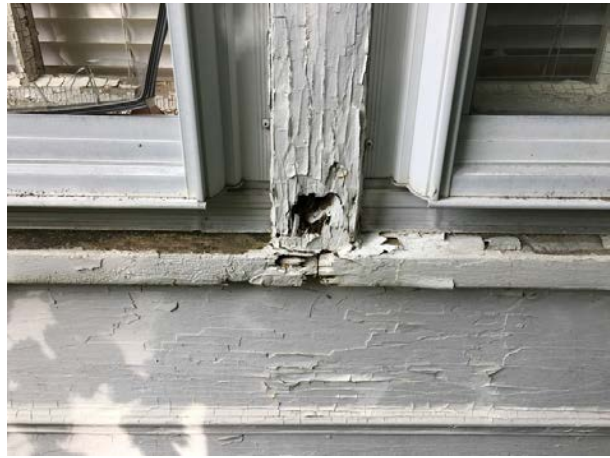
Window frame wood rot

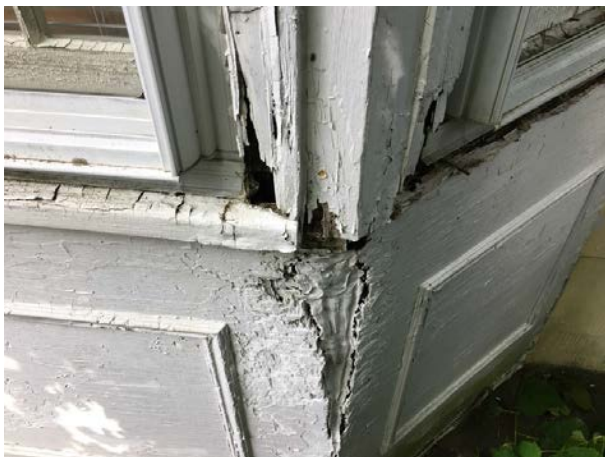
Window frame wood rot

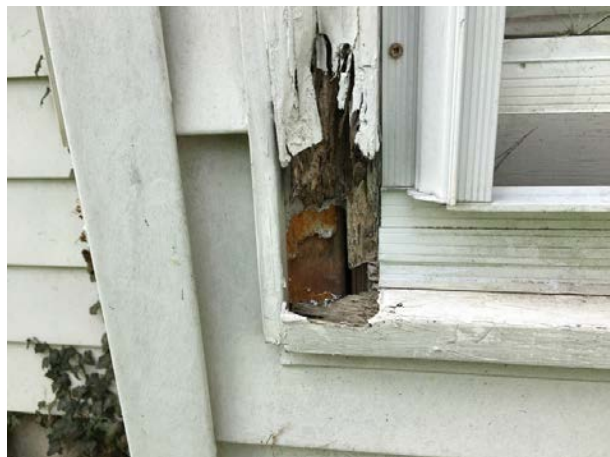
Window frame wood rot

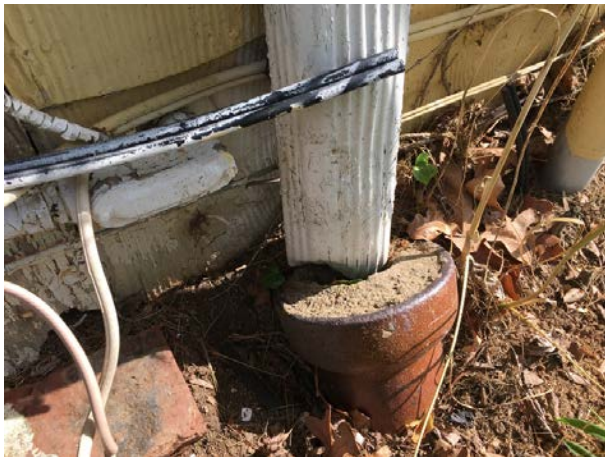
Downspout path blocked

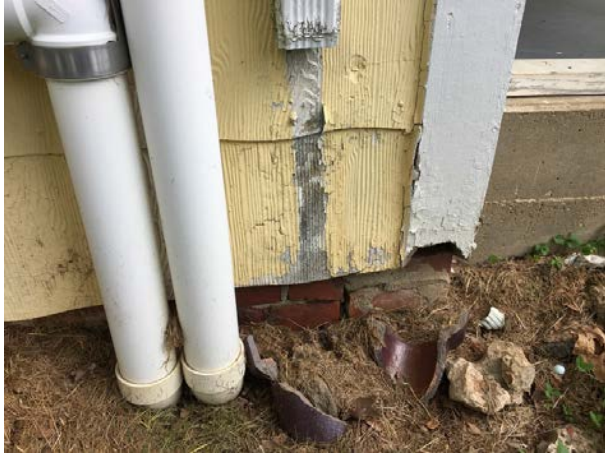
Downspout path blocked

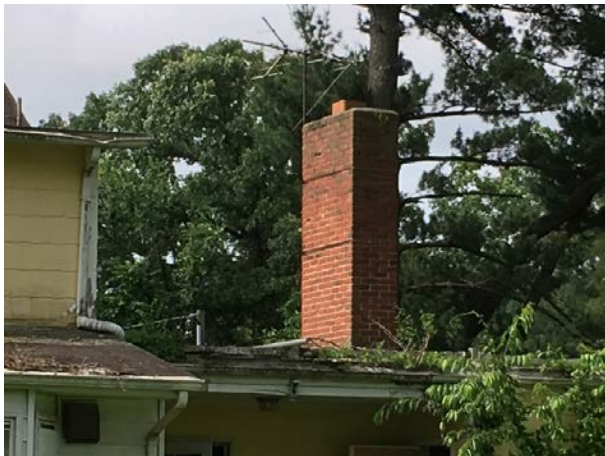
Gutters filled with debris

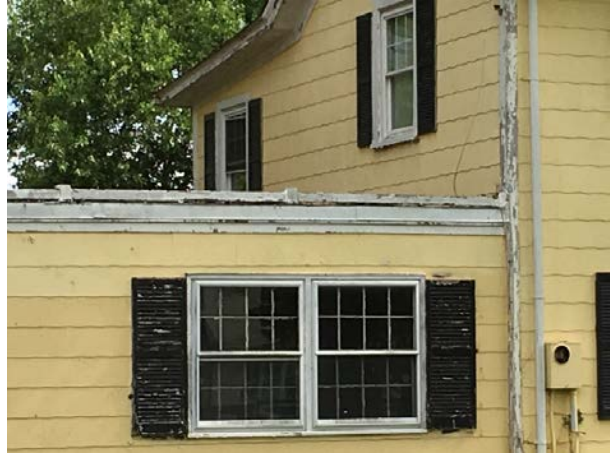
Gutters at the front

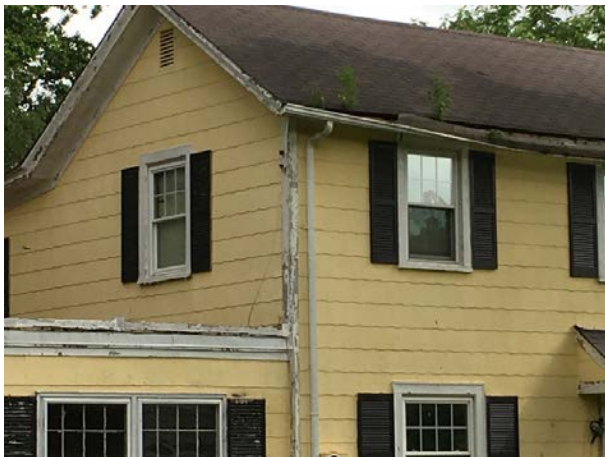
Typical roof condition

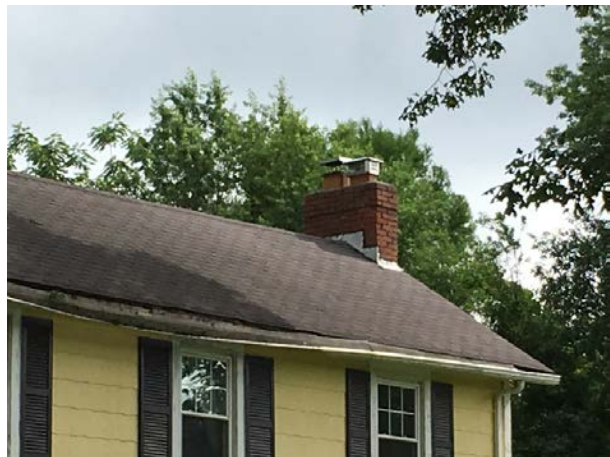
Typical roof condition

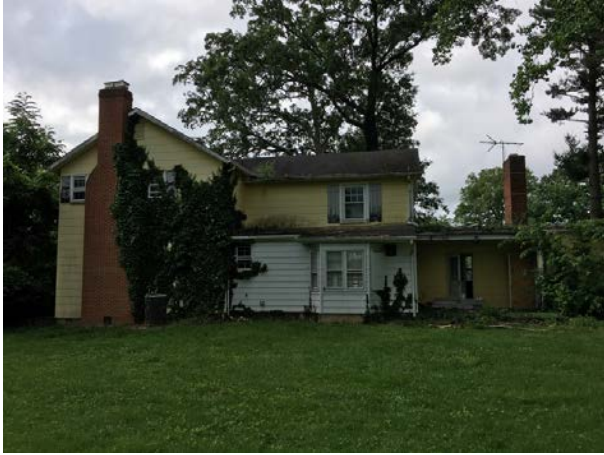
Flat roof at garage and laundry area

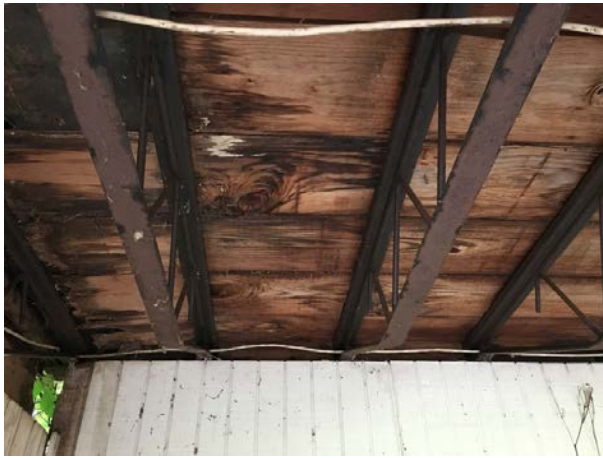
Wood roof water damaged

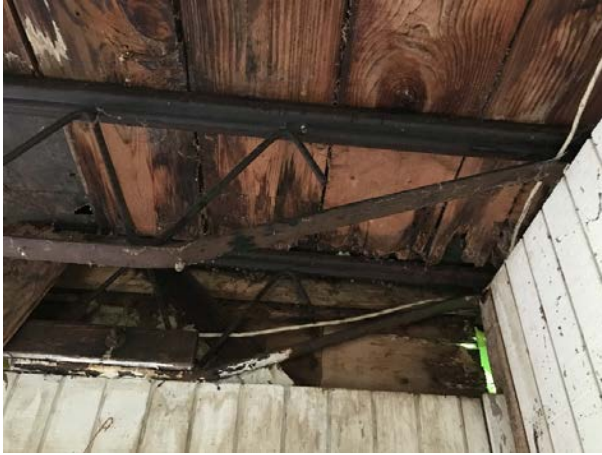
Steel surface rusted

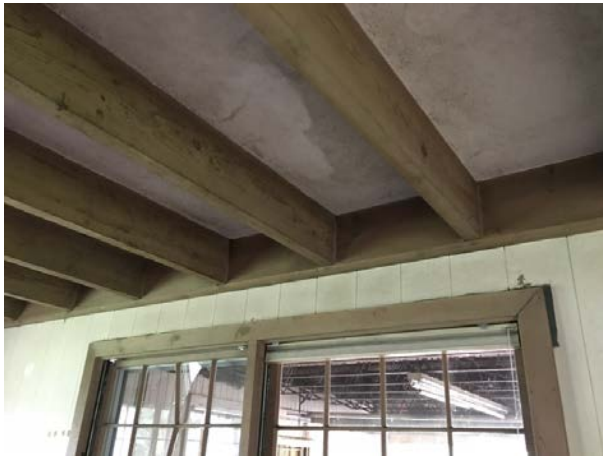
Exposed joists in room adjacent to garage

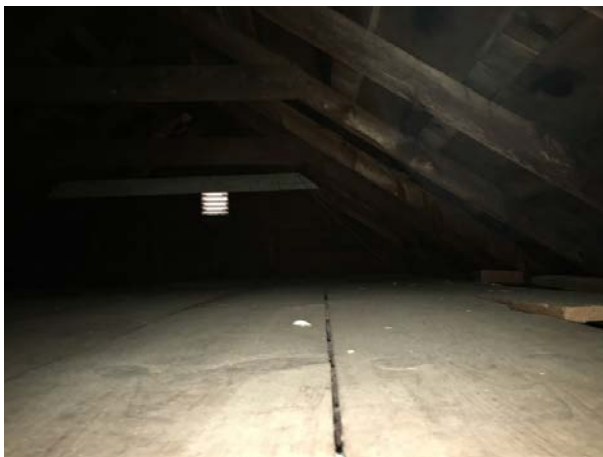
Rafter system supporting roof

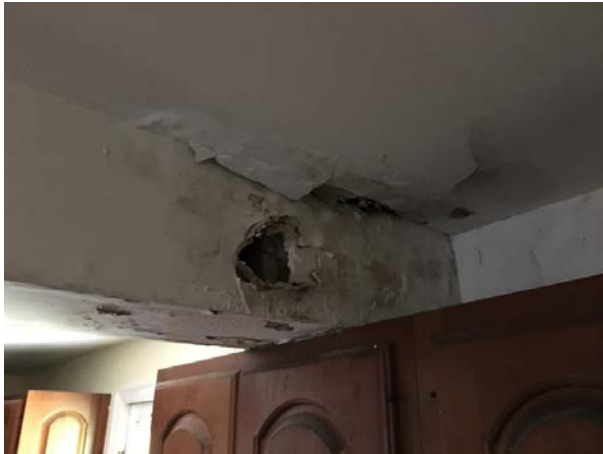
Water damaged drywall in kitchen

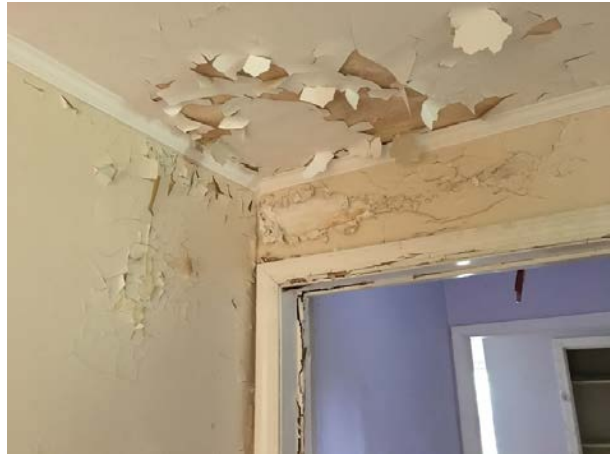
Ceiling paint peeling

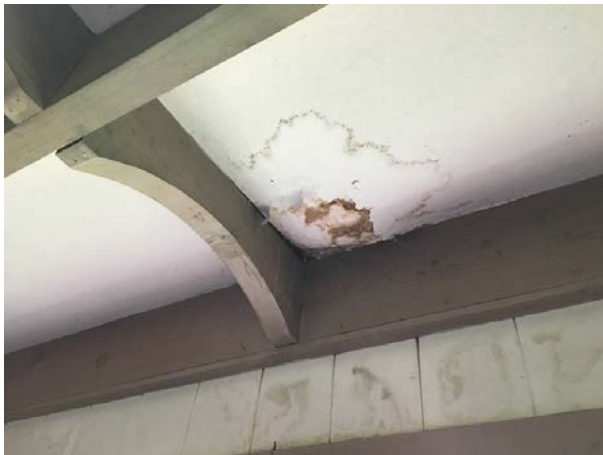
Water damage on ceiling in room adjacent to garage

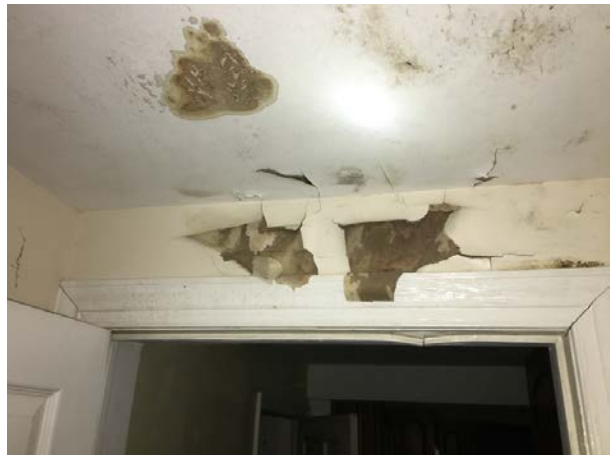
Paint peeling above door frame

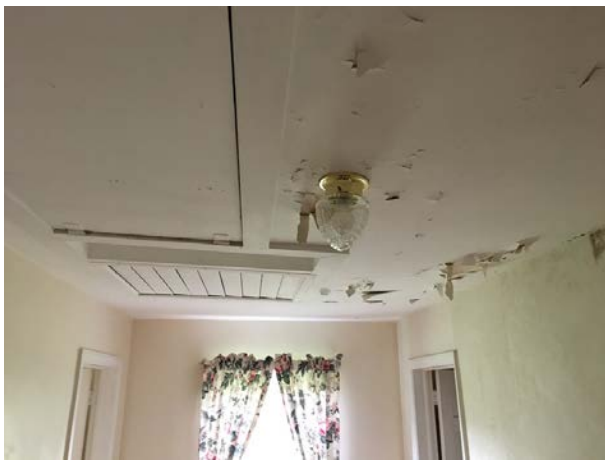
Second floor hallway ceiling sag

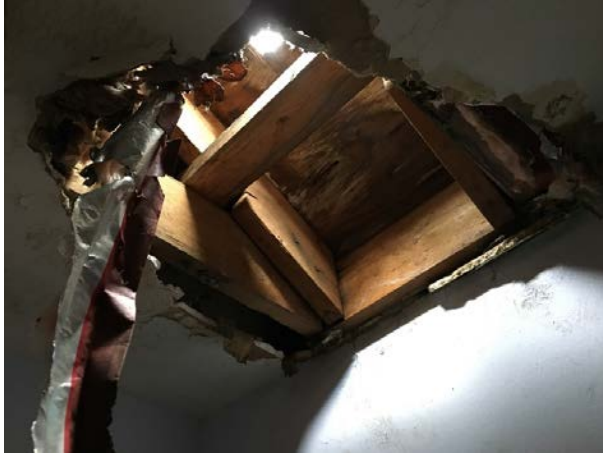
Hole penetrating from roof

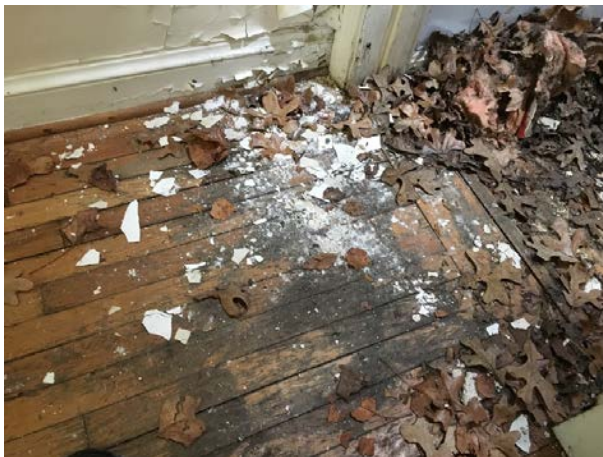
Debris fallen through hole creating possible water damage

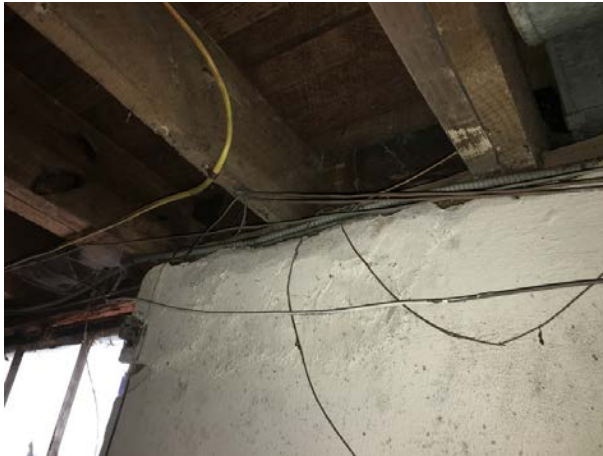
Organic growth penetrating from outside into basement

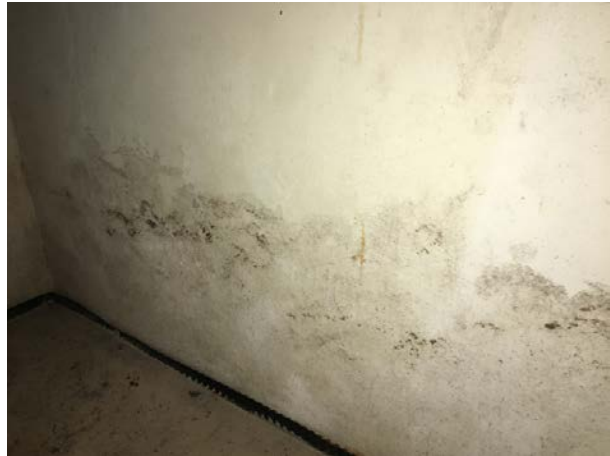
Water damage of the walls

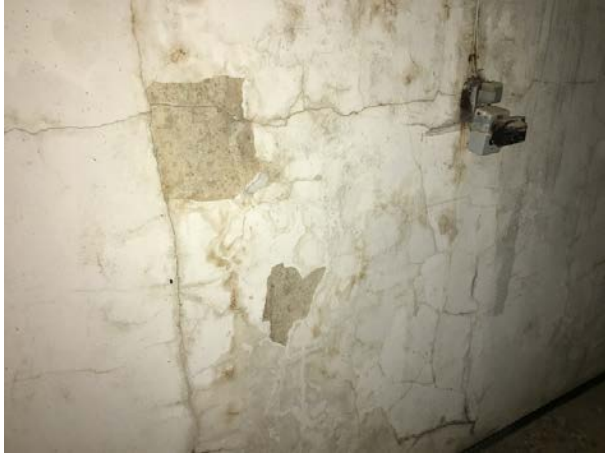
Cracks in the parged walls

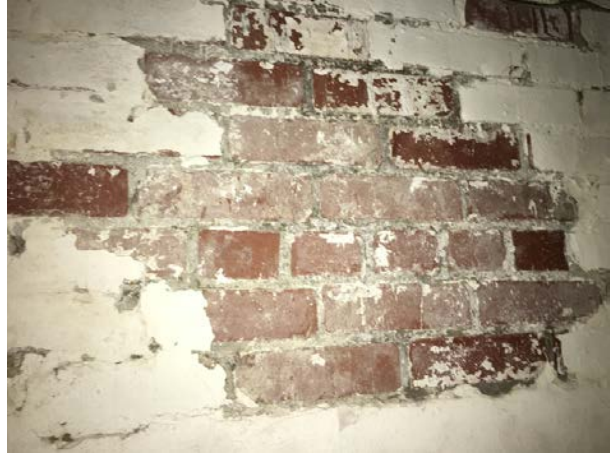
Exposed area of basement wall

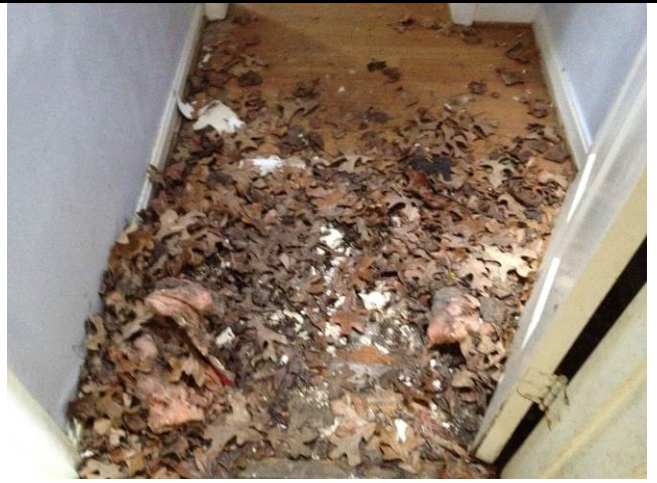
8. View of debris on the floor, partial hole in the floor from the roof leak.

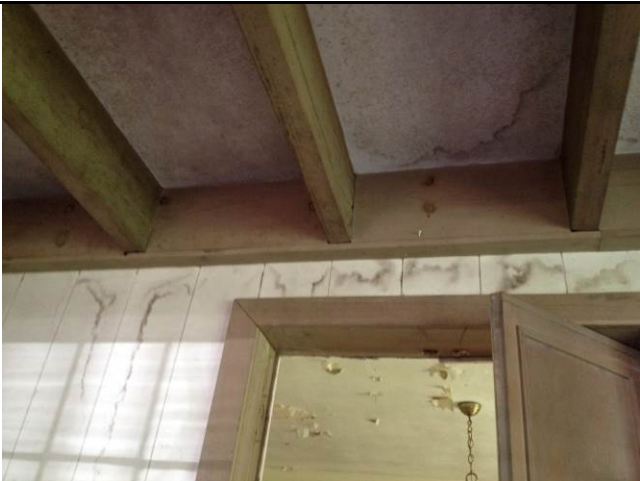
9. View of visible mold on the ceiling/walls in the den.

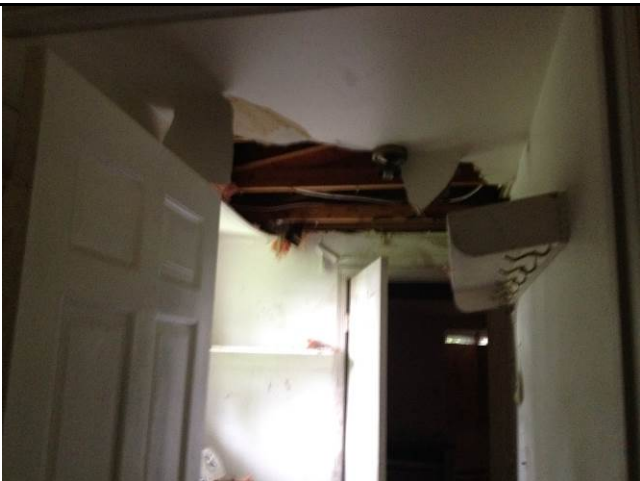
17. View of the ceiling damage from a roof leak in the laundry room/hall.

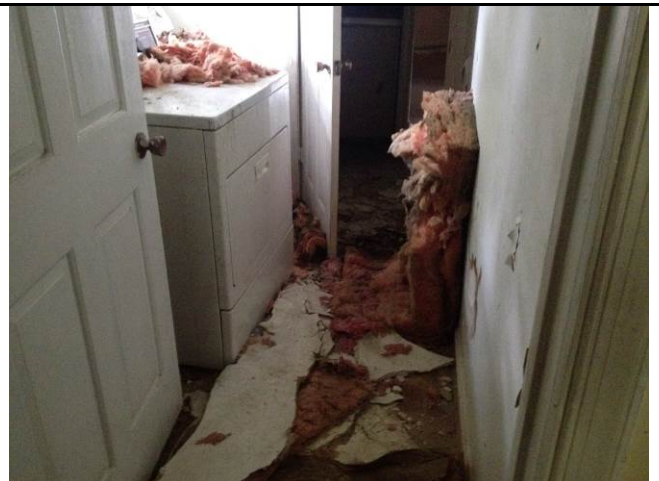
18. View of impacted materials from a roof leak in the laundry room/hall.
