## Board of Architectural Review

DATE: December 20, 2017  
TO: Board of Architectural Review Chair and Members  
THROUGH: Jason Sutphin, Community Development Division Chief (JDS)  
FROM: Tommy Scibilia, BAR Liaison (TS)  
SUBJECT: Paul VI Redevelopment – Work Session

HAZARDOUS MATERIALS AND STRUCTURAL SURVEY

YELLOW HOUSE AT 10606 CEDAR AVENUE

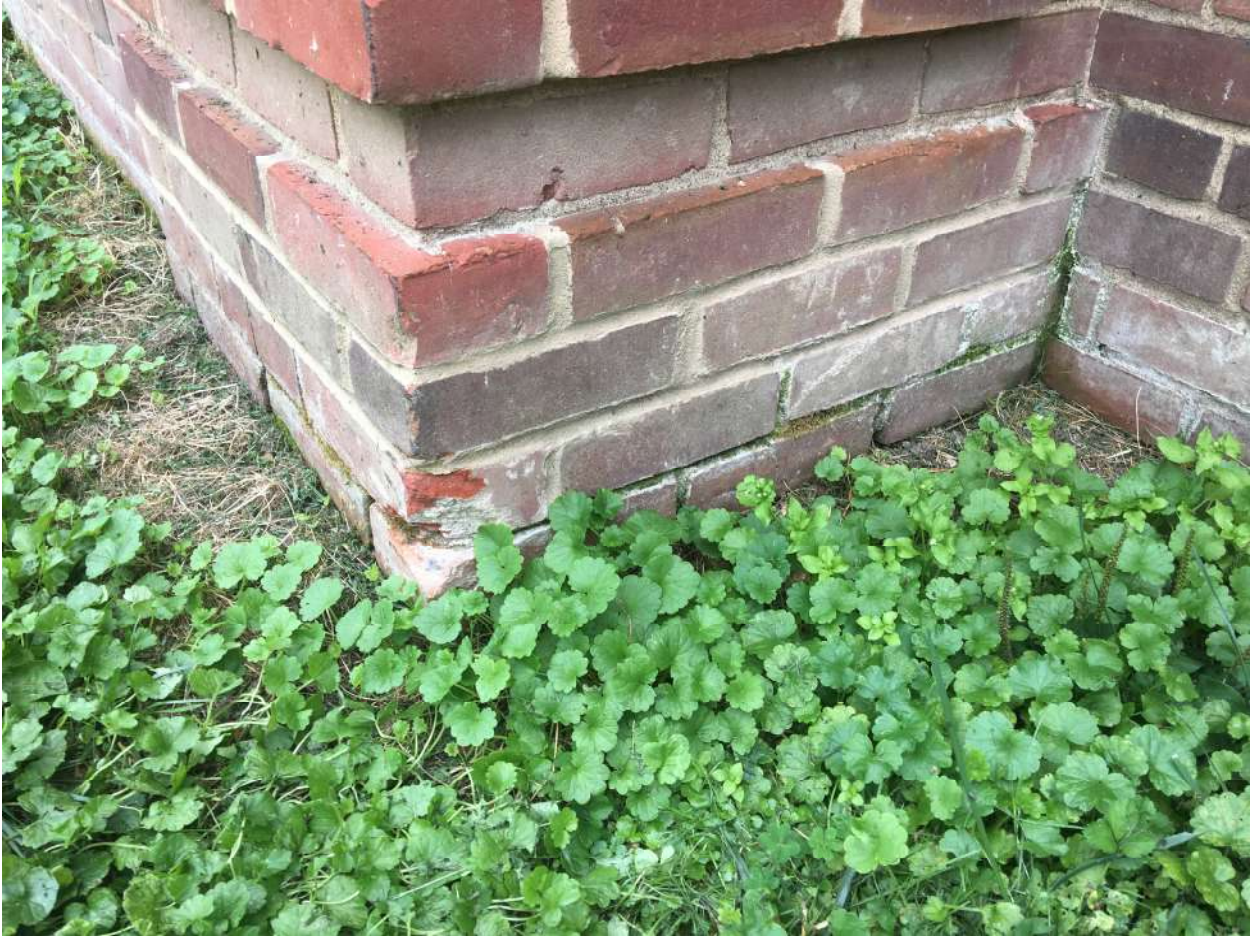
**Photo #8: Deteriorated mortar joints at base of exterior wall corner.**

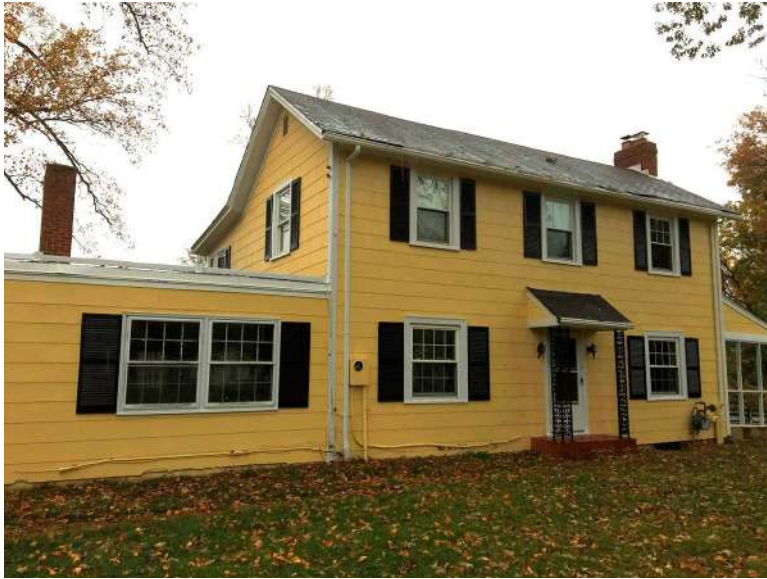
Front elevation / main entrance of property. South facing.

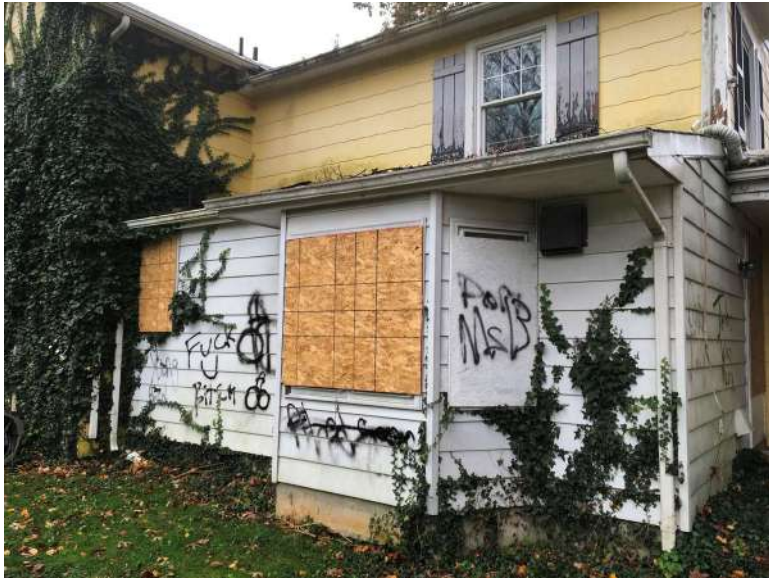
North elevation of property.

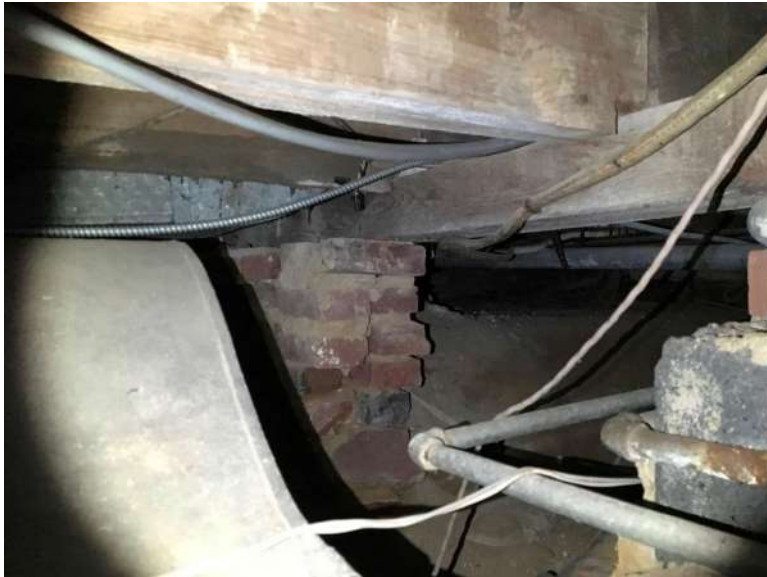
Crawl space under main portion of structure. Significant deterioration of masonry support.

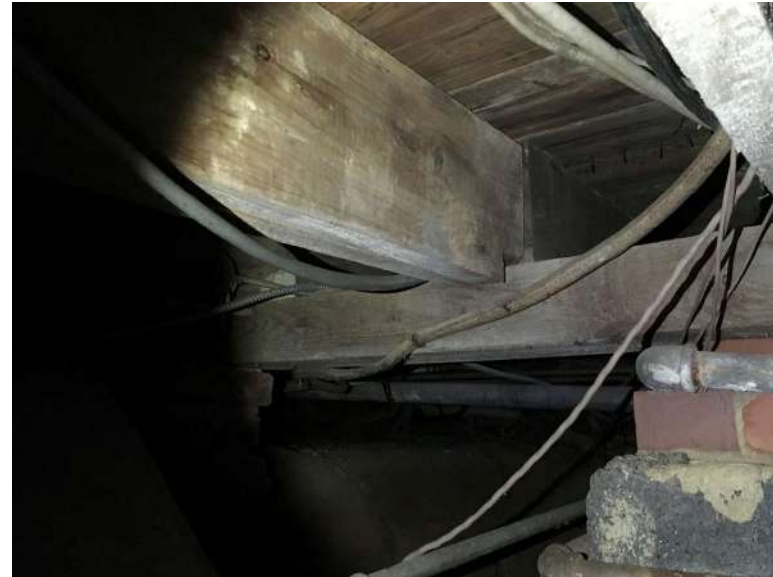
Displacement of floor beam. Beam appears undersized.

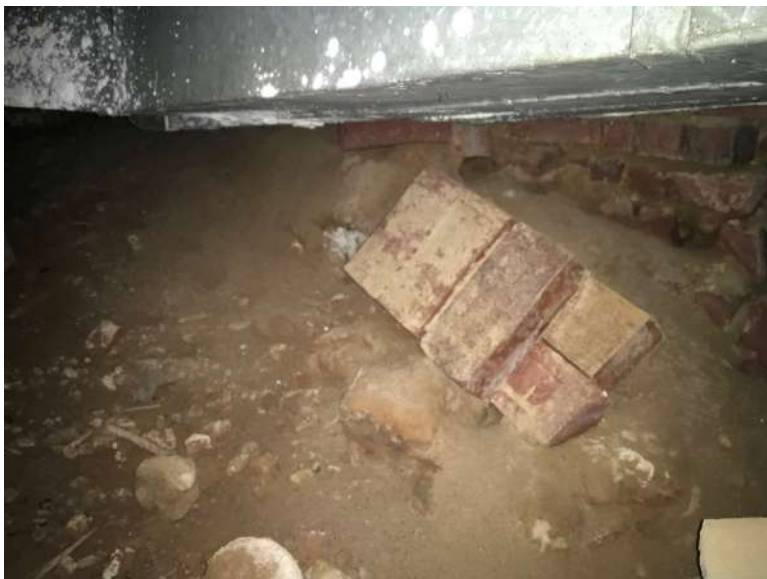
Partial collapse of masonry foundation.

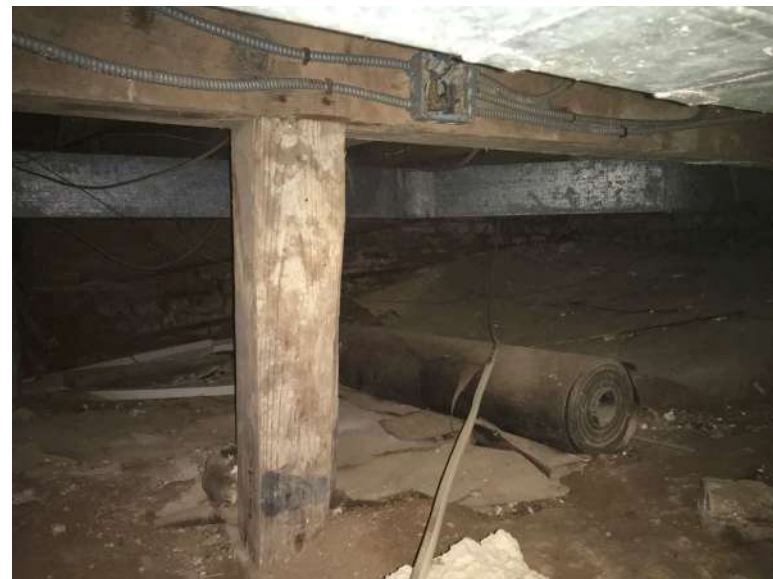
Wood post with crawl space, supporting floor. Wood deterioration.

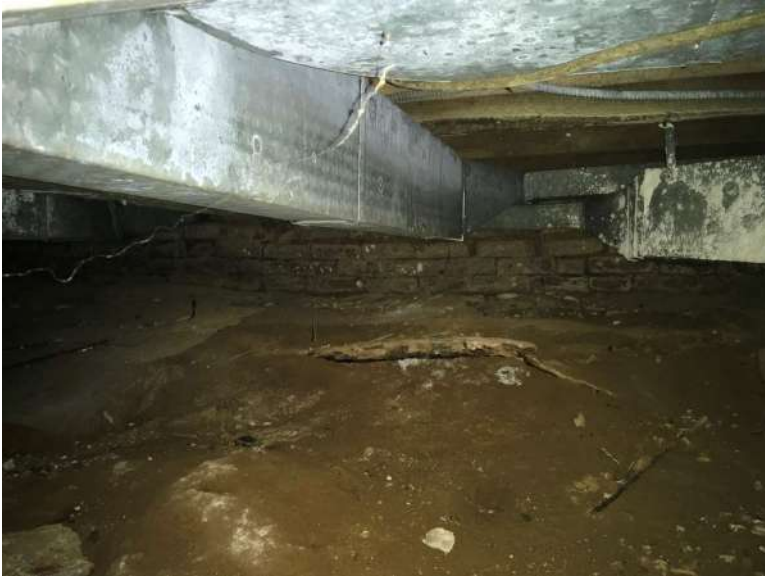
Crawl space under main portion of structure.

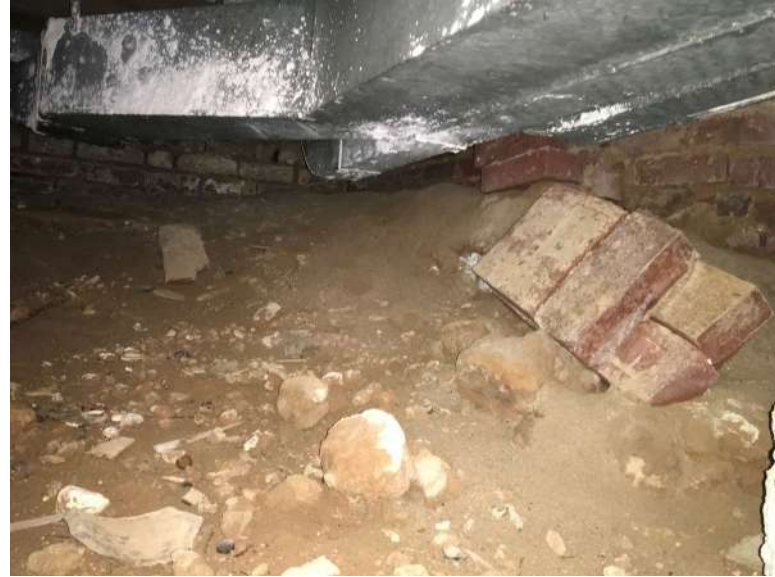
Partially collapsed masonry foundation.

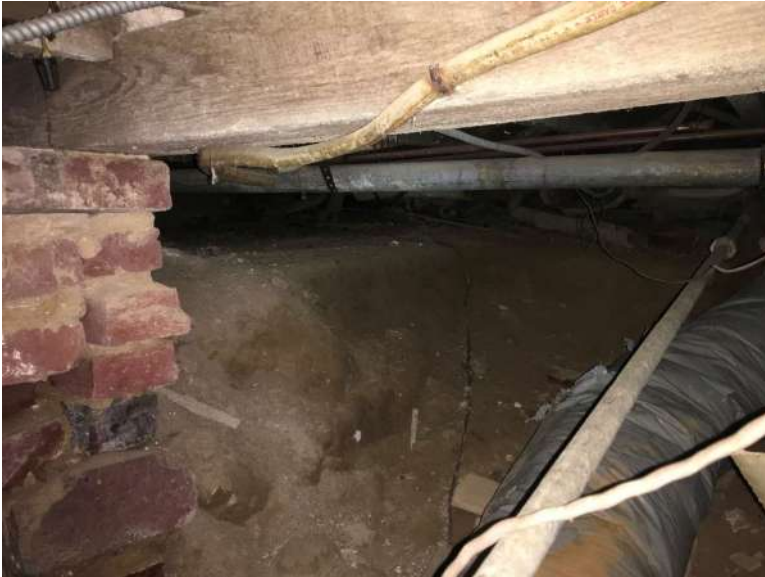
Significant deterioration of masonry foundation.

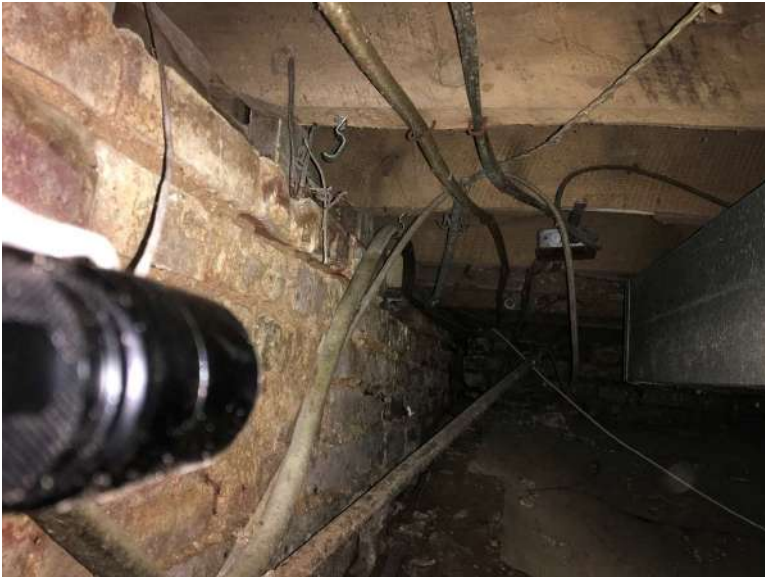
Significant deterioration of masonry foundation.

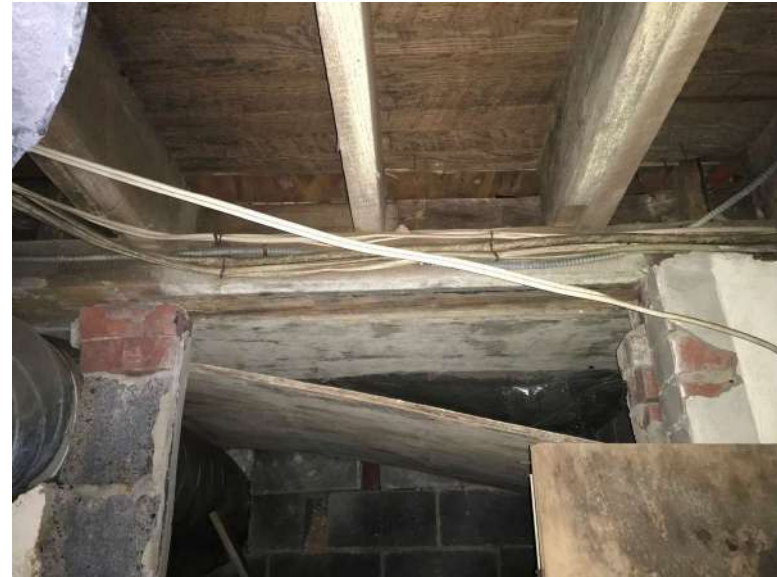
Floor support beam spanning opening.

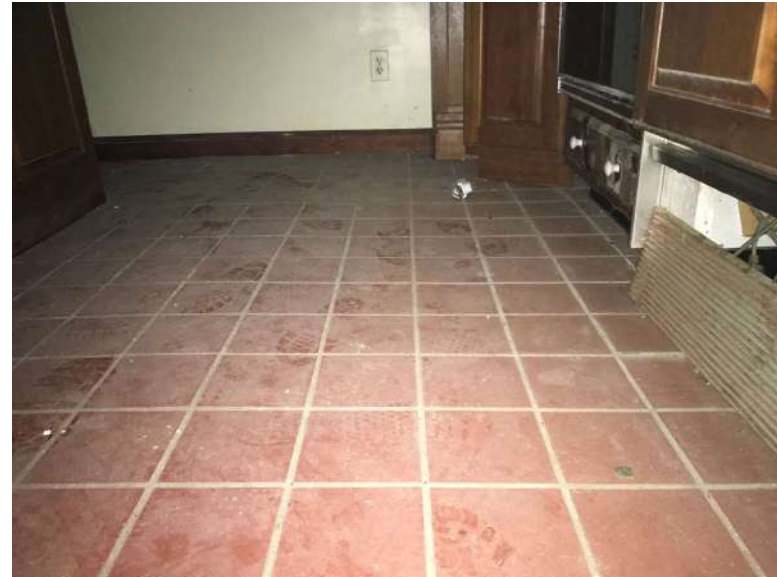
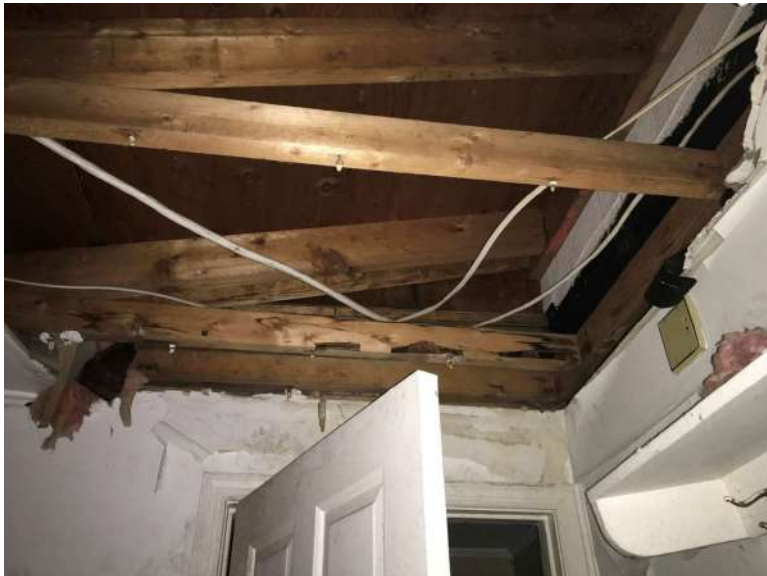
Collapsed ceiling observed on First Floor caused by water infiltration.

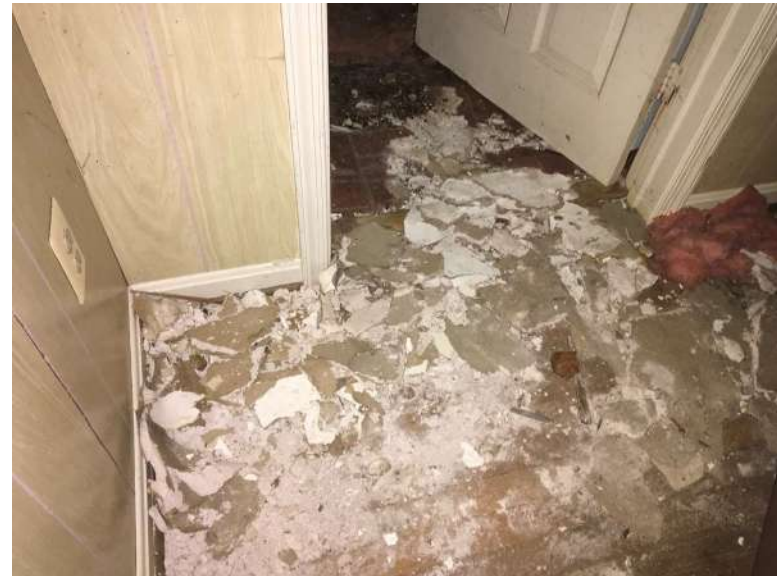
Collapsed ceiling debris on floor.

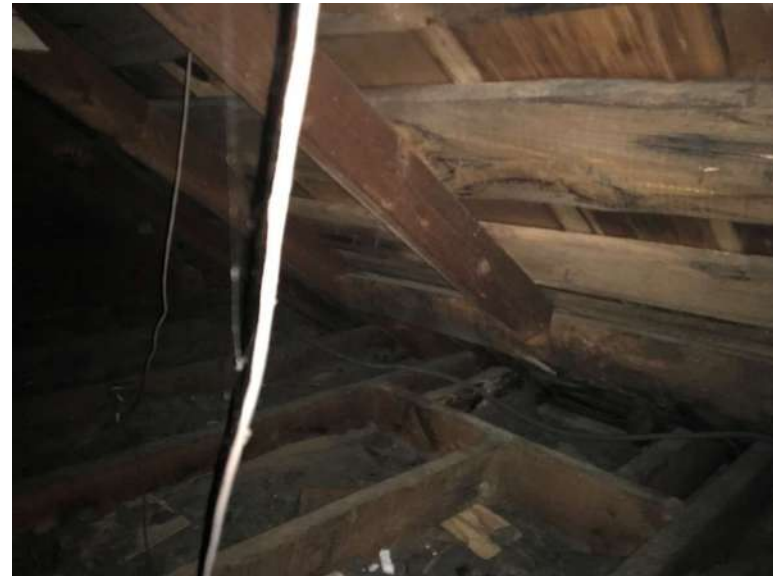
Water infiltration at roof framing. Partial failure of wood framing.

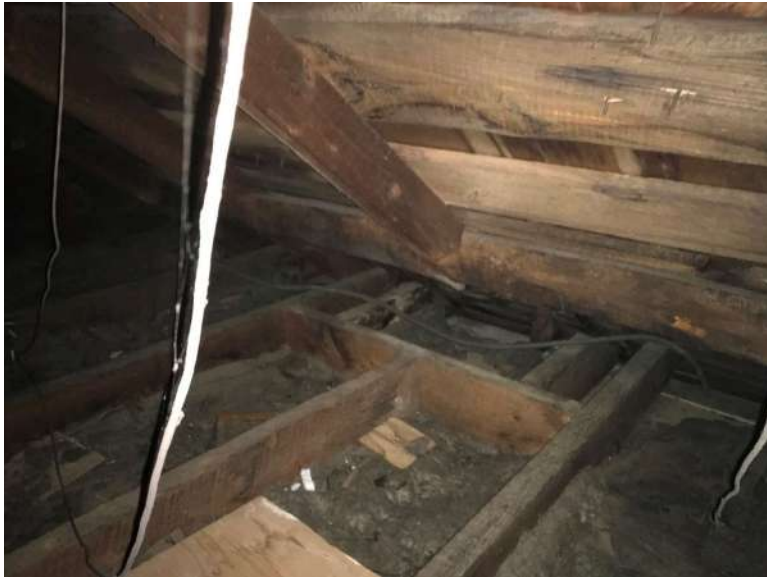
Partial failure of roof framing.

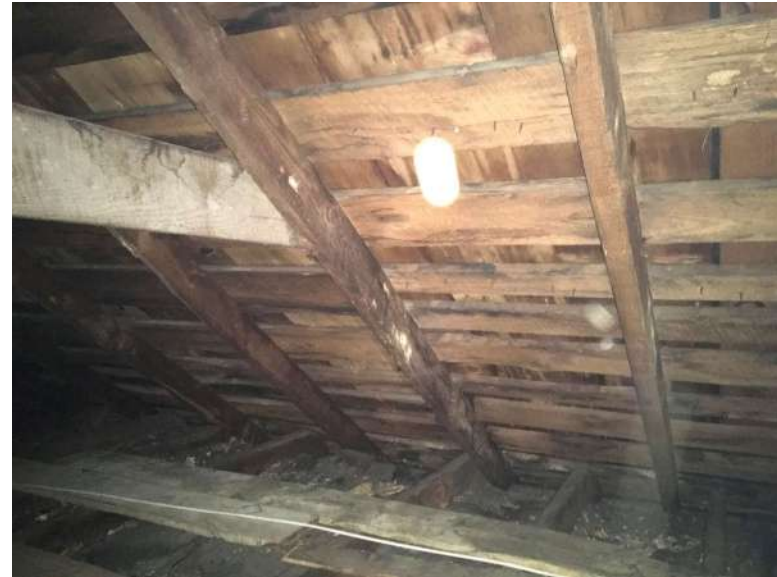
Base of roof rafters appear to have displaced outward. Wood framing appear bowed and twisted.

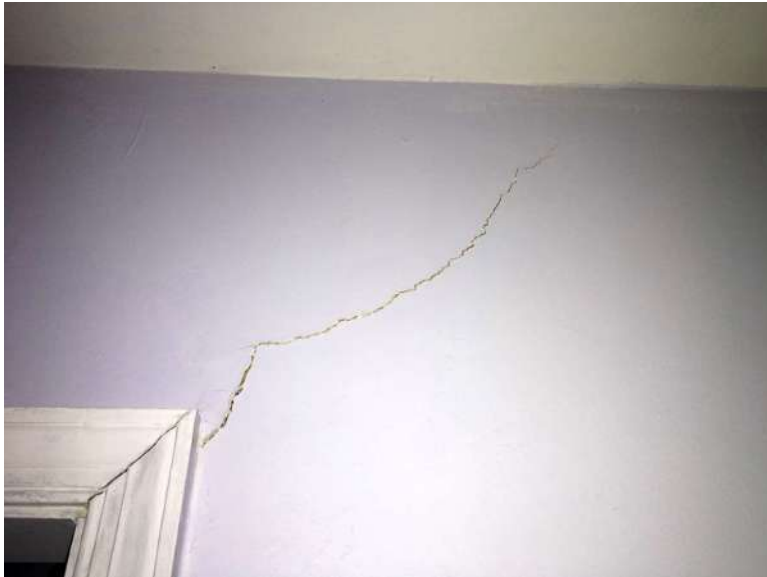
Typical diagonal cracking through wall finish at opening corners.

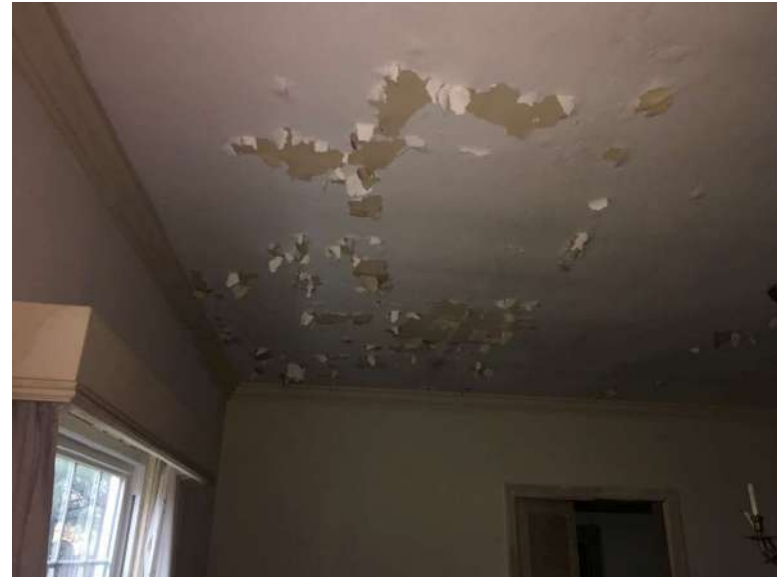
Peeling paint typical throughout building.

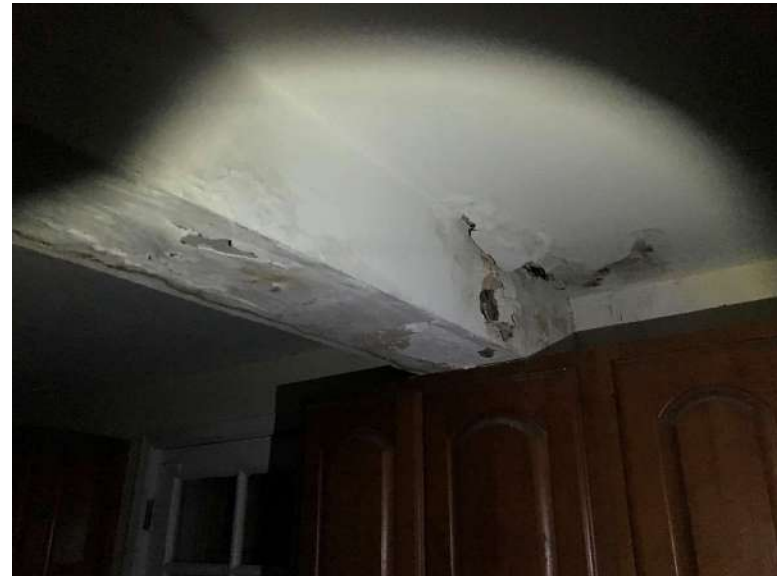
Water damage to finishes.

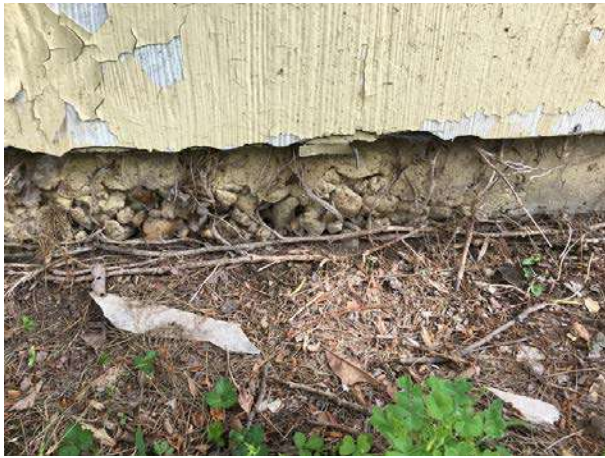
ECS observed organic growth along the bottom of the exterior of the building. Organic growth also appeared to be growing from the gutters on the roof, on the west side of the building on the side porch, and on the exterior walls of the garage. This growth had spread from the earth to inside of the wood siding. This enables water and insects to be able to penetrate the siding and into the brick exterior. It will also cause the wood siding to separate.

Organic grow into the wall

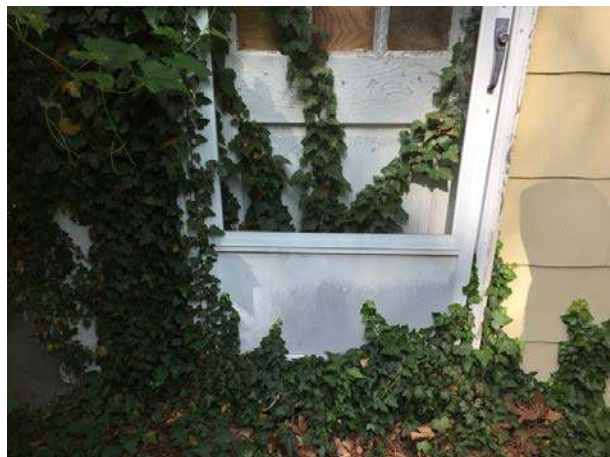
Growth on side door near porch

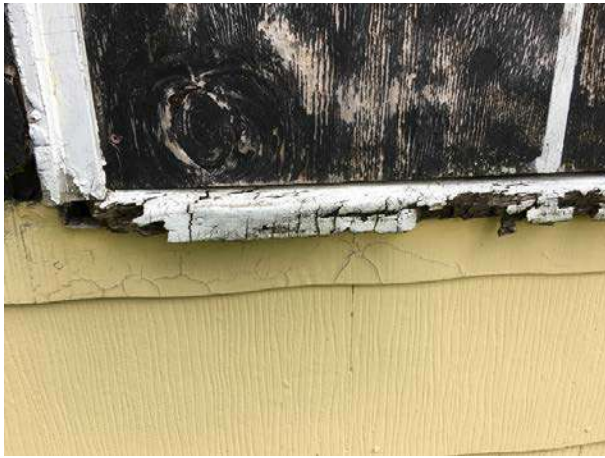
ECS observed that the wood window frames of various windows are rotted. ECS tested the severity of the wood rot using hand force which resulted in the wood falling off. This indicates that there is water damage in the wood. The rot will allow for more water to become trapped and penetrate farther into the frame causing more deterioration.

Window frame wood rot

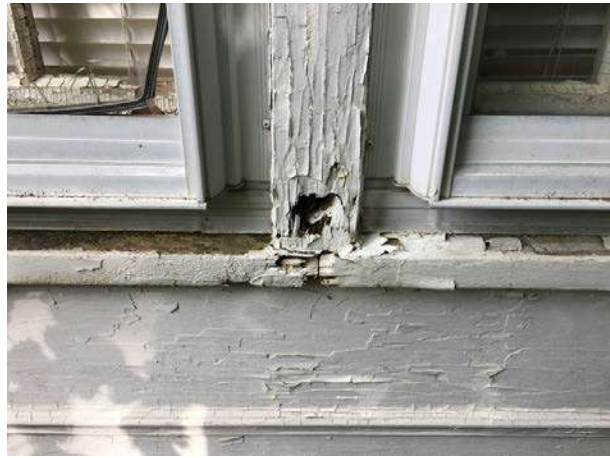
Window frame wood rot

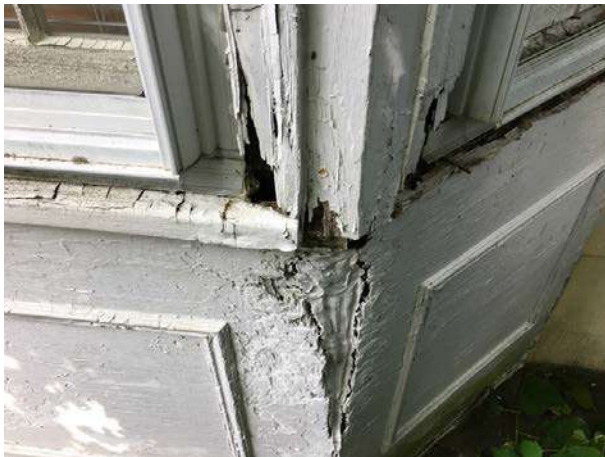
Window frame wood rot

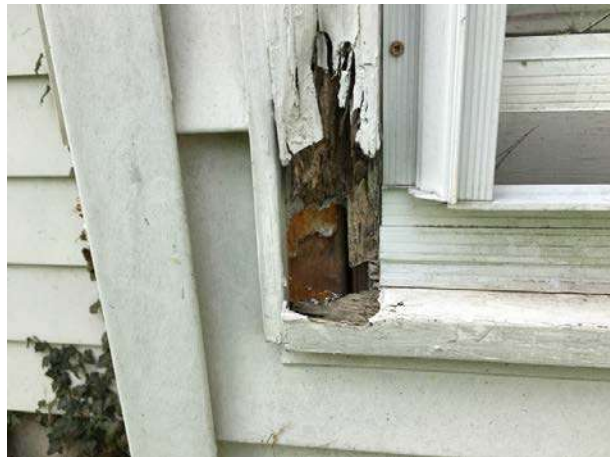
Window frame wood rot

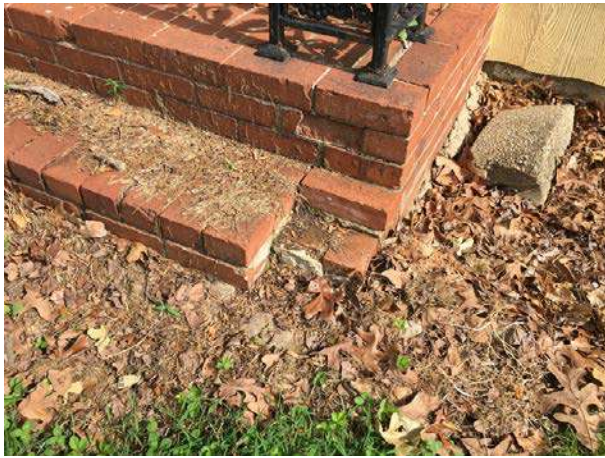
The steps in front of the main entrance are made of bricks. Some pieces of brick are missing at the right section. This may be a safety concern for people walking on them.

Bricks missing

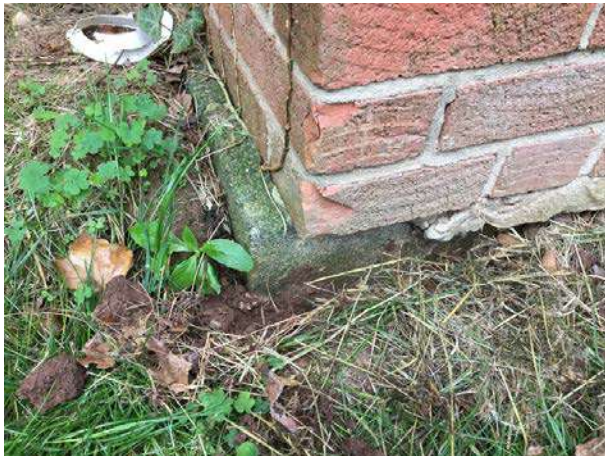
Soil erosion was observed at the rear chimney. In particular, the concrete foundation slab appeared to be exposed. The soil was soft and easily movable to the touch. This may cause washout or settlement of the chimney that can result in instabilities or cracking.

Rear chimney bottom

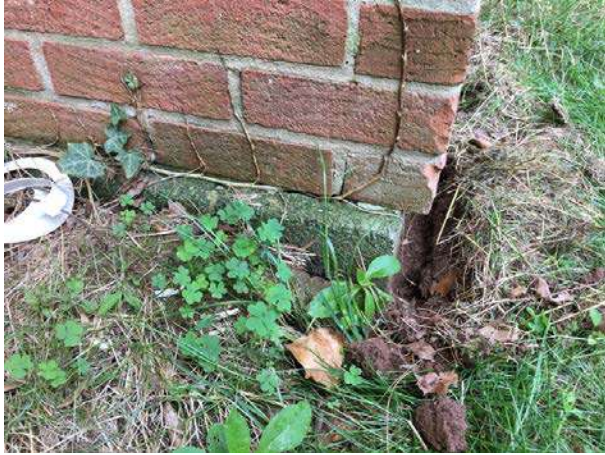
Rear chimney bottom

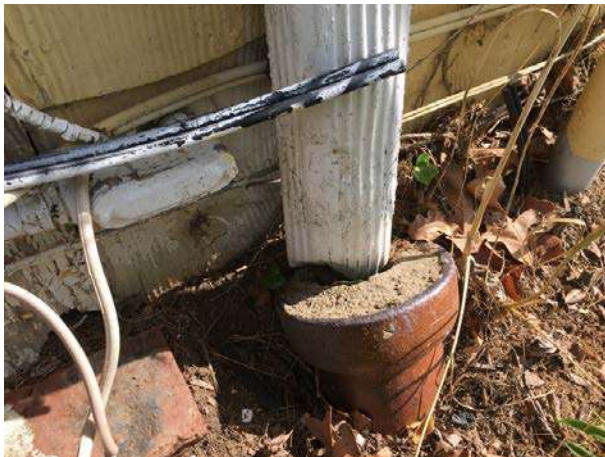
Observations were made of the downspouts on the exterior of the building. Some of these downspouts were not connected to the path of drainage for water to safely move away from the foundation soil. This may cause erosion of the soil around the foundation or create ways for water to penetrate the foundation.

Downspout path blocked

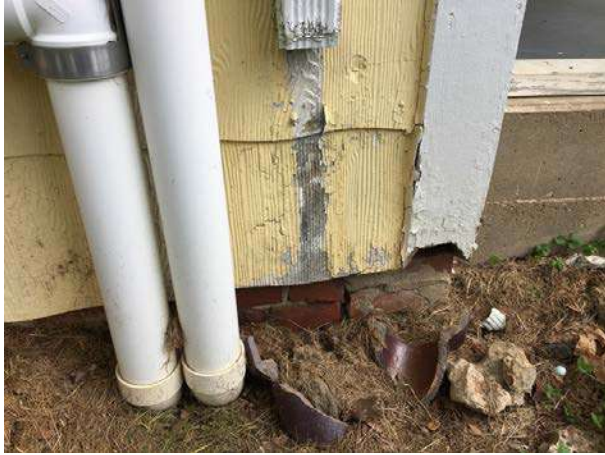
Downspout damaged

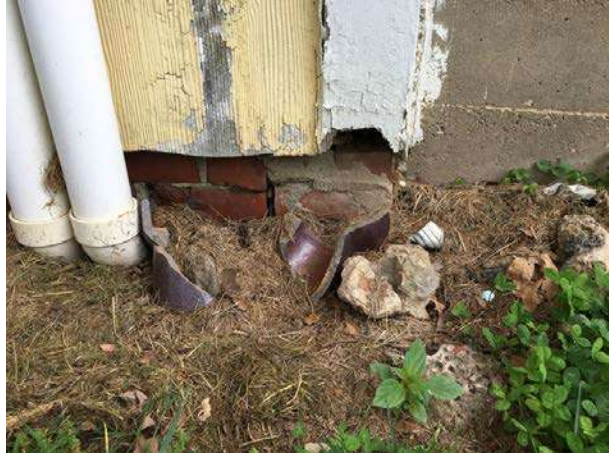
Downspout damaged

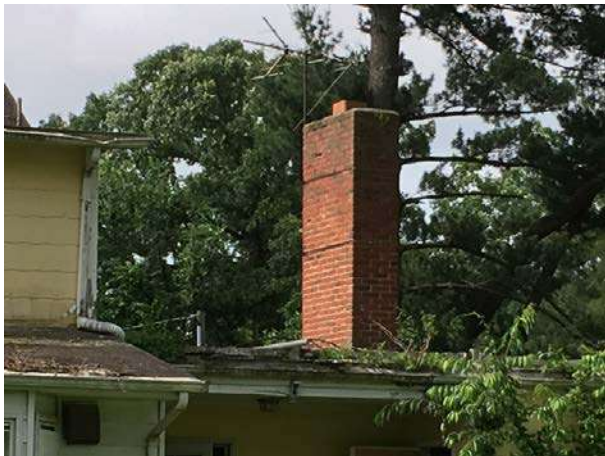
ECS observed that the gutters around the roof edge are not functional. The gutter on the front of the roof is sagging. There is also debris that fills some areas of the gutters. This may result in water not being able to drain properly into the downspouts and causing damage to the building soffits and fascia. Improper drainage may also result in soil erosion, washout of soil at the foundation, or settlement issues.

Gutters filled with debris

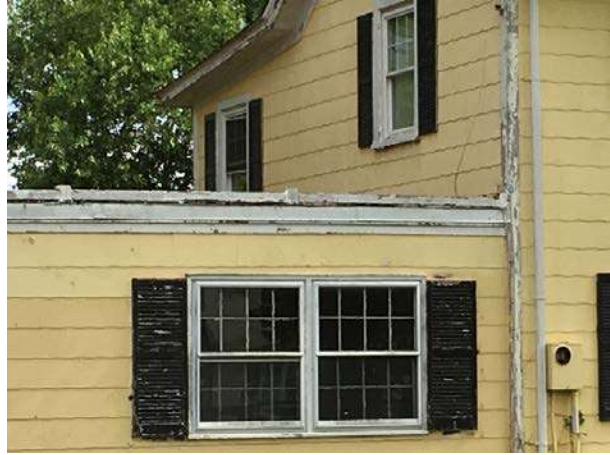
damaged gutters

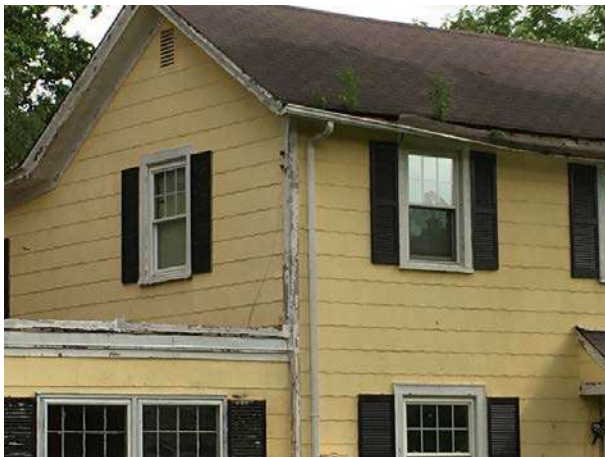
There is a hole in the roof that penetrated through the building into the second floor allowing for debris, water, and animals to collect inside.

Typical roof condition

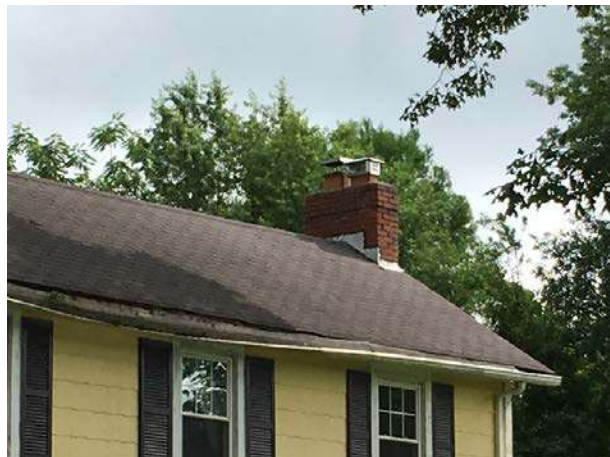
Typical roof condition

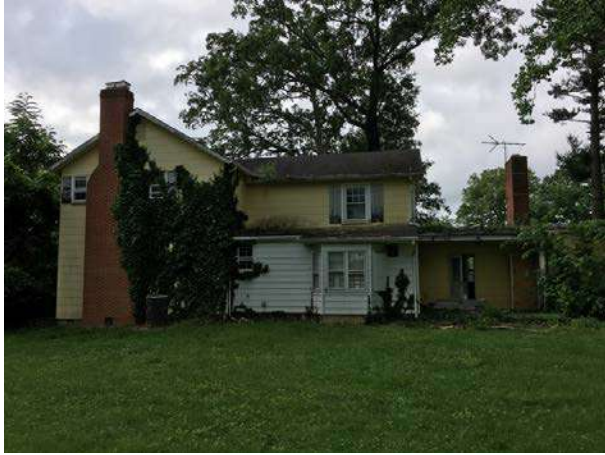
Flat roof at garage and laundry area

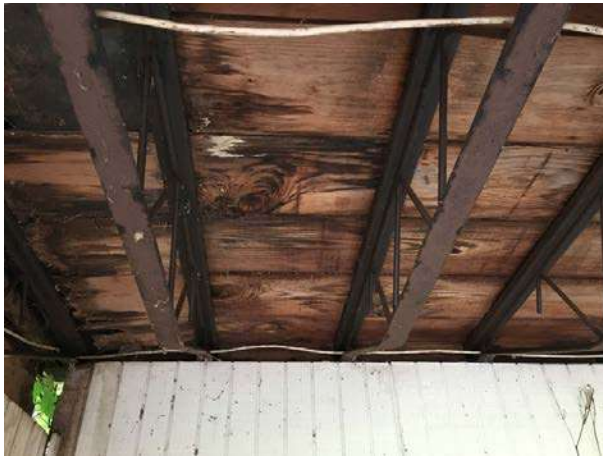
Wood roof water damaged

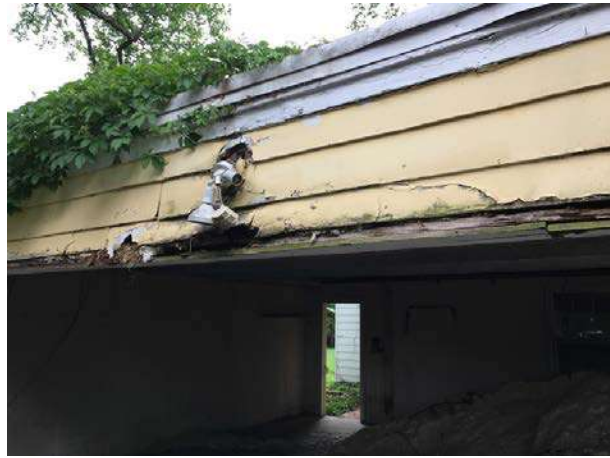
Door Frame damaged

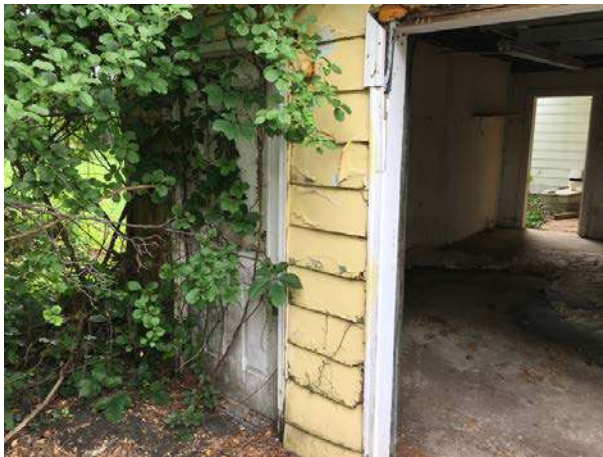
Door Frame damaged

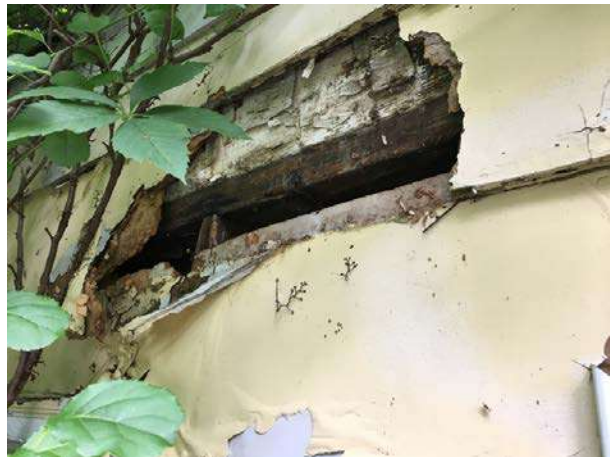
Door Frame damaged

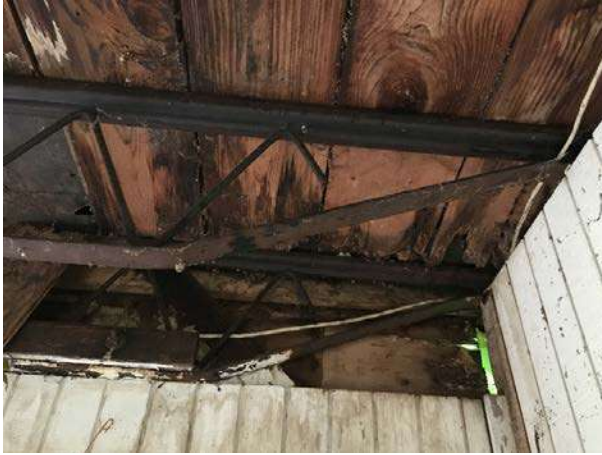
The steel joints were observed to have corrosion throughout. The corrosion appeared to be surface rust with some pitting. At this time the joist strength did not appear to be reduced due to the corrosion. If not addressed, the corrosion will continue to worsen which may eventually lead to section loss of the steel and reduced strength. To address this concern, the garage will either need to be enclosed and conditioned to prevent high humidity and other moisture from corroding the steel further, or it may be cleaned and painted with a protective coating.

Steel surface rusted

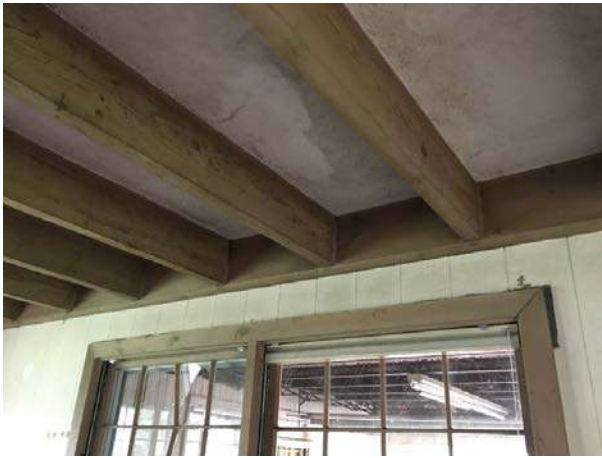
Exposed joists in room adjacent to garage

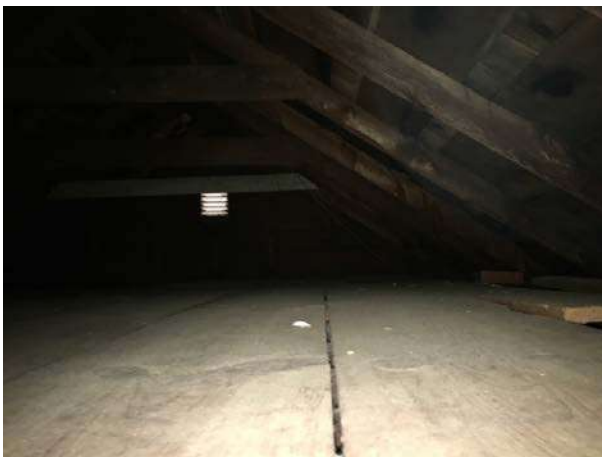
Rafter system supporting roof

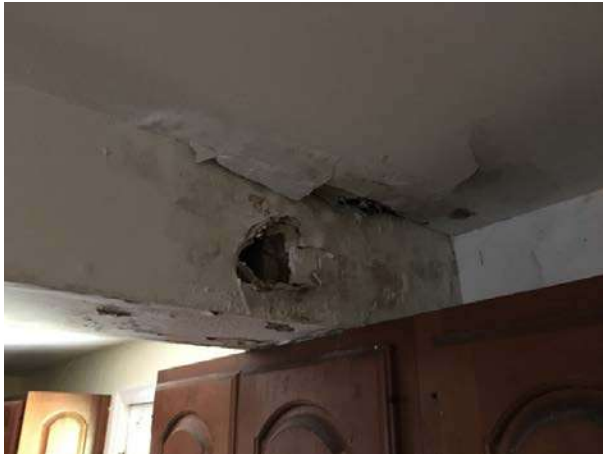
the members beyond were also exposed to moisture which can result in wood rot and a loss of strength. Damaged areas of drywall throughout the should should be removed to allow for structural observations of the members beyond.

Water damaged drywall in kitchen

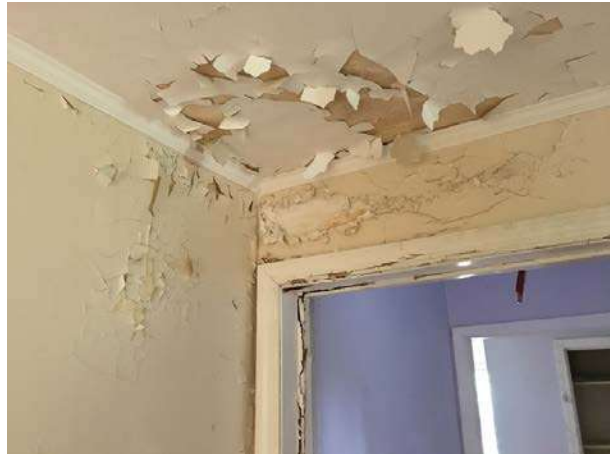
Ceiling paint peeling

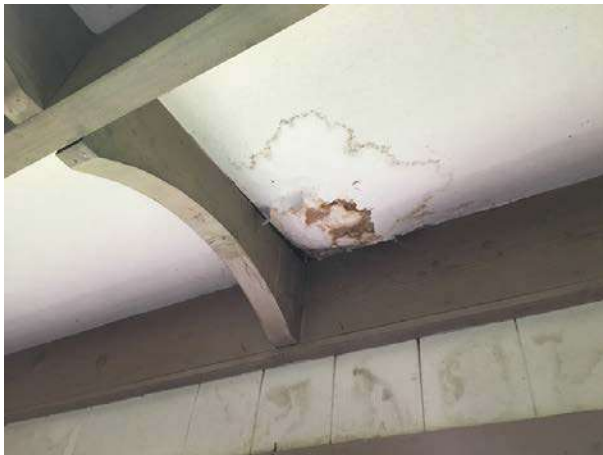
Water damage on ceiling in room adjacent to garage

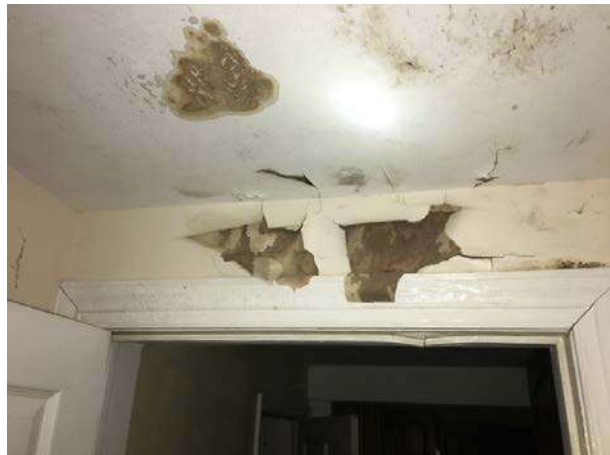
Paint peeling above door frame

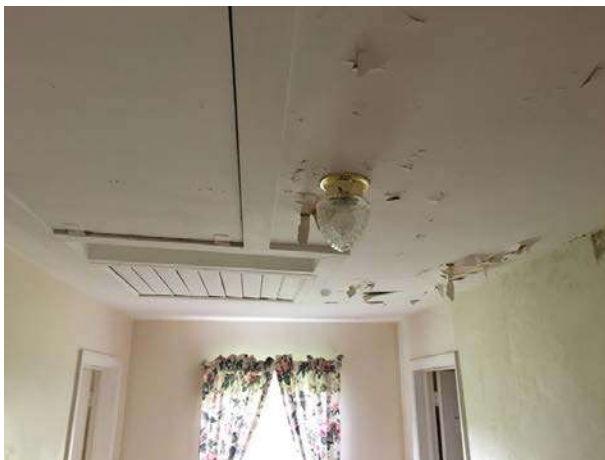
The sagging ceiling may be a result of moisture intrusion or of a damaged joist either from overstress or cracking. Further investigation of this area may be required, however shoring should be used to support the attic prior to entrance.

Second floor hallway ceiling sag

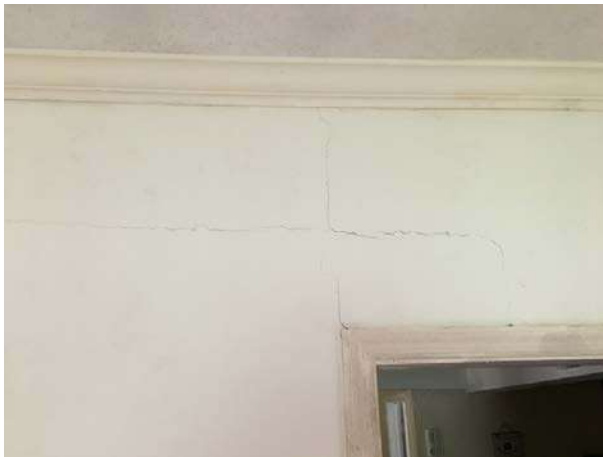
Corners where materials (both structural or finish) may change or door frame corners are common areas to observe cracks. Cracks in these locations may be the result of differential movements between materials or of slightly unintended settlement or loading. These cracks are often not an indication of large structural problems. However, the size of the observed cracks observed in the residence was noted to be greater than those expected under typical conditions. Lack of moisture control may have resulted in larger differential movements, or settlement may have occurred. Cracks may also be an indication of problems with the structural studs and joists behind the finishes. Further investigation, such as observations of the wood substrate after finishes are removed, is likely required.

Cracks along a wall

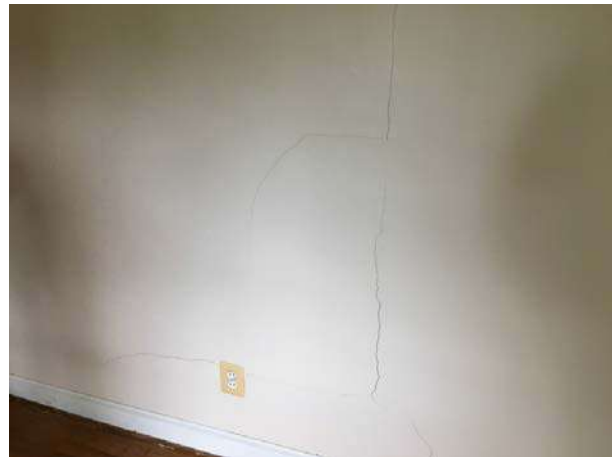
Cracks along a wall

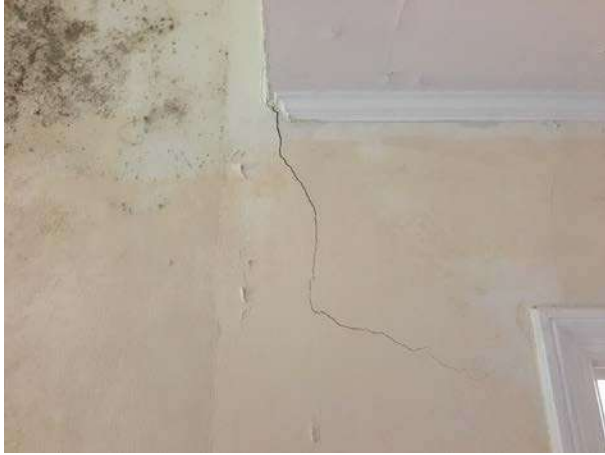
Crack along a wall

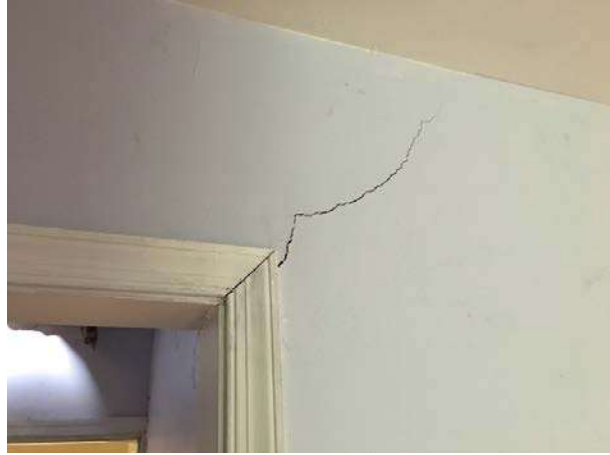
Crack along a wall

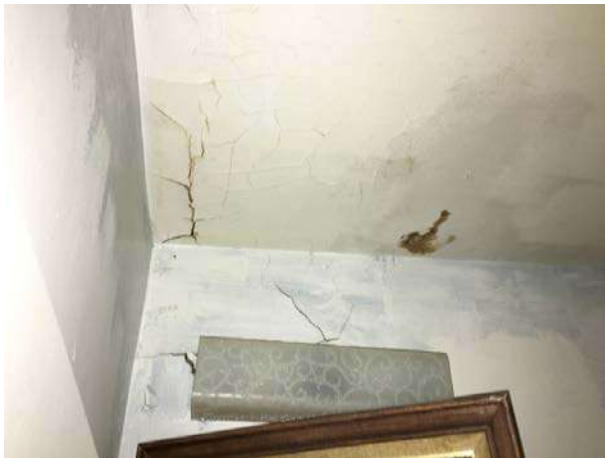
Cracks on a ceiling

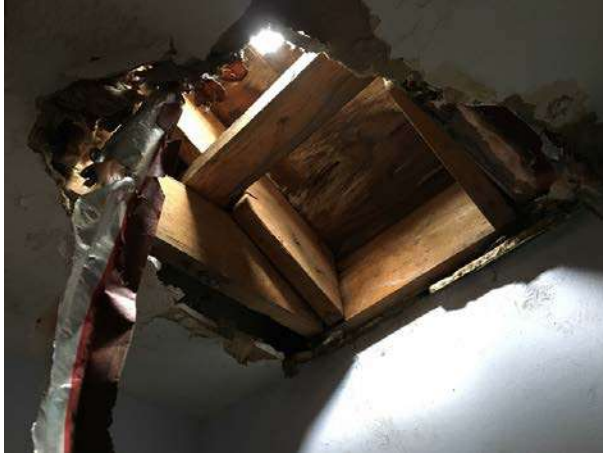
The collapsed area is a serious condition and failure of the structural system.

Hole penetrating from roof

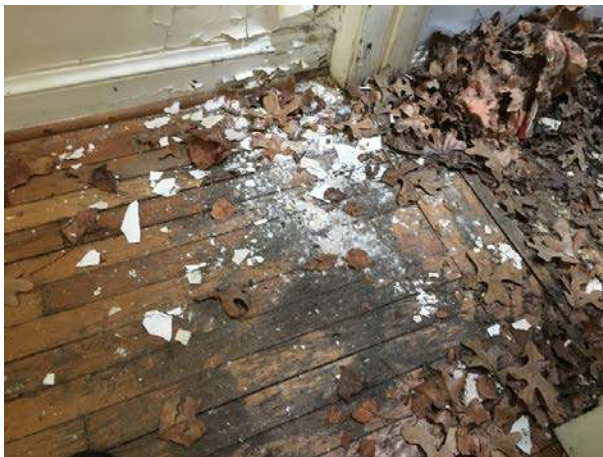
Debris fallen through hole creating possible water damage

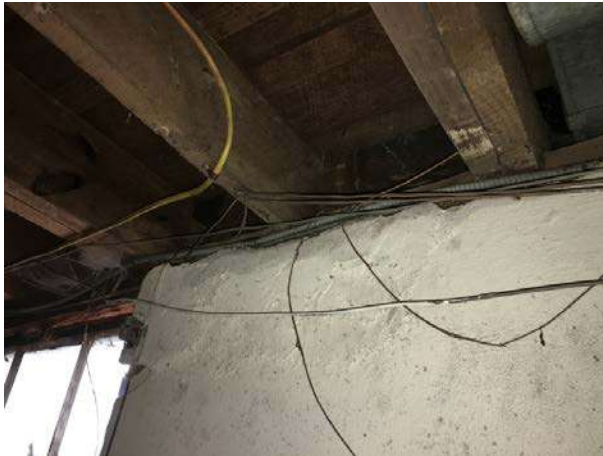
Organic growth penetrating from outside into basement

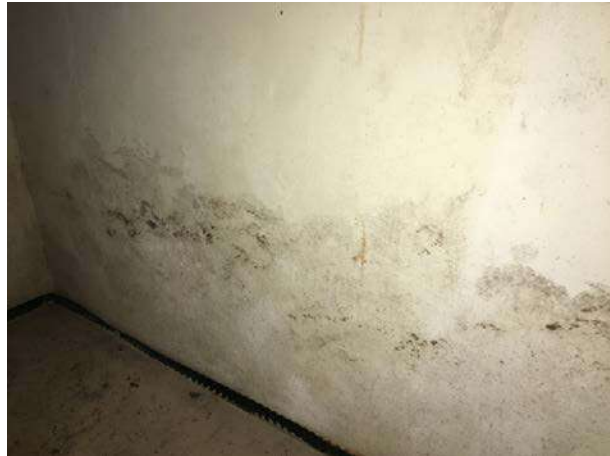
Water damage of the walls

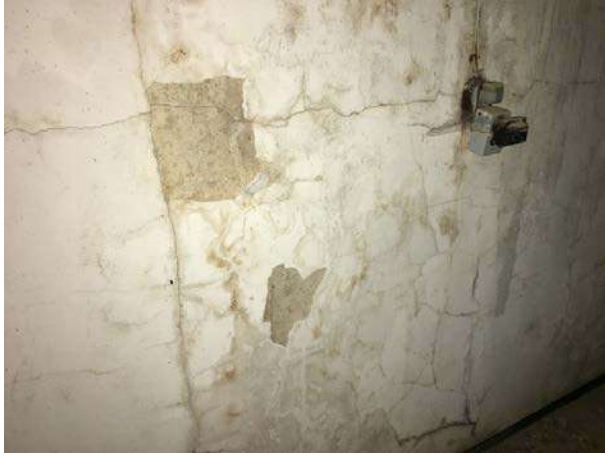
Cracks in the parged walls

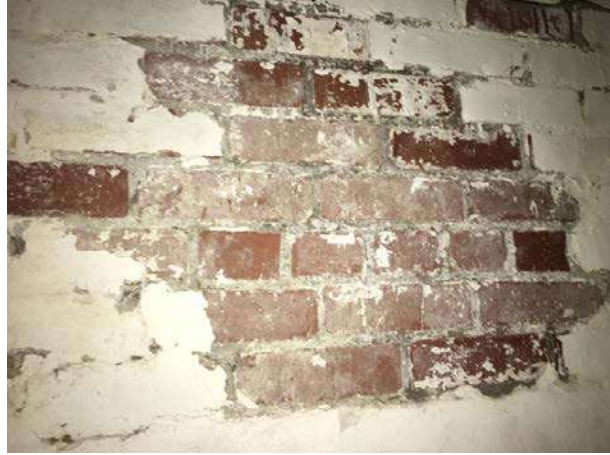
Exposed area of basement wall
