## Board of Architectural Review

DATE: December 20, 2017  
TO: Board of Architectural Review Chair and Members  
THROUGH: Jason Sutphin, Community Development Division Chief (JDS)  
FROM: Tommy Scibilia, BAR Liaison (TS)  
SUBJECT: Paul VI Redevelopment – Work Session

HAZARDOUS MATERIALS AND STRUCTURAL SURVEY

YELLOW HOUSE AT 10606 CEDAR AVENUE

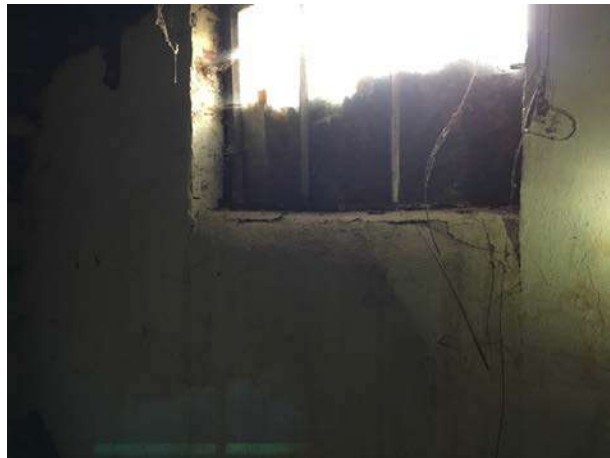
In particular, severe damage was observed at the basement window sill. Cracking and overall material deterioration were observed. This window will likely require replacement with some amount of demolition and rebuilding of the brick adjacent to it.

Basement window

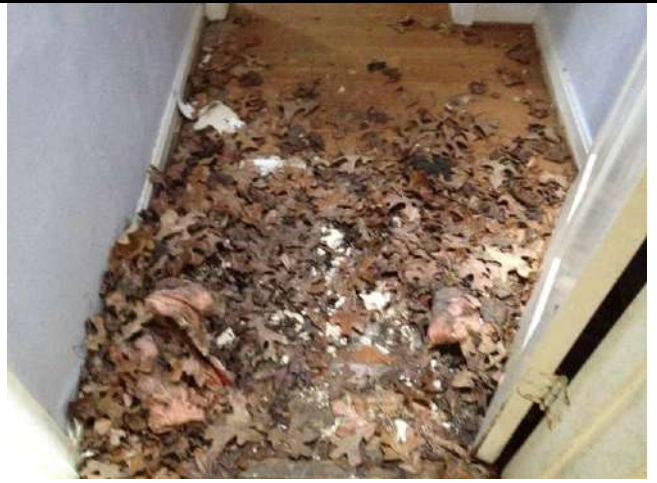
8. View of debris on the floor, partial hole in the floor from the roof leak.

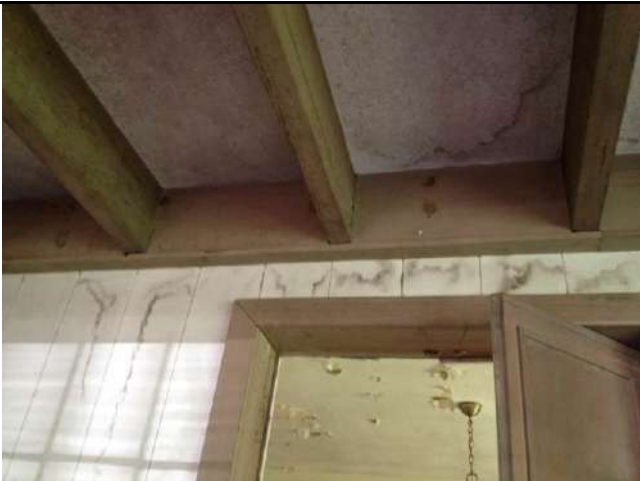
9. View of visible mold on the ceiling/walls in the den.

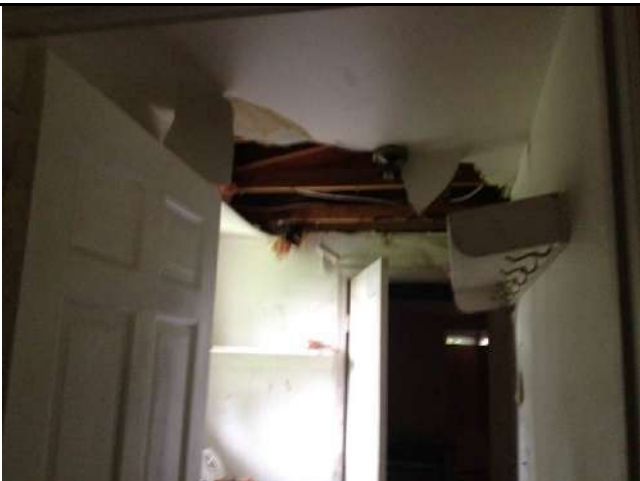
17. View of the ceiling damage from a roof leak in the laundry room/hall.

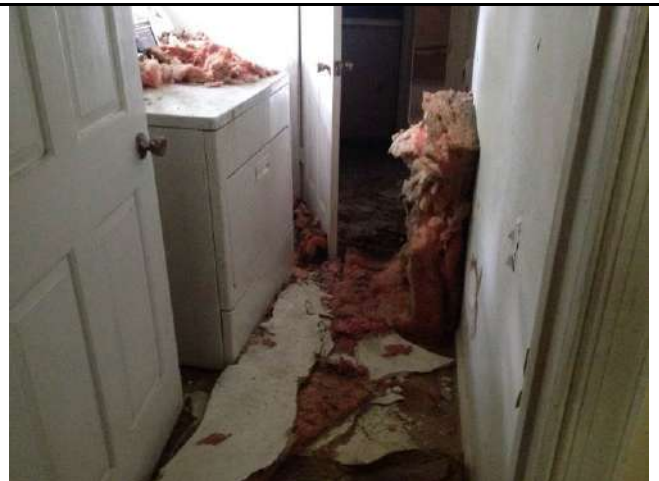
18. View of impacted materials from a roof leak in the laundry room/hall.
