NATIONAL BANK OF FAIRFAX BUILDING

4029 Chain Bridge Road
Fairfax, Virginia

Building History Report

February 2024

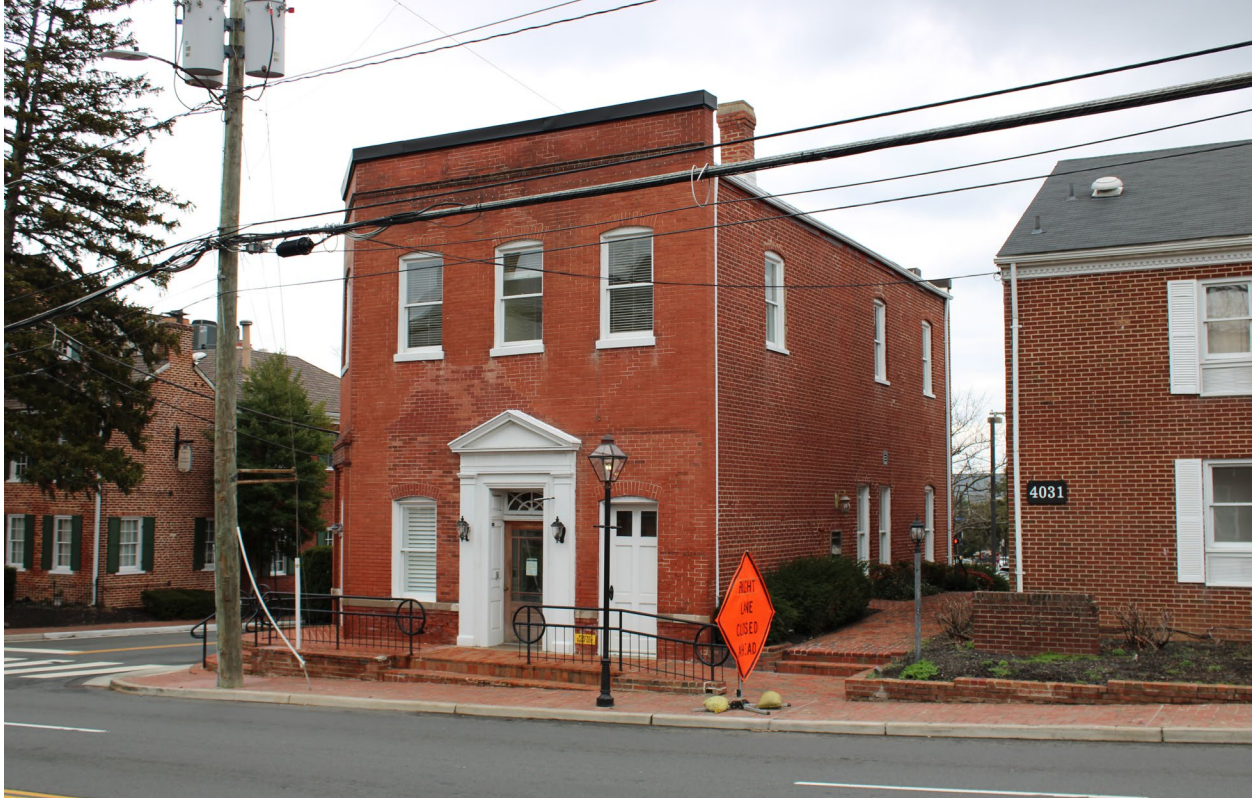
Figure 3: West elevation, looking northeast. EHT Traceries.

The first story of the west elevation shows evidence of alterations and extensive brick repairs. Alterations include the removal of the large storefront window, which was replaced with a smaller window. A new, secondary entrance with a large pediment was added to the center bay. Based on historic photos, it appears that there was a secondary entrance located in the south bay of the west elevation. Evidence of repairs surrounding this entrance suggest it may have been altered at some point.

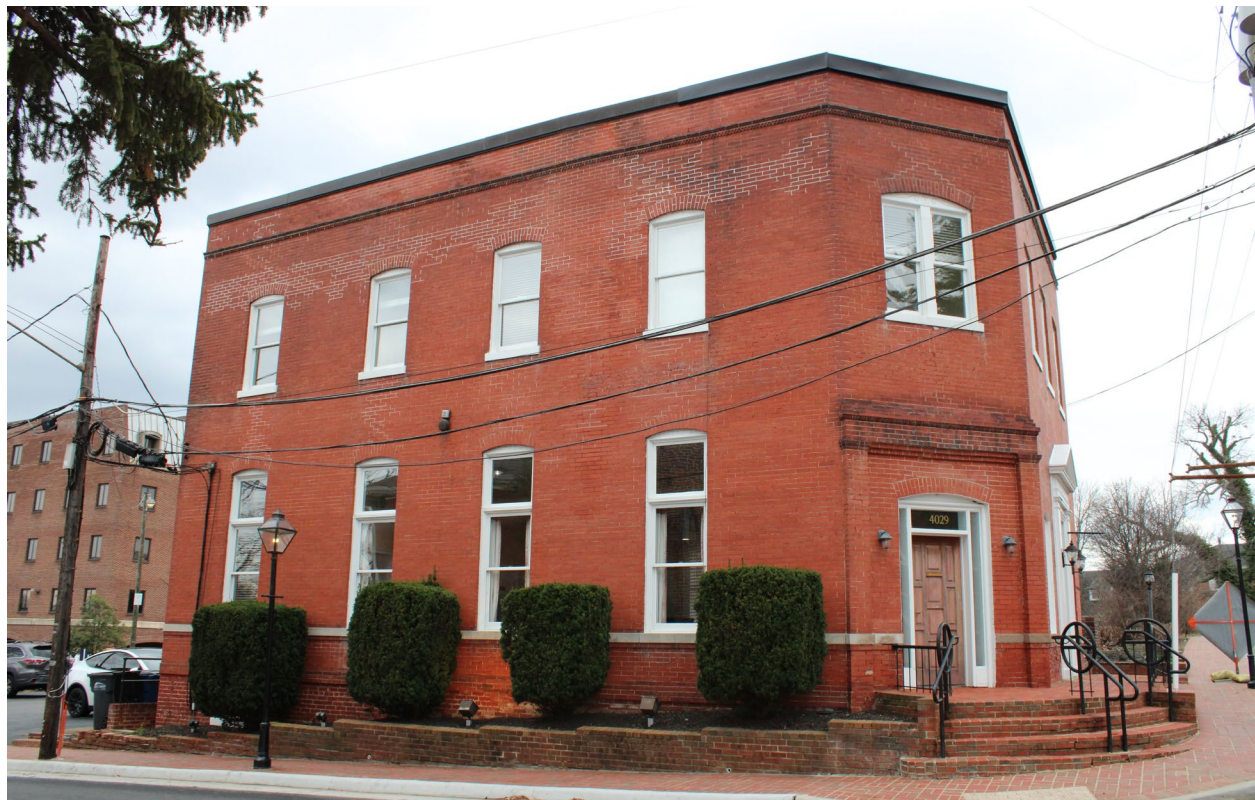
Figure 4: North elevation, looking southeast. EHT Traceries.

On the chamfered corner entrance between the west and north elevations, the door openings retains its historic profile with brick segmental arch; however, the historic double leaf door was replaced with a single leaf wood door with contemporary sidelites. On the north elevation, alterations include the addition of a raised brick planting bed. On the east elevation, alterations include the addition of a new window in the middle bay. On the south elevation, alterations include the addition of a contemporary bank drop box.

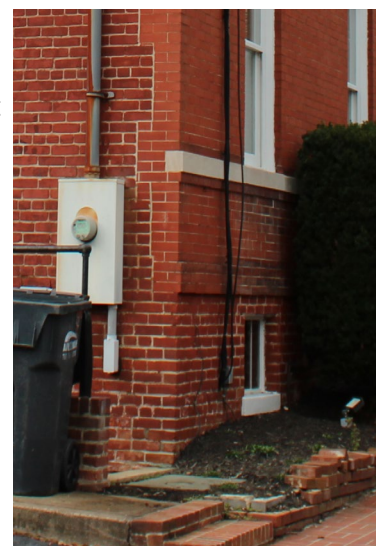
Figure 7: Detail of differing brick bonds. EHT Traceries.
