**Appendix A:
Project Maps, Site Photographs,
and Project Narratives**

FAIRFAX OLD TOWN HALL REHABILITATION
CITY OF FAIRFAX, VIRGINIA
VICINITY MAP

City of Fairfax
Old Town Hall
3999 University Drive
Proposed Exterior Renovation/Rehabilitation

HUD/State ID B-22-CP-VA-0894

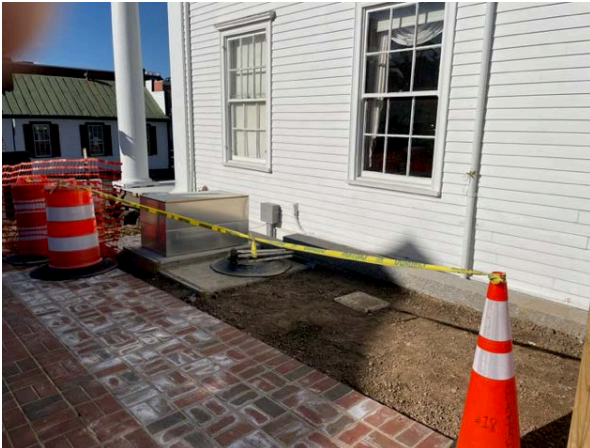
View of area on Old Town Hall southern exterior to be landscaped and stabilized, facing northwest.

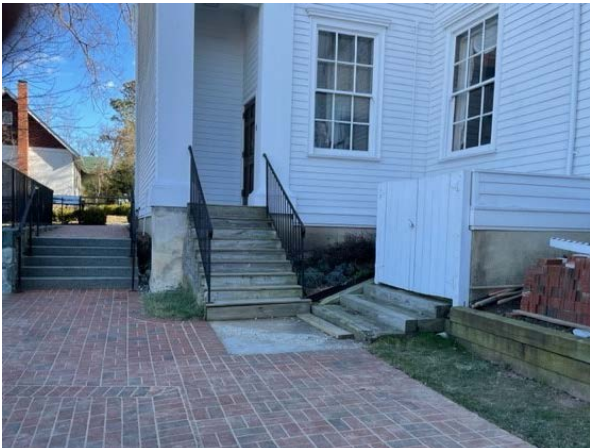
View of Old Town Hall northeast side stairs to be replaced.

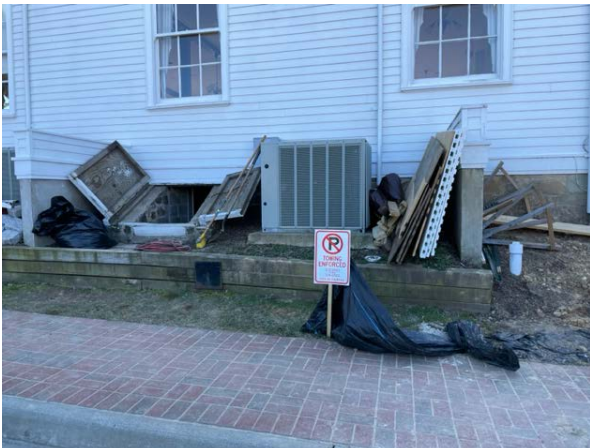
View of Old Town Hall north side HVAC equipment to be removed and relocated. Sanitary sewer is currently behind the timber retaining wall to the left of the visible cleanout.

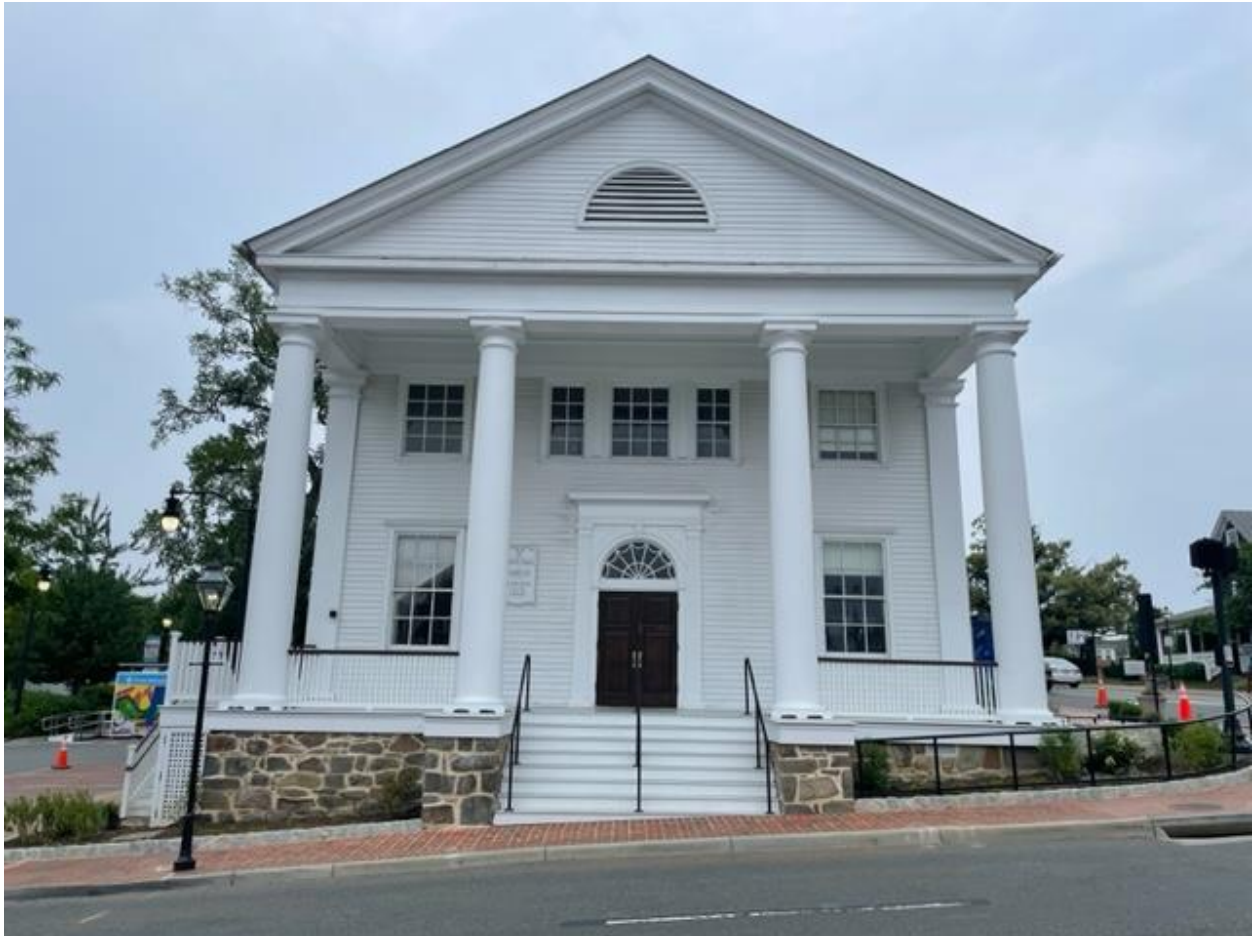
West (front) Elevation (historic)

Restoration of the masonry foundation, replacement of concrete deck with wood flooring, installation of an ADA compliant access ramp and new stairs were recently completed as part of a project necessitated by the failure of the left (northwest) column. The failed column was replaced with a new wood column. The remaining three columns were removed, restored and returned to use. This work was completed in May 2023 using local funding.

Proposed grant-funded work on this elevation is limited to repairs to damaged and rotted trim, restoration of windows, doors and tympanum vent, and repainting of siding and trim at façade and tympanum. The exterior wood siding on the historic portion of the building appears to match the original siding based on the historic photograph (see cover page) but was clearly replaced at a more recent point as “Tyvek” material can be seen behind the siding material. Research as to appropriate colors is in process through historic records and paint analysis. Consideration is also being given to re-installing shutters on the first-floor windows to replace those seen in the historic photograph.

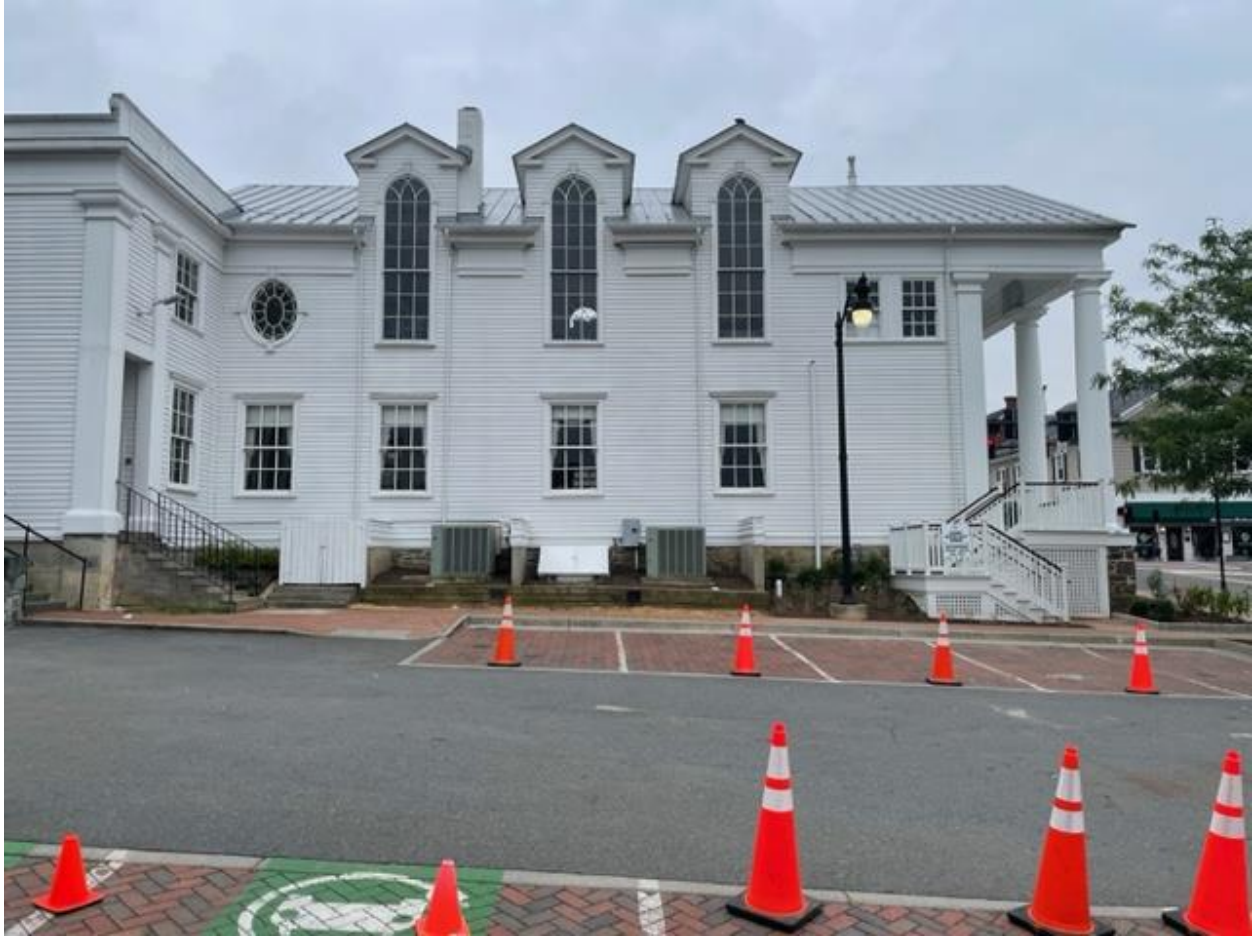
North Elevation (historic)

New stairs were added to the end of the front porch to facilitate access to the parking area as part of the porch repair work. These stairs were included in an informal review presented to the Virginia Department of Historic Resources and comments were incorporated into the design. A formal review was not completed as only local funds were expended for this work. The area to the left of the picture shows an addition that was completed in the 1990's.

Proposed grant-funded work on this elevation includes the removal of the two HVAC compressors (with relocation to the flat roof of the addition), removal of the screening walls that were added to screen the HVAC units, removal of the wood trash enclosure, localized repair or replacement of damaged trim and siding, restoration of windows, rehangng improperly sloped gutters, repointing of the stone foundation wall and localized areas of the brick chimney, and painting of entire façade (see notes on front elevation regarding siding and paint selection). Replacement of the temporary wood stairs leading to the entry door to the addition is proposed as part of this work. As with the front elevation, providing new shutters consistent with those shown in a historic photograph is under consideration.

Land disturbance will include removal of the wood timber retaining wall and regrading of the area along this elevation (approximately eight feet by forty feet), construction of footings for replacement stairs, and installation of new curbing along existing sidewalk.

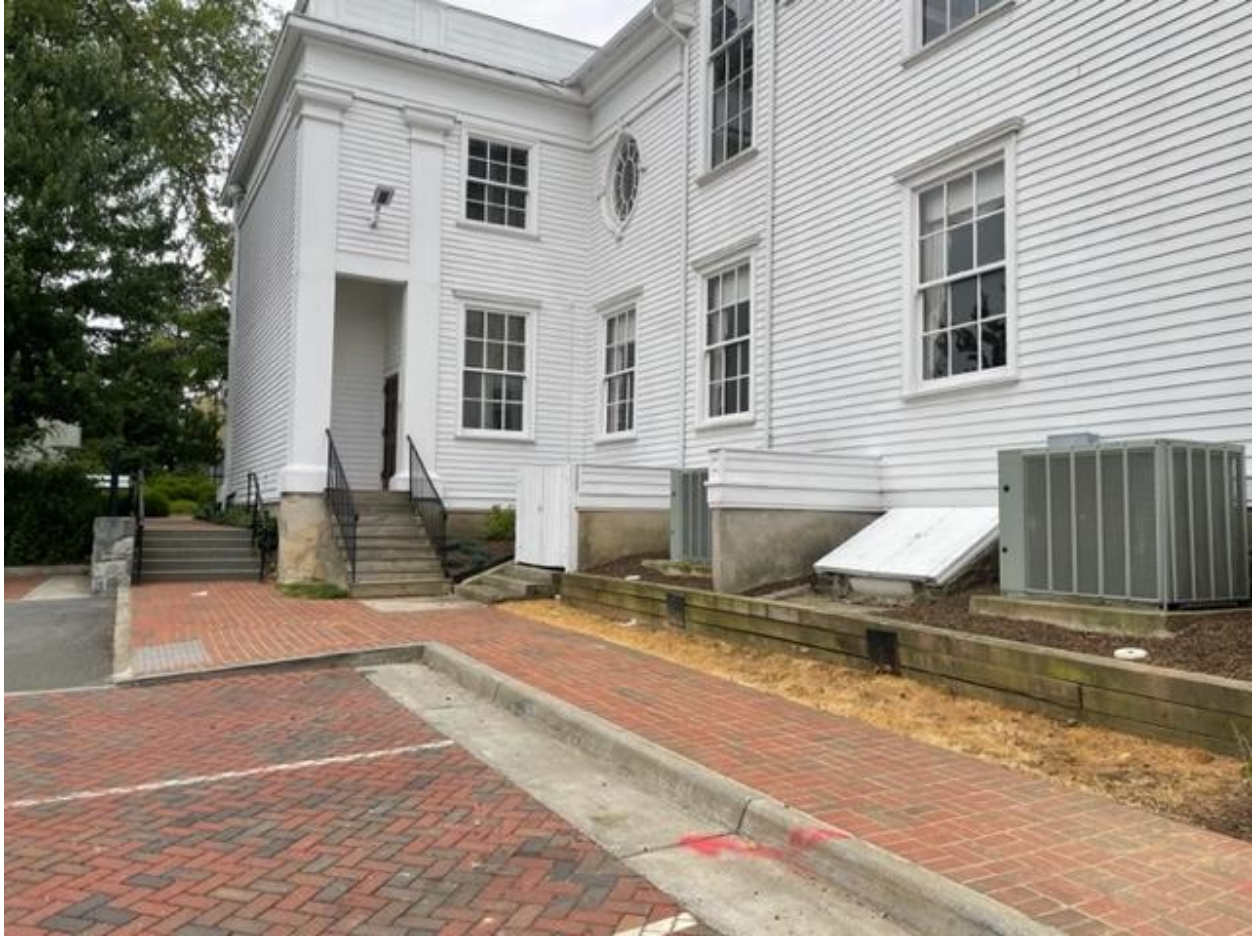
Additional View of North Elevation (addition/historic)

This view shows HVAC units to be relocated, screen walls and trash enclosure to be removed and stairs to be replaced. Light fixture above door will also be replaced with a more appropriate unit. The entrance elevation of the addition will also be considered during the exterior redesign, including potentially eliminating the recessed entrance and creating a more complimentary rhythm to the openings.
