City of Fairfax
Old Town Hall
3999 University Drive
Proposed Exterior Renovation/Rehabilitation

HUD/State ID B-22-CP-VA-0894

Prepared by City of Fairfax Department of Public Works
for use in completing Environmental Assessment and Preliminary VA DHR Review

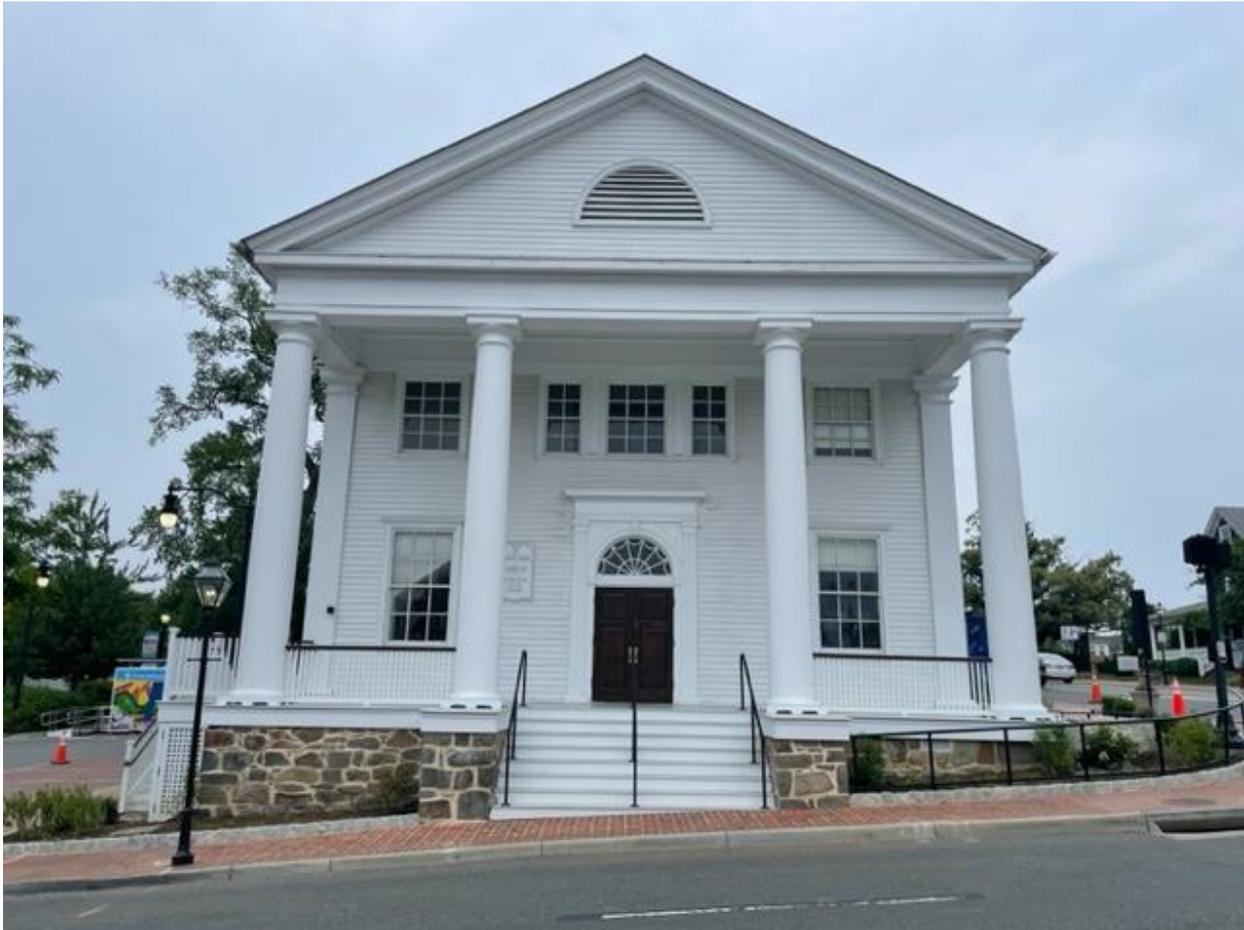
West (front) Elevation (historic)

Restoration of the masonry foundation, replacement of concrete deck with wood flooring, installation of an ADA compliant access ramp and new stairs were recently completed as part of a project necessitated by the failure of the left (northwest) column. The failed column was replaced with a new wood column. The remaining three columns were removed, restored and returned to use. This work was completed in May 2023 using local funding.

Proposed grant-funded work on this elevation is limited to repairs to damaged and rotted trim, restoration of windows, doors and tympanum vent, and repainting of siding and trim at façade and tympanum. The exterior wood siding on the historic portion of the building appears to match the original siding based on the historic photograph (see cover page) but was clearly replaced at a more recent point as “Tyvek” material can be seen behind the siding material. Research as to appropriate colors is in process through historic records and paint analysis. Consideration is also being given to re-installing shutters on the first-floor windows to replace those seen in the historic photograph.

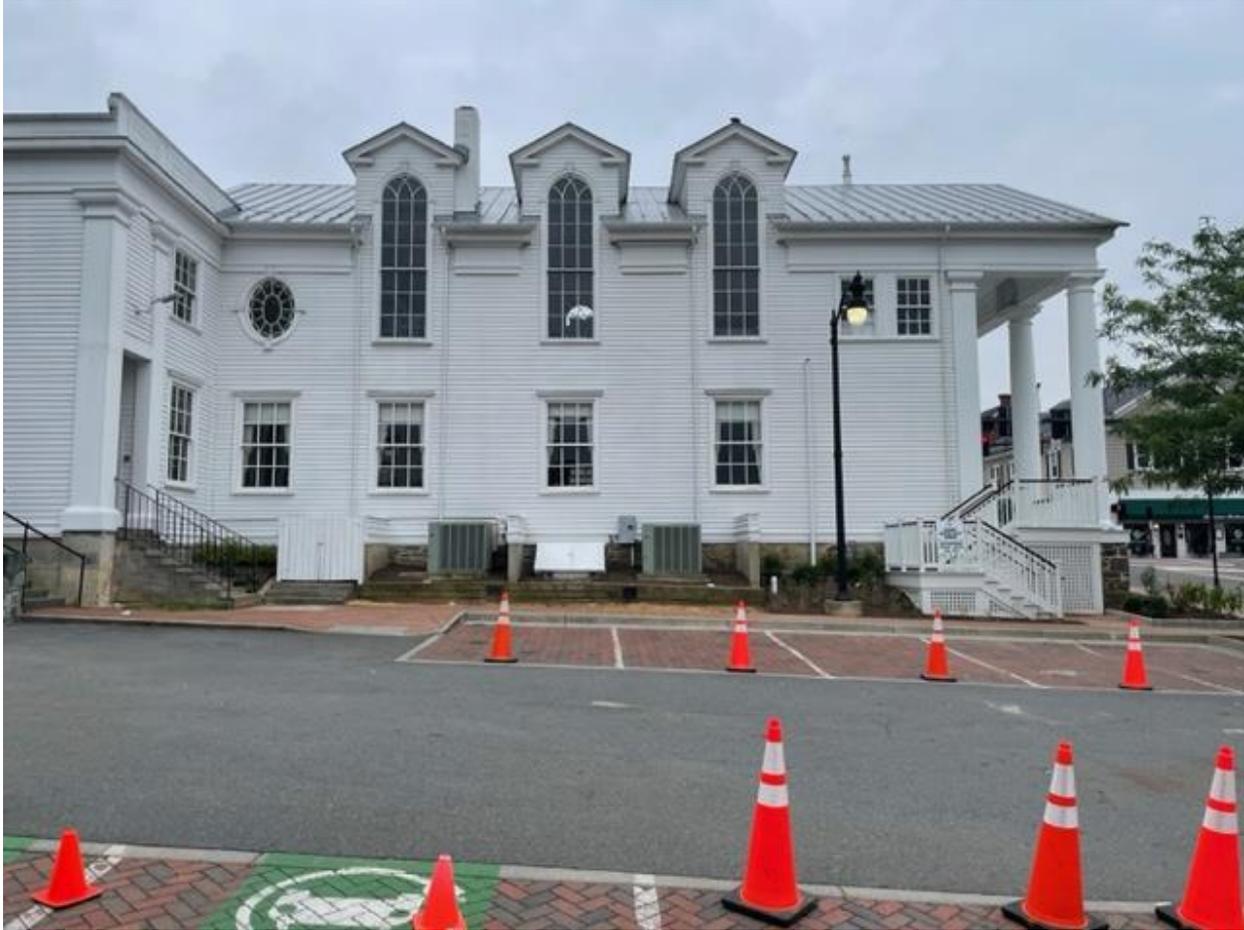
North Elevation (historic)

New stairs were added to the end of the front porch to facilitate access to the parking area as part of the porch repair work. These stairs were included in an informal review presented to the Virginia Department of Historic Resources and comments were incorporated into the design. A formal review was not completed as only local funds were expended for this work. The area to the left of the picture shows an addition that was completed in the 1990's.

Proposed grant-funded work on this elevation includes the removal of the two HVAC compressors (with relocation to the flat roof of the addition), removal of the screening walls that were added to screen the HVAC units, removal of the wood trash enclosure, localized repair or replacement of damaged trim and siding, restoration of windows, rehangng improperly sloped gutters, repointing of the stone foundation wall and localized areas of the brick chimney, and painting of entire façade (see notes on front elevation regarding siding and paint selection). Replacement of the temporary wood stairs leading to the entry door to the addition is proposed as part of this work. As with the front elevation, providing new shutters consistent with those shown in a historic photograph is under consideration.

Land disturbance will include removal of the wood timber retaining wall and regrading of the area along this elevation (approximately eight feet by forty feet), construction of footings for replacement stairs, and installation of new curbing along existing sidewalk.

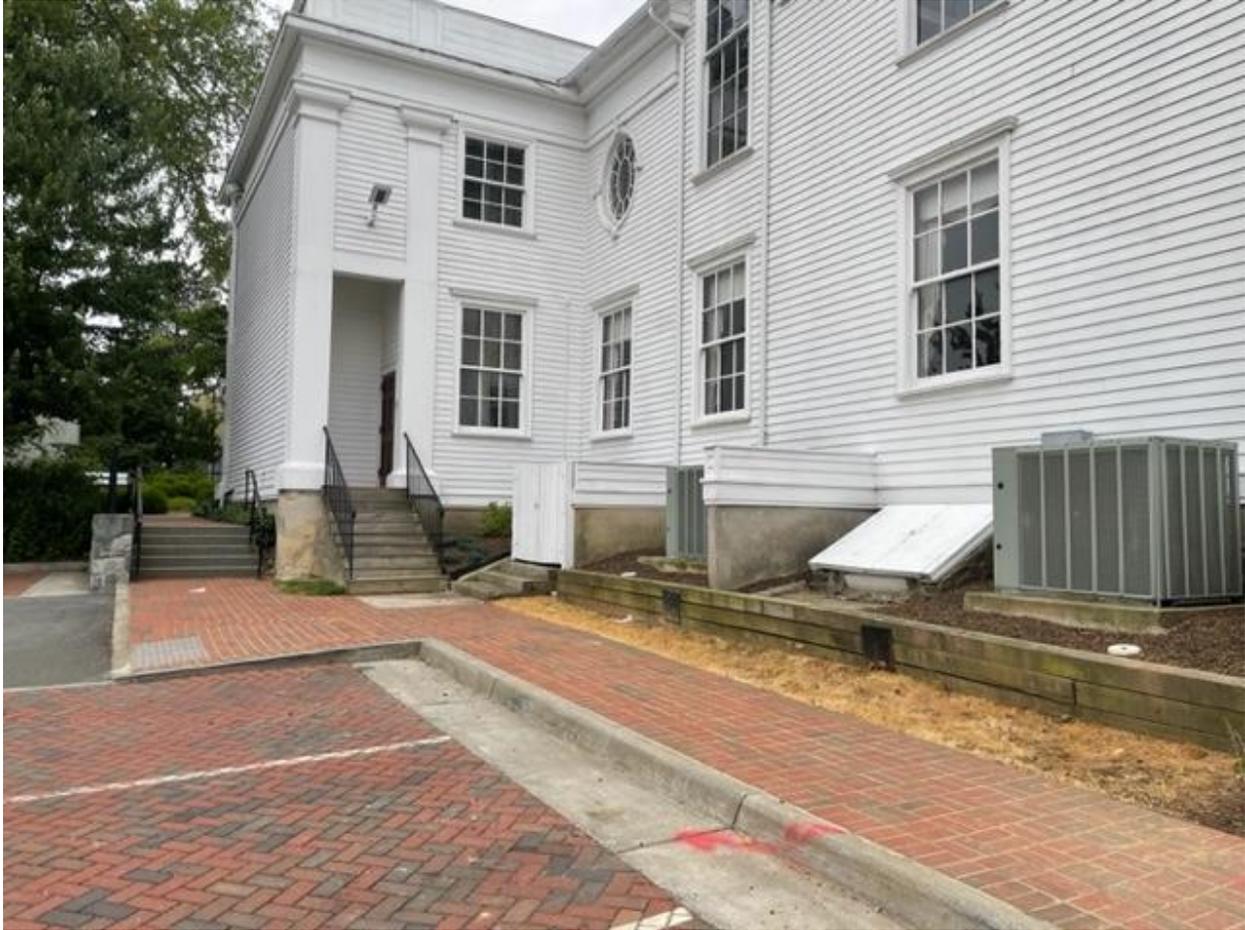
Additional View of North Elevation (addition/historic)

This view shows HVAC units to be relocated, screen walls and trash enclosure to be removed and stairs to be replaced. Light fixture above door will also be replaced with a more appropriate unit. The entrance elevation of the addition will also be considered during the exterior redesign, including potentially eliminating the recessed entrance and creating a more complimentary rhythm to the openings.
