**Appendix K:
Historic Preservation**

City of Fairfax
Old Town Hall
3999 University Drive
Proposed Exterior Renovation/Rehabilitation

HUD/State ID B-22-CP-VA-0894

Prepared by City of Fairfax Department of Public Works
for use in completing Environmental Assessment and Preliminary VA DHR Review

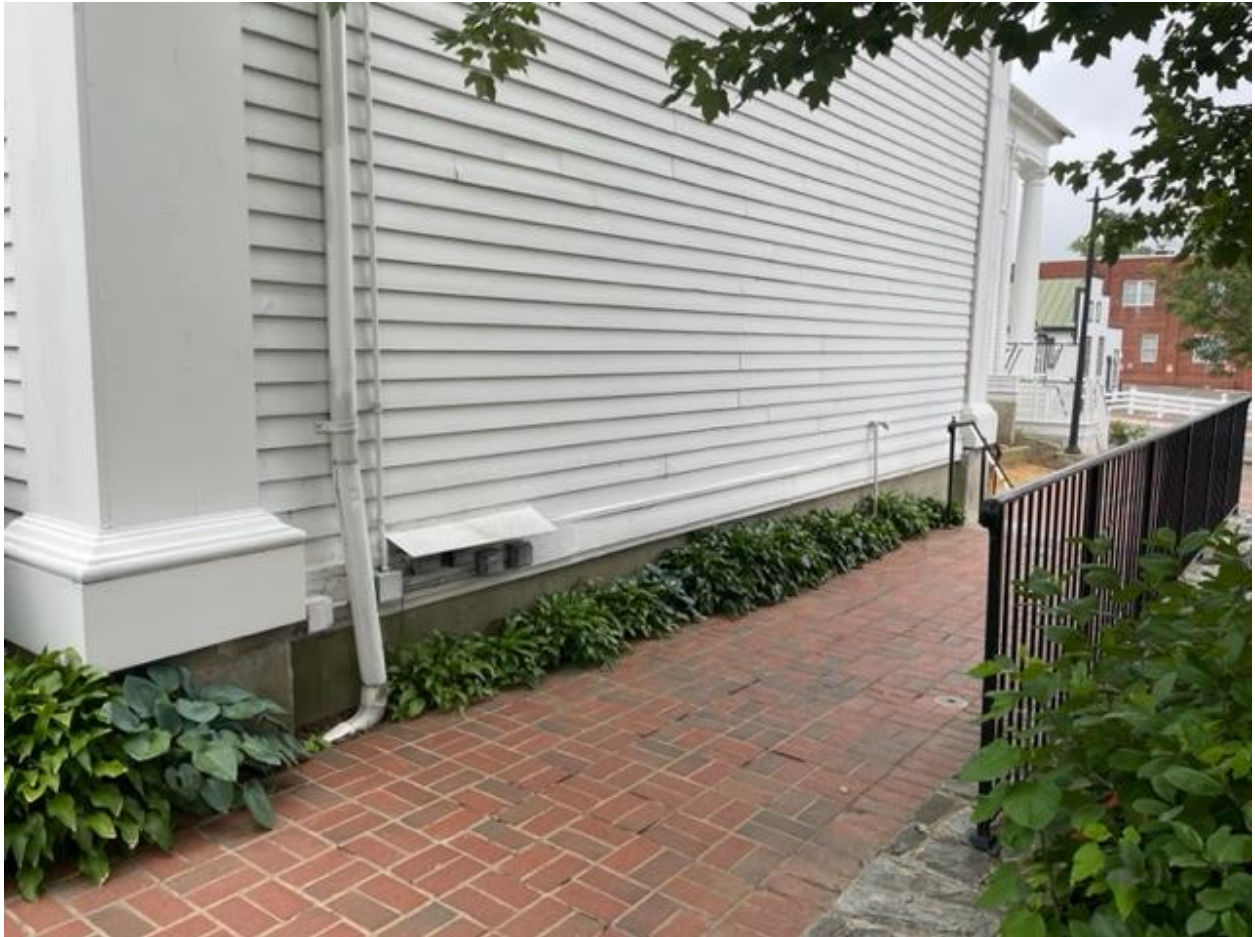
North Elevation (addition)

Proposed work on this elevation is limited to repair or replacement of damaged and rotted trim and siding and repainting to match other elevations. No land disturbance is anticipated in this area.

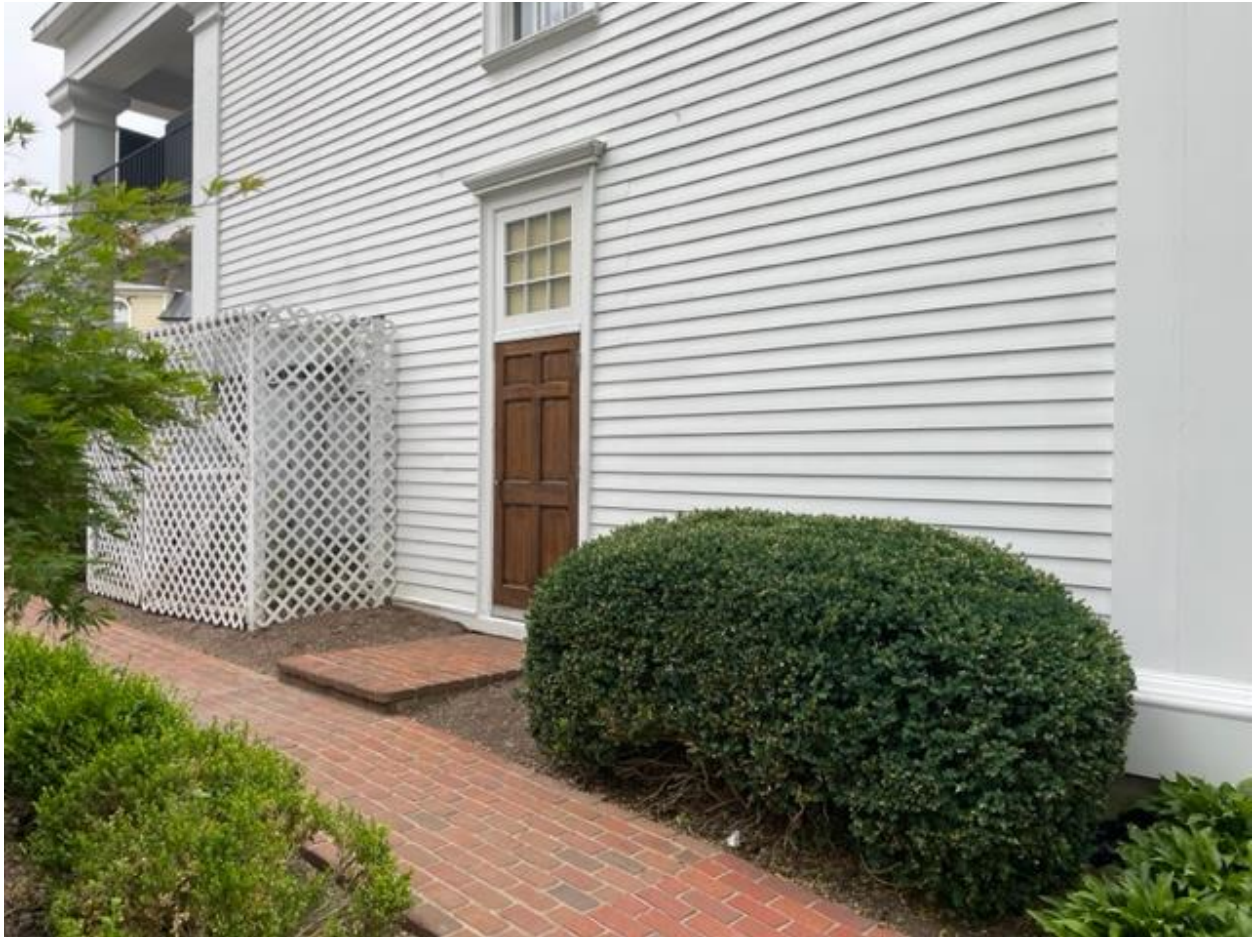
East (rear) Elevation (addition)

This view also shows part of the addition that was completed in the 1990's. Proposed grant-funded work on this elevation includes repair or replacement of damaged and rotted trim and siding and repainting to match other elevations. In addition, the lattice screen covering the electrical service will be replaced with a more appropriate design. This elevation will be reviewed as a part of the exterior redesign of the addition, including enclosing the existing open porch to the left of the image as well as potentially providing additional windows to create a more complimentary rhythm. Consideration is also being given to constructing a ramp to this rear door for accessibility purposes. The front entrance of the building was made accessible as part of the front porch restoration, but an accessible entrance at the rear is desired as it provides the most direct access by elevator to the second floor.

Land disturbance in this area would be limited to raising the level of and potentially widening the existing walkway.

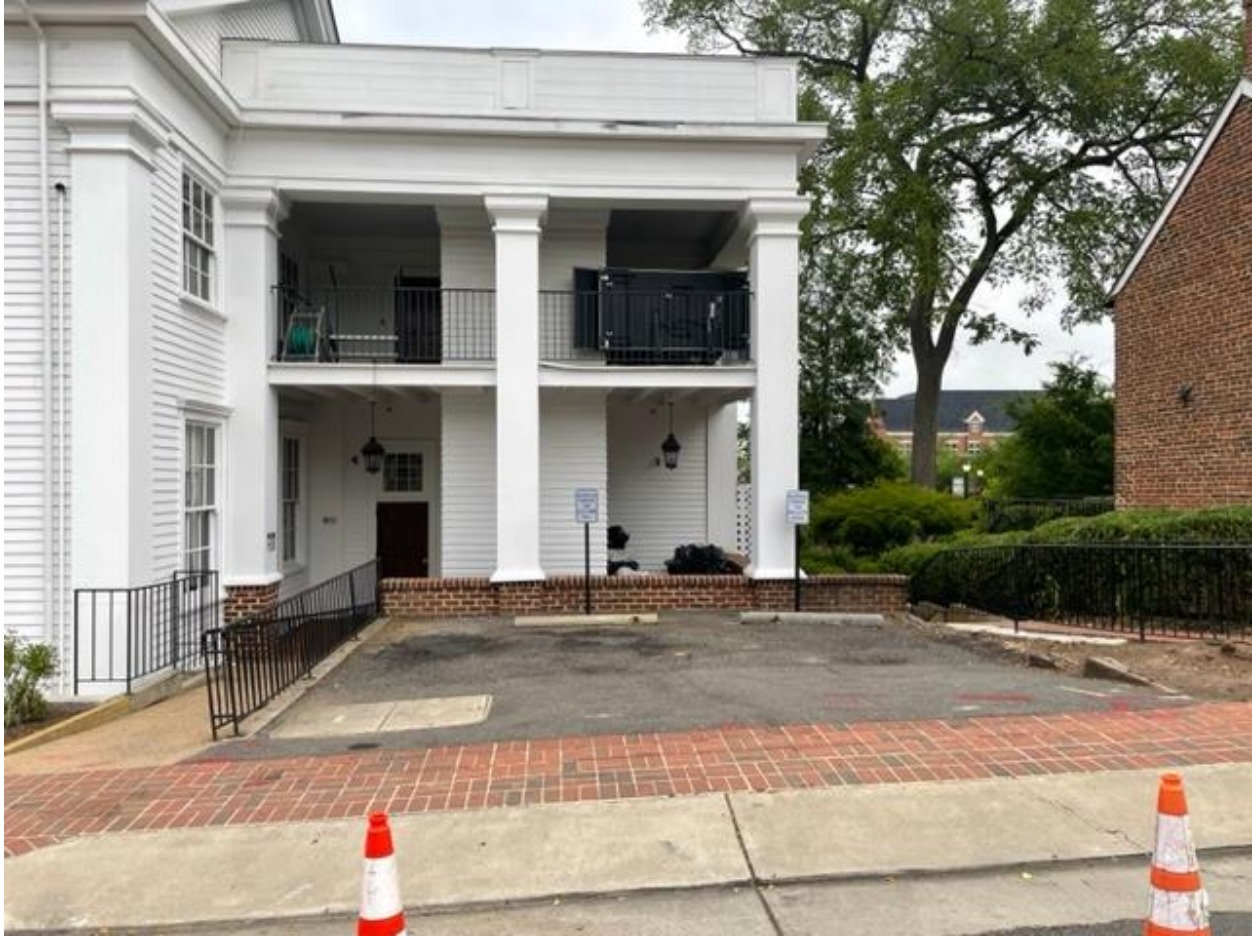
South Elevation (addition)

On this façade the proposed grant-funded work includes enclosing the upper porch and area below to provide additional storage for the facility. As evident in the photograph, the upper porch is currently used to store equipment, which is inappropriate and unsightly. The exterior redesign of the enclosed porch will seek to provide a more appropriate relationship of the addition to the original building, including resolving misaligned elements and improving the relationship of the building to the surrounding grade. Damaged and rotted trim would be replaced and painted as needed. The ramp to the left would be eliminated and replaced with a new, compliant ramp on the right side of the parking area. The parking area would be regraded to provide ADA compliant parking and the brick sidewalk passing in front of the parking spaces would be widened to match the adjacent sidewalk.

Land disturbance would be needed to regrade the parking area, remove the existing non-compliant concrete ramp, and to provide an accessible ramp. Note that this area has been heavily disturbed previously to provide underground power in the area (including this building). An electrical utility vault, which will remain in place, is visible at lower right.

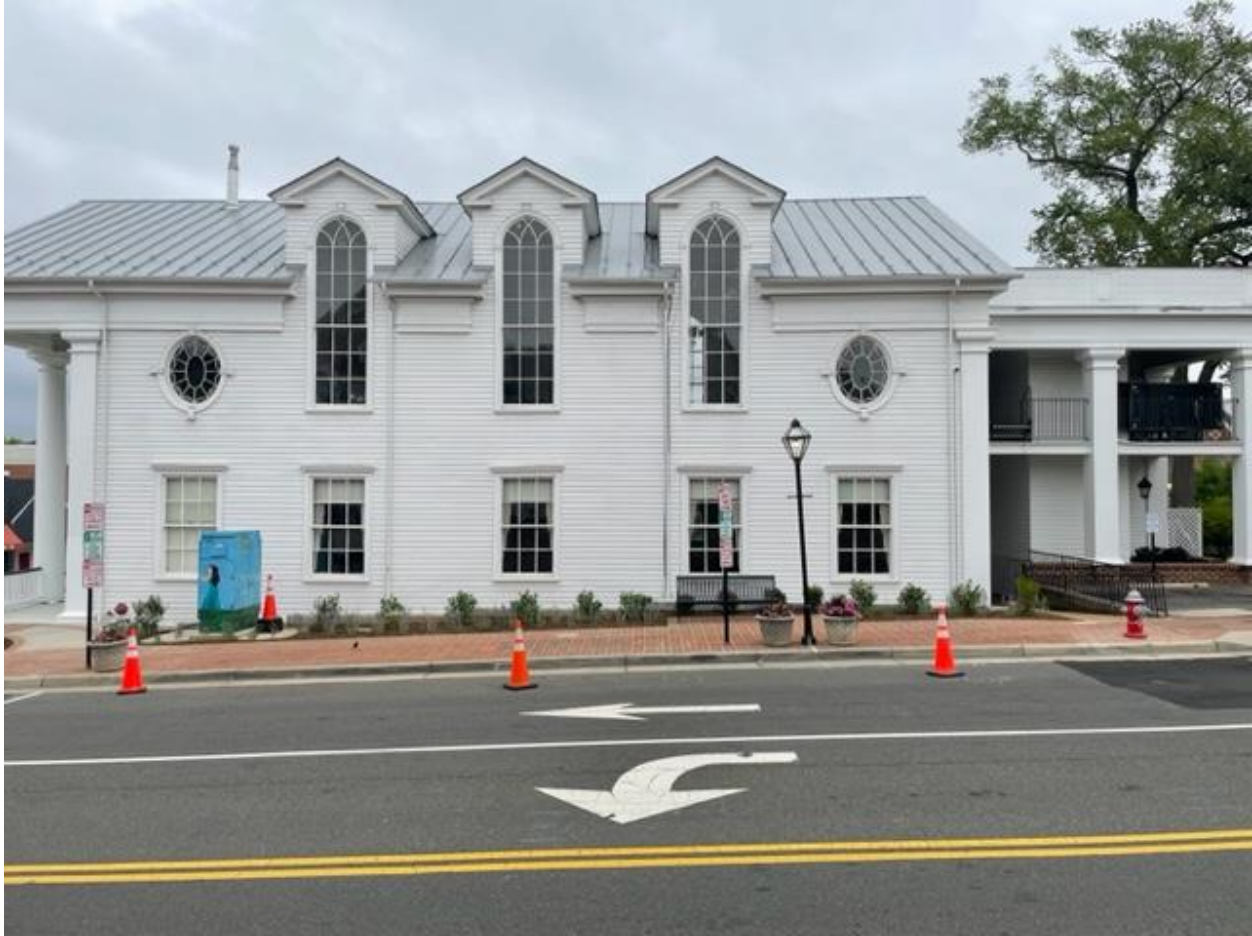
South Elevation (historic)

Proposed grant-funded work on this portion of the south elevation would be limited to repairs to damaged and rotted trim, replacement of corroded flashings, restoration of windows, and repainting of siding at façade. As with the front elevation, shutters may be installed on the first-floor windows to match those shown in the historic photograph. Paint selection would be subject to the notes provided for the front elevation. The vent flue visible to the left of the roofline will be eliminated if it is possible to replace a gas-fired duct heater in the attic with a different heat source, or replaced if removal is not possible. Surface-mounted wiring and defunct conduit will be removed from the elevation.

No land disturbance is anticipated for this area other than as noted on the previous page.
