ACCOTINK CREEK STREAM STABILITY ASSESSMENT AND PRIORITIZATION PLAN

FINAL REPORT

City of Fairfax, Virginia

October 22, 2007

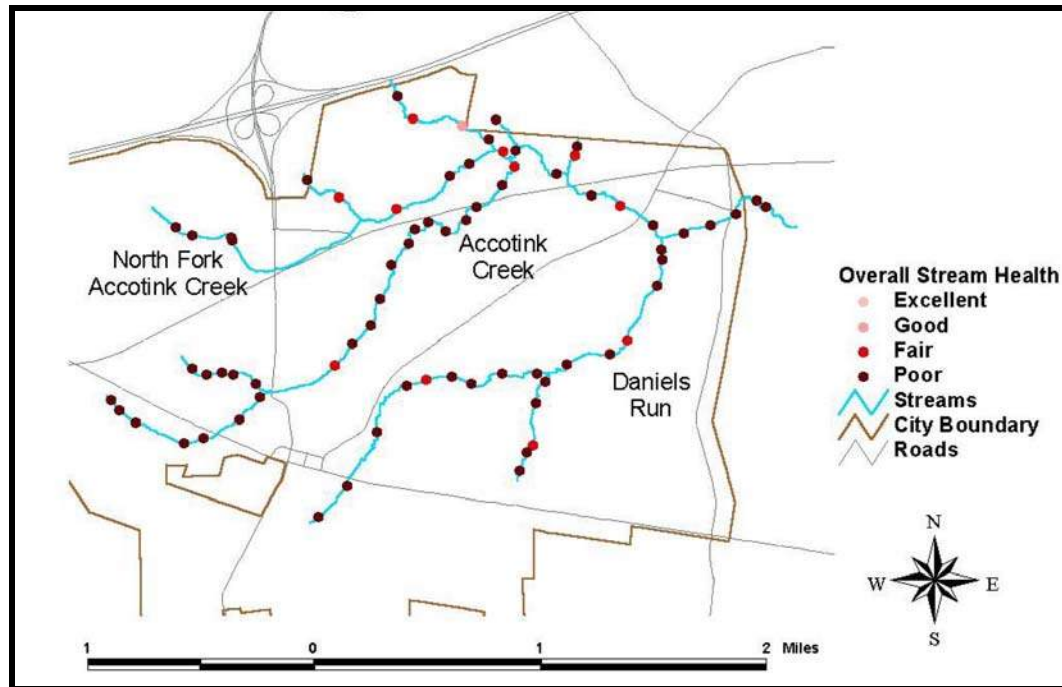
Figure 2: Overall Stream Health in the City of Fairfax (Adapted from City of Fairfax, 2002)

of the streams were given an overall score of good, 20% received a score of fair, and 77% were given a score of poor. Aside from Daniel's Run, the South reach and lower Main Stem of Accotink Creek are in the worst condition. The Overall result scores are seen in Figure 2.

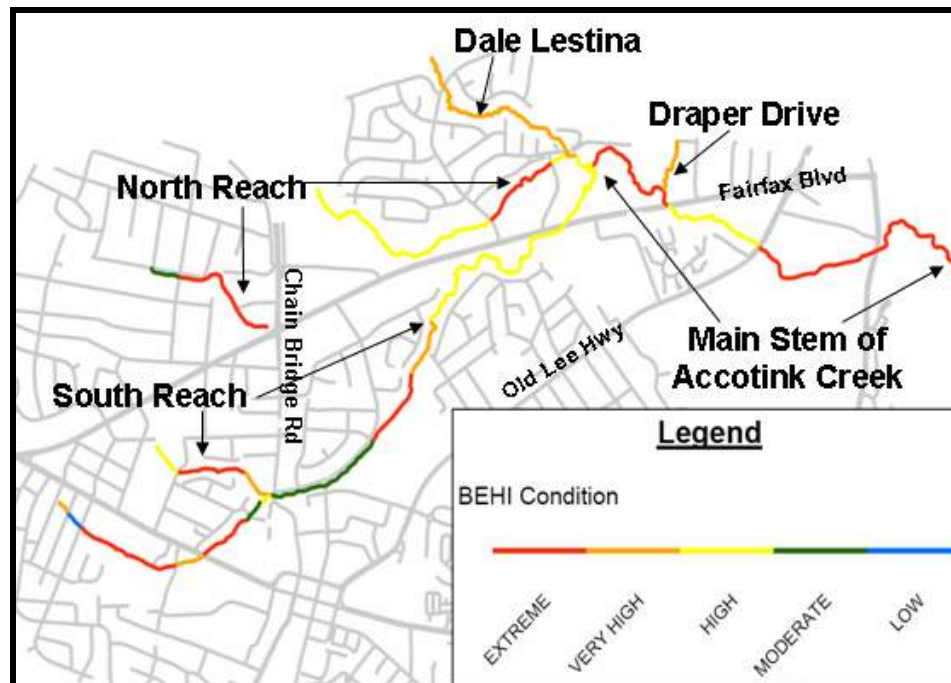
Figure 4: BEHI Score Distribution

BEHI ratings of very high and extreme are considered critically unstable. Table 1 shows over half of the stream length assessed in this study falls into this category. This result illustrates that stream bank erosion is a major concern for streams in the Accotink Creek watershed within City limits. Even when these systems reach a point of dynamic equilibrium, the rate of lateral migration may continue to erode stream banks at a high rate. High bank erosion can lead to further downstream sedimentation problems at culverts and bridge crossing. Also, pollutants such as phosphorus, nitrogen and heavy metals may adsorb on to sediment particles that are flushed out to downstream water bodies, such as the Potomac River and Chesapeake Bay. The distribution of BEHI scores are shown in Figure 4. Summary sheets of extreme and very high BEHI ratings are included in Appendix D.

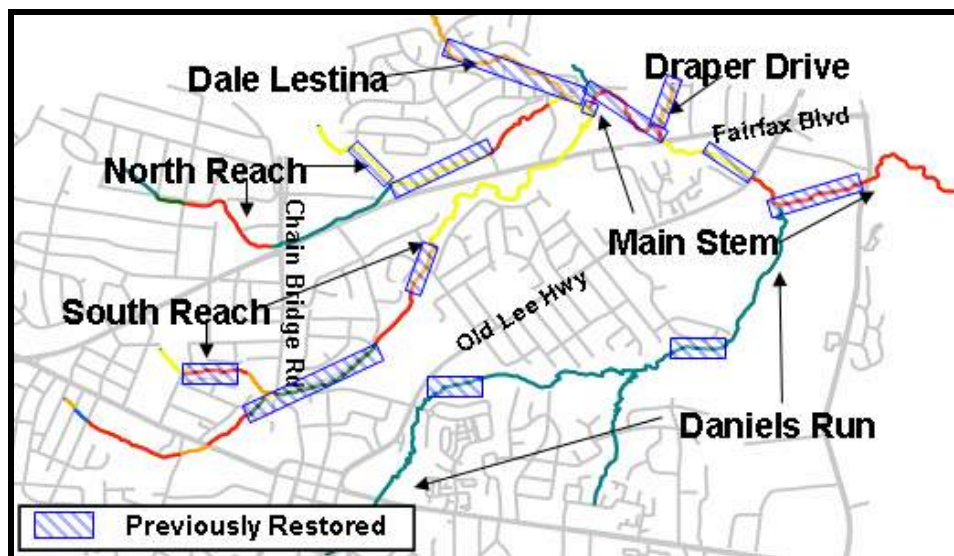
Figure 5: Previously Restored Areas on Accotink Creek

Criteria other than erosion severity, feasibility, public sentiment, and cost play into prioritization of projects. The City has been involved with stream restoration and stabilization since the mid-1990's. Reaches previously restored are shown in Figure 5. These restored areas have been observed by City officials over the last decade. Through this observation several reaches have been identified as having continuing stream stability problems. Since these areas were previously restored only light restoration and maintenance is required on most instances to allow these restored reaches to perform as originally designed.

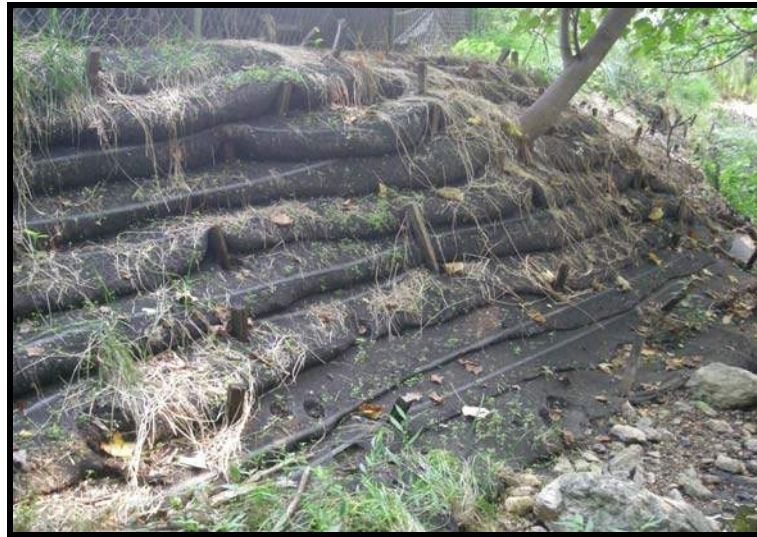
Figure 6: Filtrexx Socks at Daniels Run

As Figure 6 illustrates, plantings have not become established, although many of the tubes are still stable and in-place. This reach can be stabilized by identifying areas of local destabilization and a comprehensive planting plan to reinforce the Filtrexx systems already in place. This reach requires light restoration. Portions of the downstream reach have been previously stabilized (near a pedestrian bridge). This reach is experiencing severe bank erosion, as is evident in the near-vertical 5-6 foot high banks. This reach will require a greater effort than the upper reach. Moderate restoration should be assumed for this area. Any work done in these reaches should incorporate public educational components and be integrated into the restoration work performed previously on school grounds.

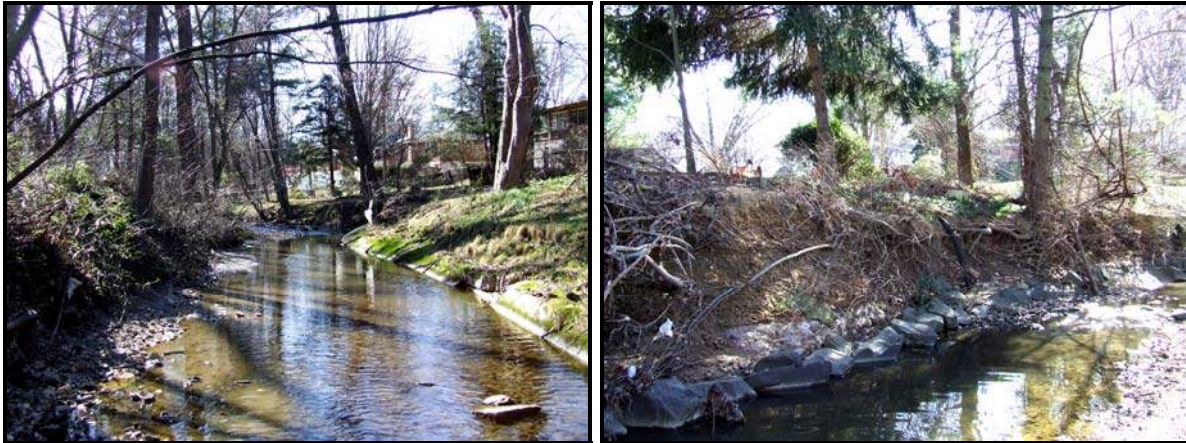
Site Score: 42.0, “Very High”

Location: Spring Lake Terrace, along Jean St. between the two intersections of Jean St. and Dale Dr., ends at Spring Lake Terrace

Site Description: Drainage Area \approx 950 acres \pm

The reach begins immediately upstream of a foot bridge at Jean Street. Backwater from the bridge may reduce erosion potential in this area. Approximately 6 residential properties are located to the west of the stream, with parkland located to the east. There is one sanitary sewer crossing. This reach has steep banks, with ad-hoc armoring on the stream banks.

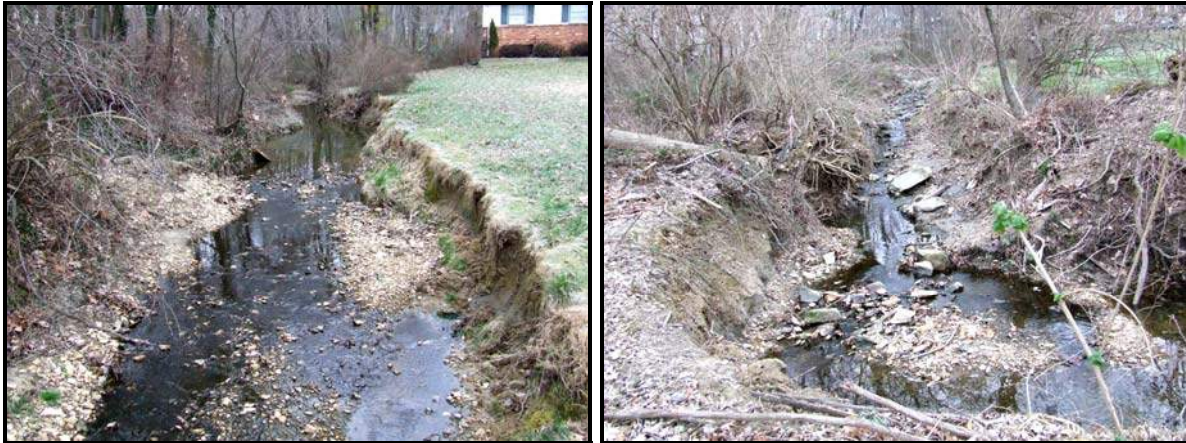
Site No.: NR1-002
Site Score: 58.5, “Extreme”
Location: Howerton Ave. and Orchard St., from Burrows Ave. to Chain Bridge Rd.

Site Description: Drainage Area \approx 182 acres \pm

The reach begins downstream of Cobbdale Park and crosses approximately 11 residential properties. A sanitary sewer crosses the stream about 3 times. This reach is incised and has extremely active banks with one tight meander that is accelerating erosion.

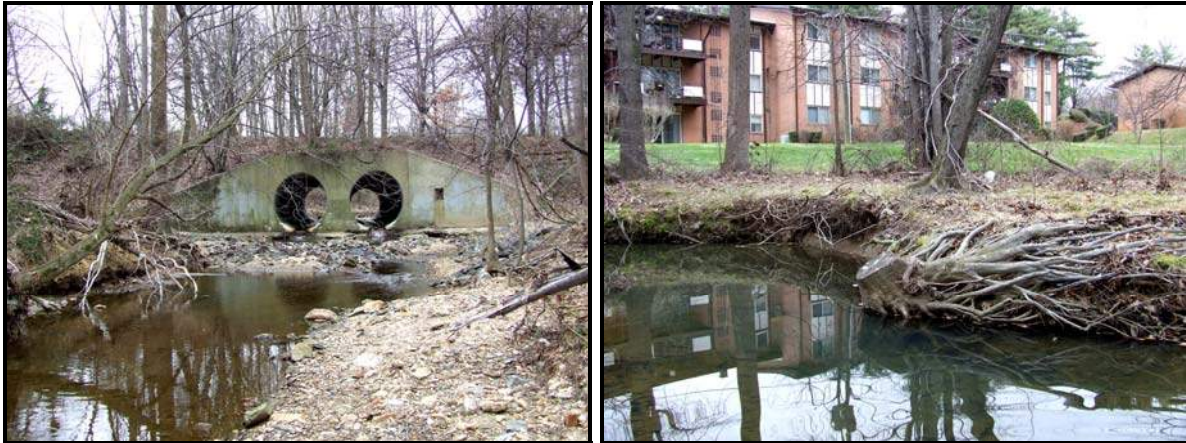
Site No.: NR2-002
Site Score: 50.0, “Extreme”
Location: Mosby Woods Dr., from Plantation Pkwy. to Stafford Dr.

Site Description: Drainage Area \approx 180 acres \pm

This reach is located mostly on one parcel of City parkland. The north side of the stream is a residential area called Mosby Woods Condos. There appears to be one sanitary sewer crossing. This reach is overwidened and has poor floodplain access. Substantial mature forest exists on both sides of the stream channel. There is evidence of extensive flooding in the area.

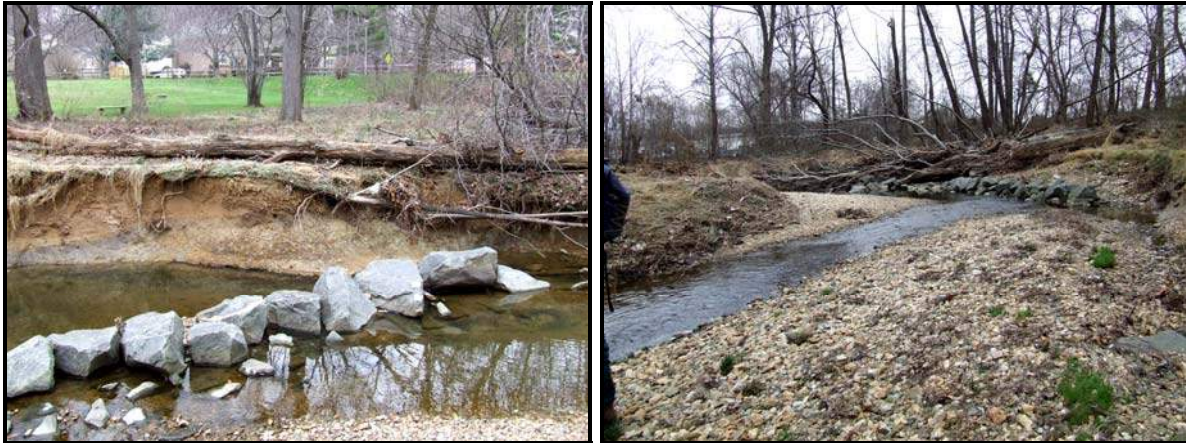
Site Score: 52.0, “Extreme”

Location: South side of Draper Drive Park, from Ranger Rd. to Lee Hwy.

Site Description: Drainage Area \approx 2,200 acres \pm

This reach is located mostly within park land. Prior restoration efforts appear to have no affect on stream stability. The stream banks are active, and many instream structures are not functioning as designed. This reach is overwidened and has poor floodplain access. Sanitary sewer crossings occur in three locations and then the line parallels the reach for approximately 500 feet.

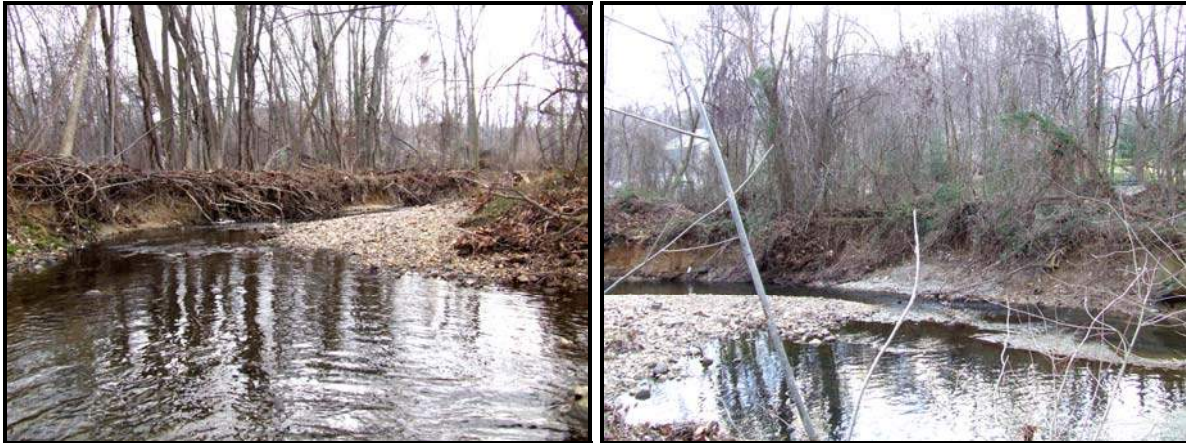
Site Score: 49.5, “Extreme”

Location: Old Pickett Dr., from Old Lee Hwy. to Pickett Rd.

Site Description: Drainage Area \approx 4,800 acres \pm

This reach is overwidened and shows evidence of frequent flooding. The area is mostly commercial, with no residential buildings. The sanitary sewer parallels the stream and crosses at least twice. There is some sewer protection located in the stream.

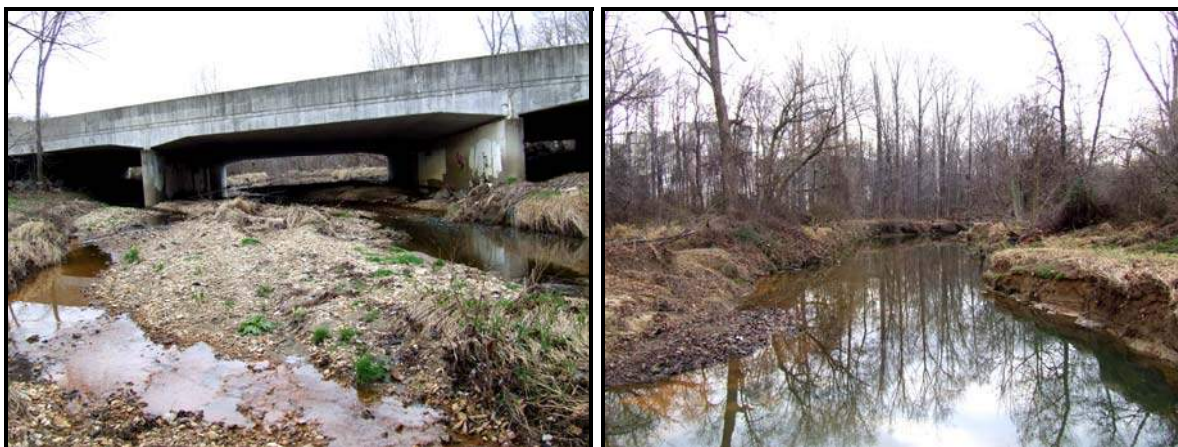
Site No.: MS1-005
Site Score: 51.0, “Extreme”
Location: Thaiss Park, east of Pickett Rd.

Site Description: Drainage Area \approx 4,960 acres \pm

This reach, though within a park, is located in a mostly industrial area that would have little or no direct impact to residential areas. Large active sand bars and woody debris continually block the channel and bridge at Pickett Road. This channel is overwidened and very tortuous downstream of Pickett Road. There is the appearance of extensive flooding, which often exceeds the banks. The sanitary sewer crosses the stream channel at least twice.

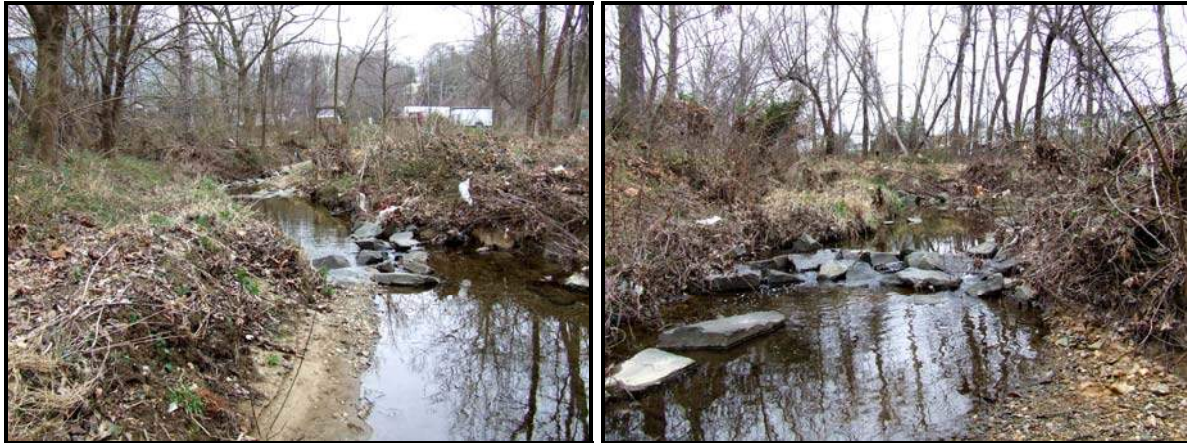
Site No.: DDT1-001
Site Score: 42.5, “Very High”
Location: Draper Drive, east side of Draper Drive Park, from Beech Dr. to Lee Hwy.

Site Description: Drainage Area \approx 400 acres \pm

The stream is located mostly within Draper Drive Park. There are approximately 6 commercial properties to east of the stream, but they are not directly impacted from erosion. No sanitary sewer line is located near the stream channel. Previous restoration efforts have provided some protection.

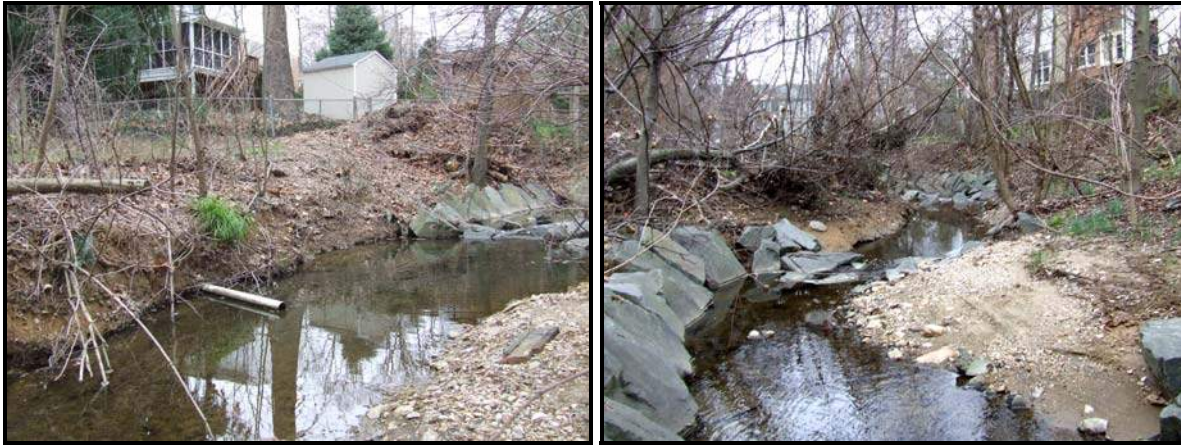
Site No.: DLT1-001
Site Score: 41.5, “Very High”
Location: Dale Lestina Park, from Rt. 66 to Ranger Rd.

Site Description: Drainage Area \approx 275 acres \pm

The reach is mostly contained within Dale Lestina Park and Villa D’Este Park. Previous restoration efforts are showing signs of erosion. The upper end of the reach is not constrained by adjoining residents. The downstream end passes through a narrow channel between Cambridge Station town home communities.
