## Board of Architectural Review

DATE: December 20, 2017  
TO: Board of Architectural Review Chair and Members  
THROUGH: Jason Sutphin, Community Development Division Chief (JDS)  
FROM: Tommy Scibilia, BAR Liaison (TS)  
SUBJECT: Paul VI Redevelopment – Work Session

HAZARDOUS MATERIALS AND STRUCTURAL SURVEY

YELLOW HOUSE AT 10606 CEDAR AVENUE

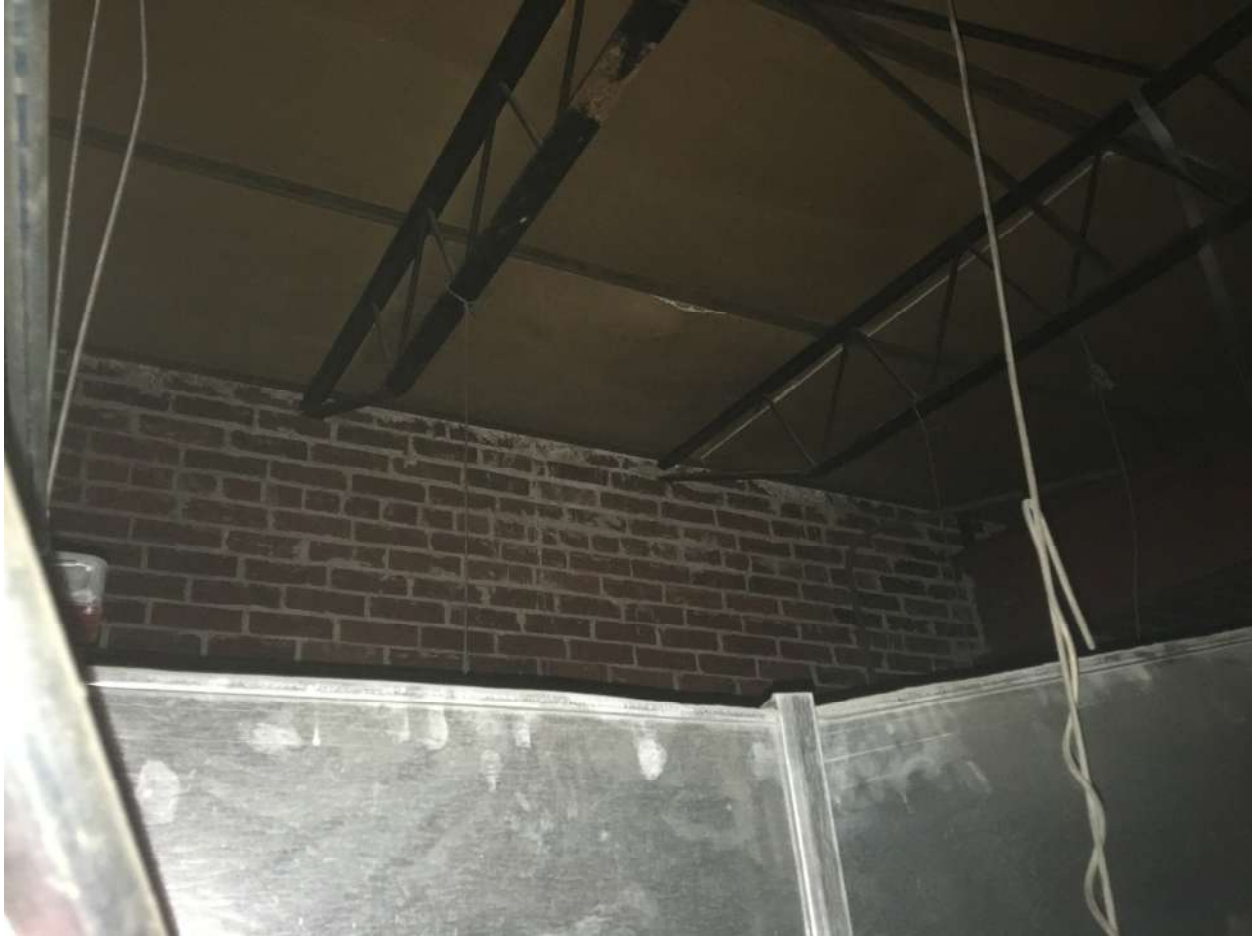
**Photo #3: Roof joist bearing on interior brick wall.**

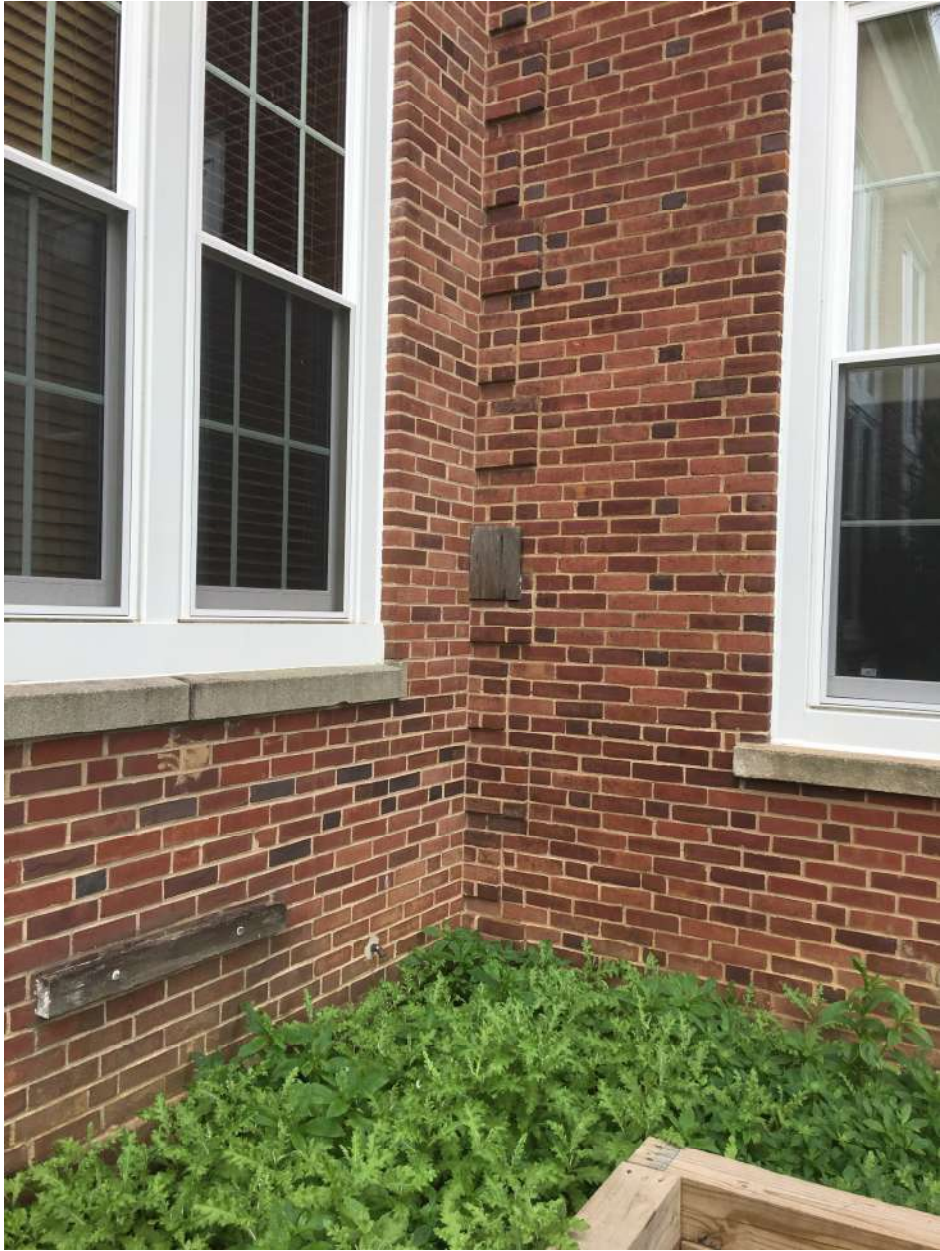
The exterior walls are composed of interlocking multi-wythe brick. Header courses are present every few feet to tie the wythes together. See Photo #6. It appears that the walls are (3) courses in thickness at the exterior and (2) courses thick at the interior bearing wall locations. Brick walls are also evident in the transverse direction of the building at the interior of the building between the classrooms. It was confirmed that these walls are non-load bearing but may be contributing to the lateral force resisting system of the building.

**Photo #6: Front elevation at building corner**

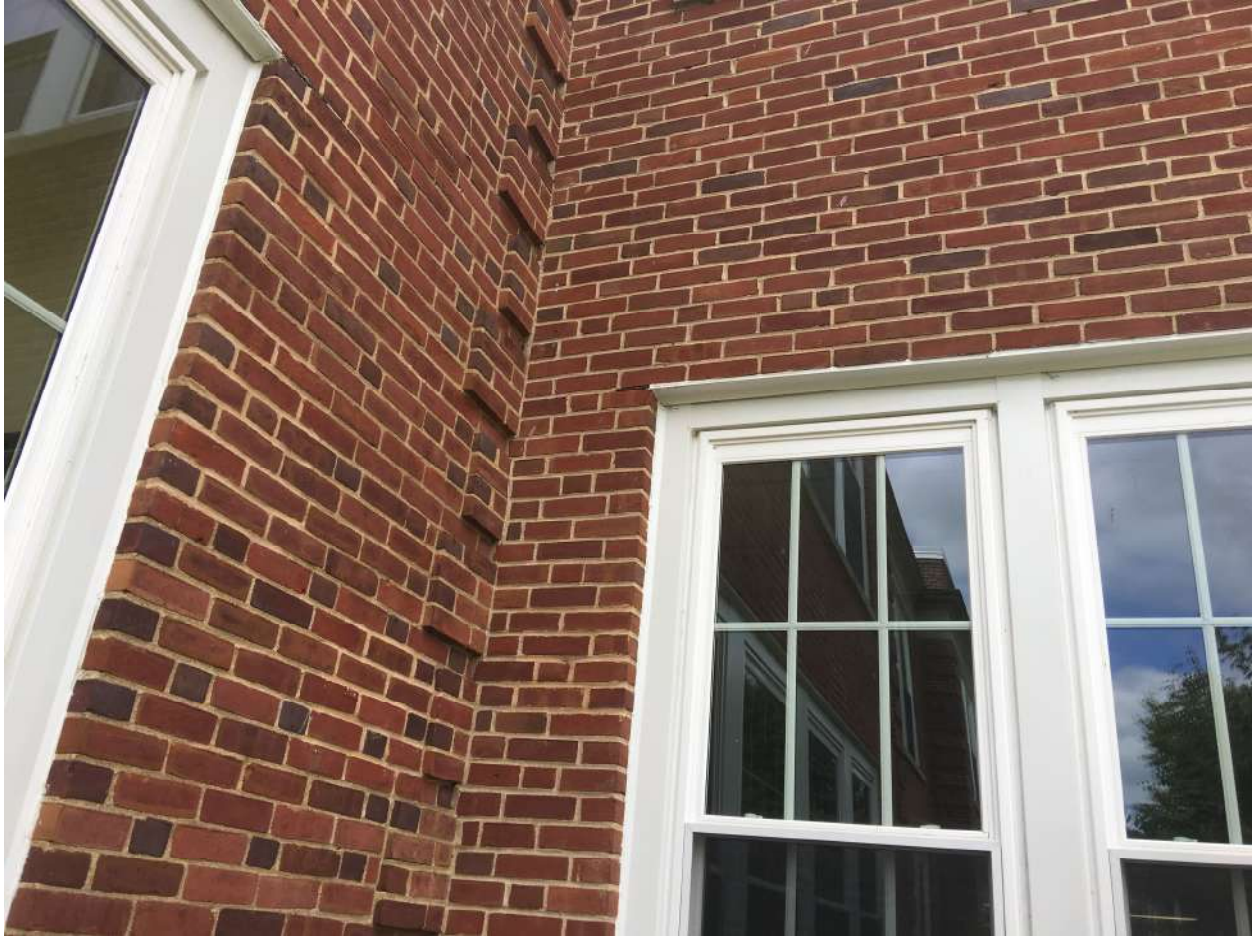
The only portion of the building where any signs of deterioration were observed was at isolated exterior mortar joint locations. The most consistent damage has occurred at the mortar joint locations at the jambs of the window openings where it appears that the steel angle lintel has rusted, causing volumetric expansion of the steel. This condition causes tensile stresses to develop in the adjacent mortar joints which cracks the mortar and causes the mortar joint to become loose and in some case open to the exterior. Subsequent additional brick damage is likely at these locations as additional water penetration can occur which leads to possible freeze-thaw damage. See Photo #7.

**Photo #7: Open mortar joint at corner of window**

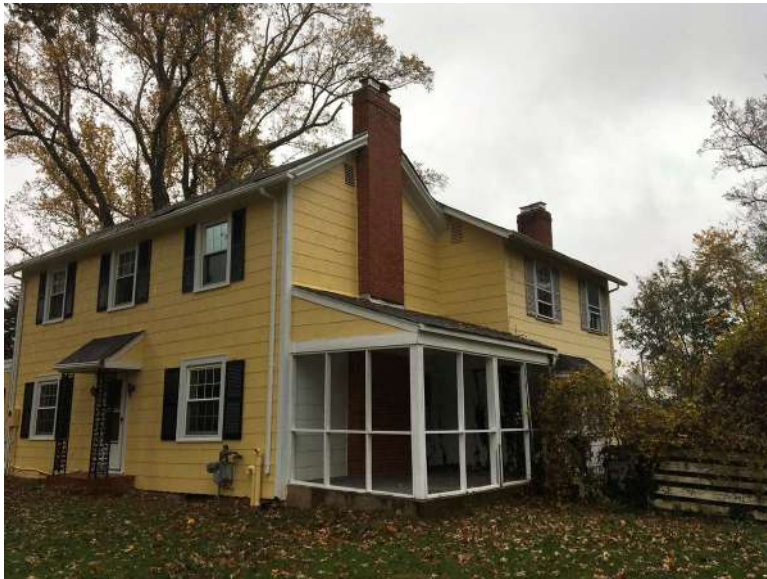
Southeast corner of building.

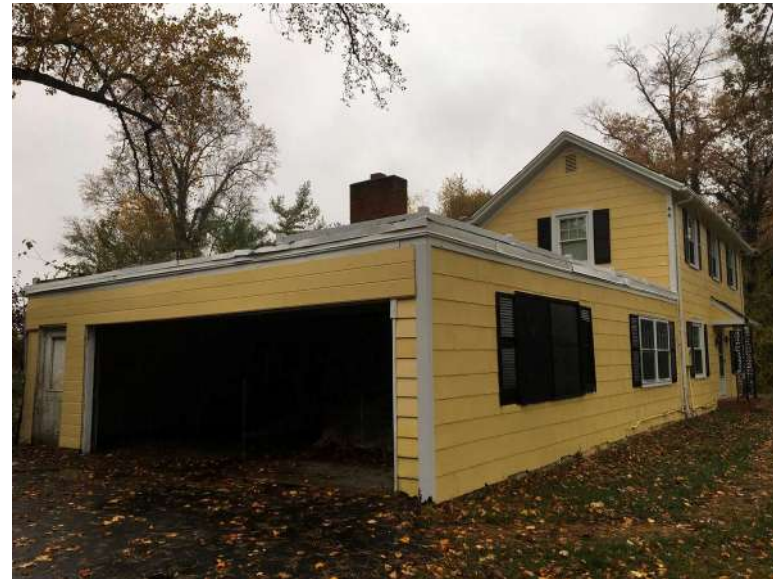
West side of building.

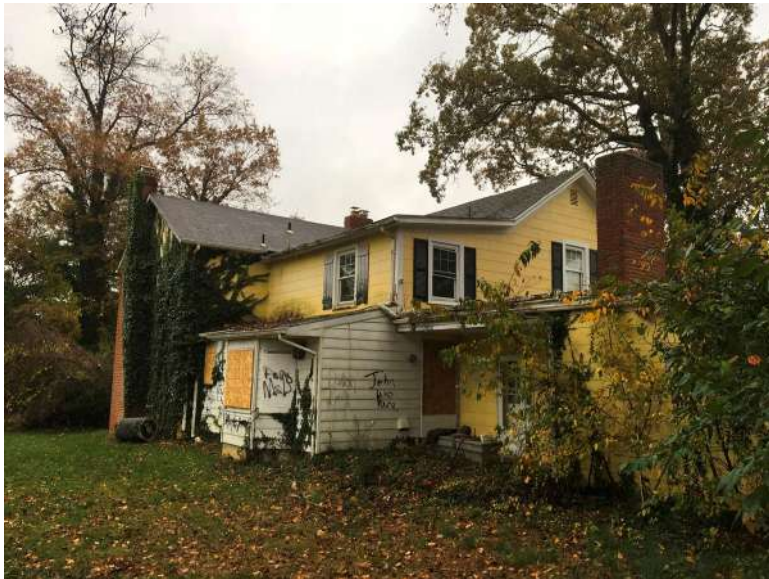
North elevation of property.

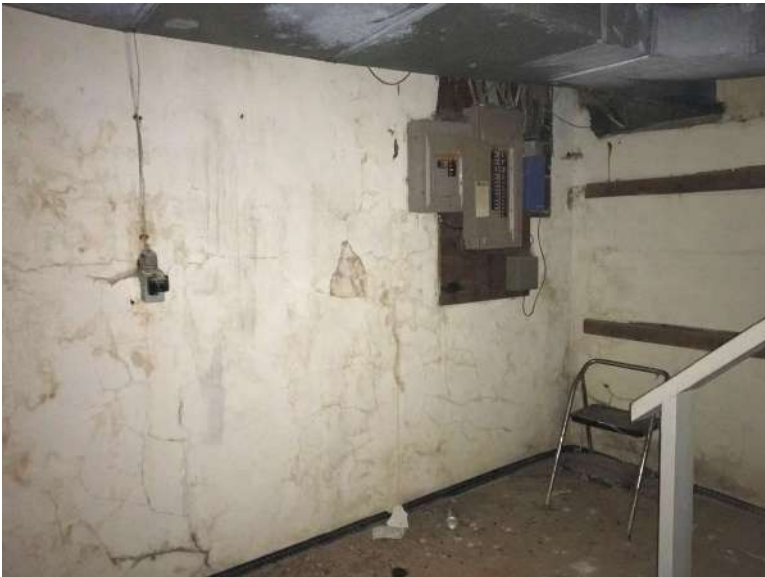
Cellar level under structure.

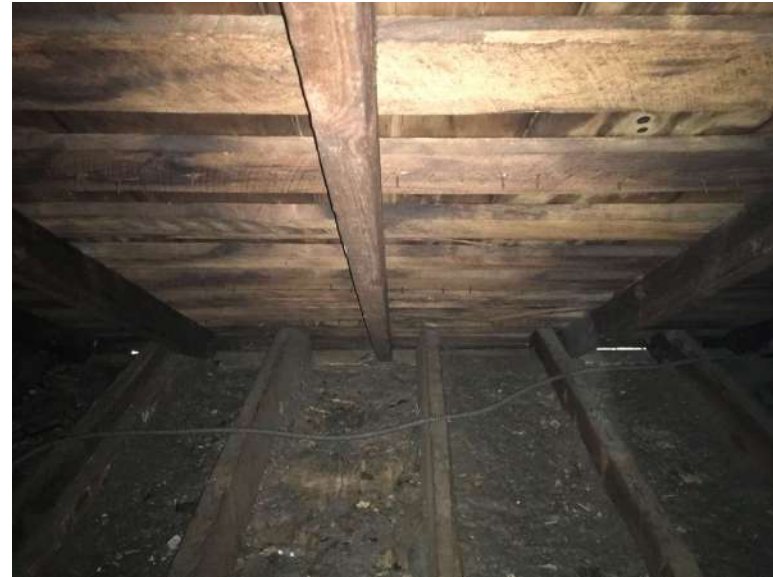
Typical roof rafter.

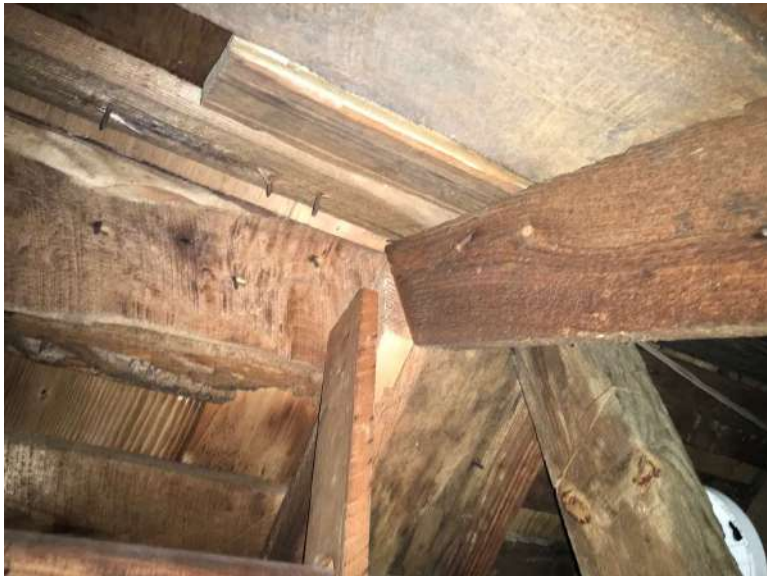
Roof rafters have displaced out of plane along ridge.

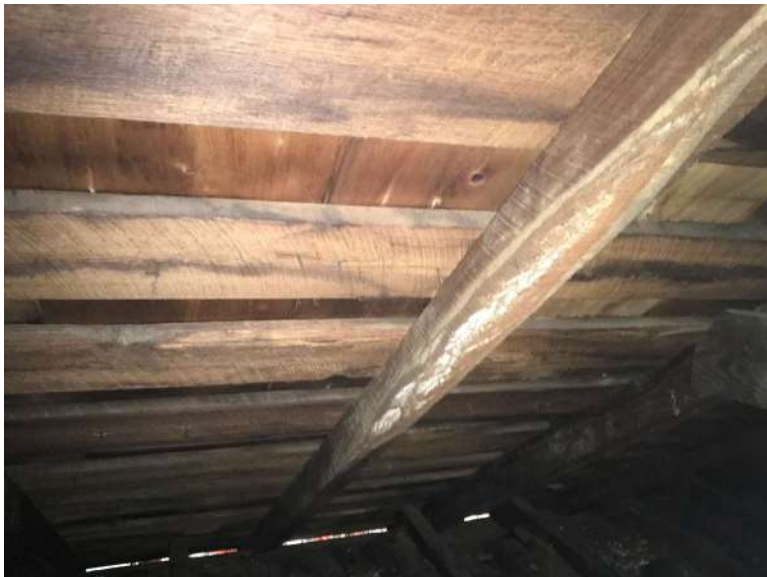
Wood framing appear bowed and twisted.

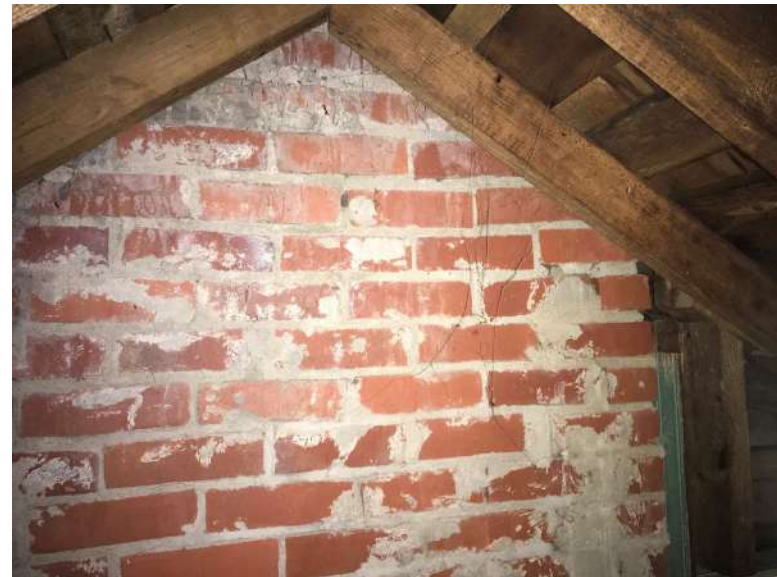
Brick wall at gable end.

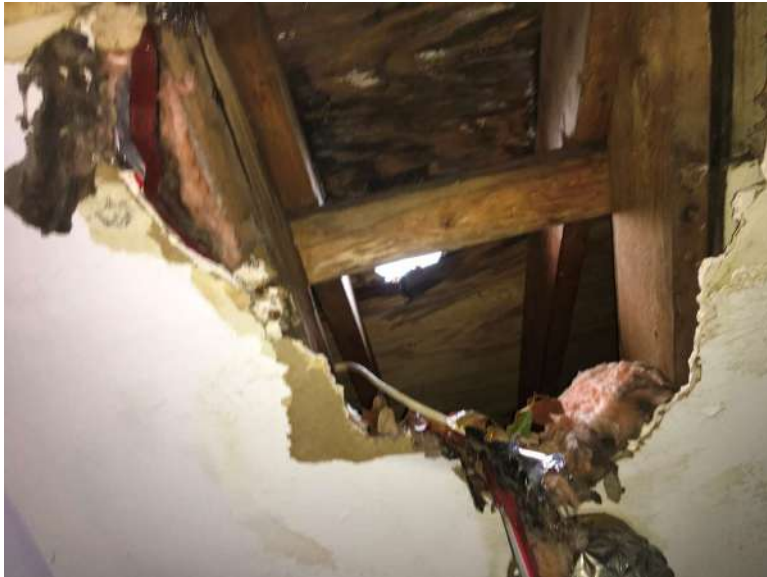
Partial collapse of roof structure.

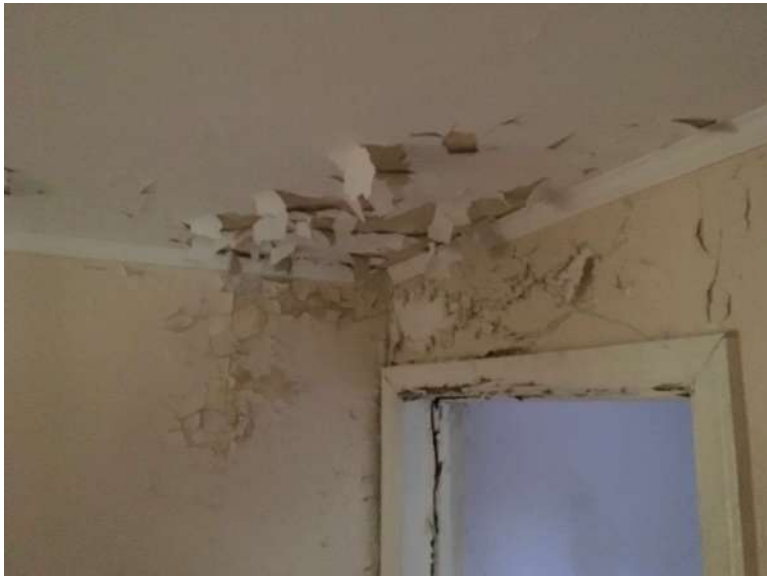
Peeling paint typical throughout building.

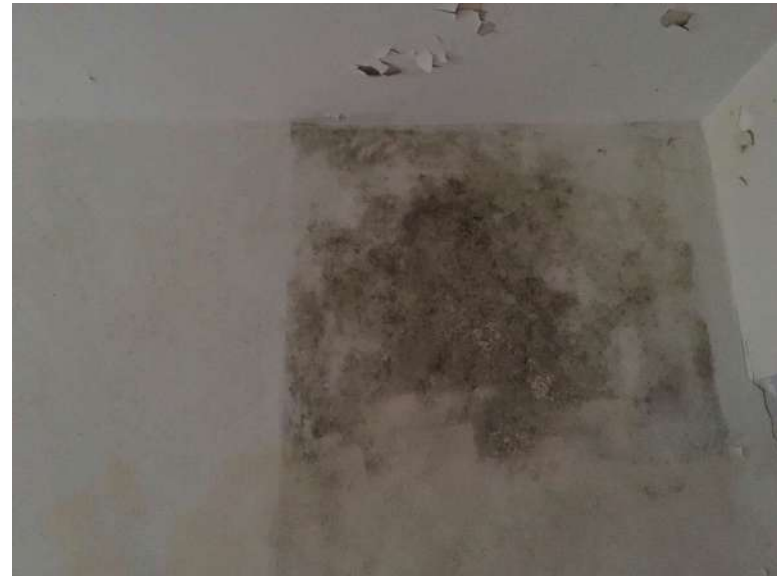
Peeling paint and mold growth.

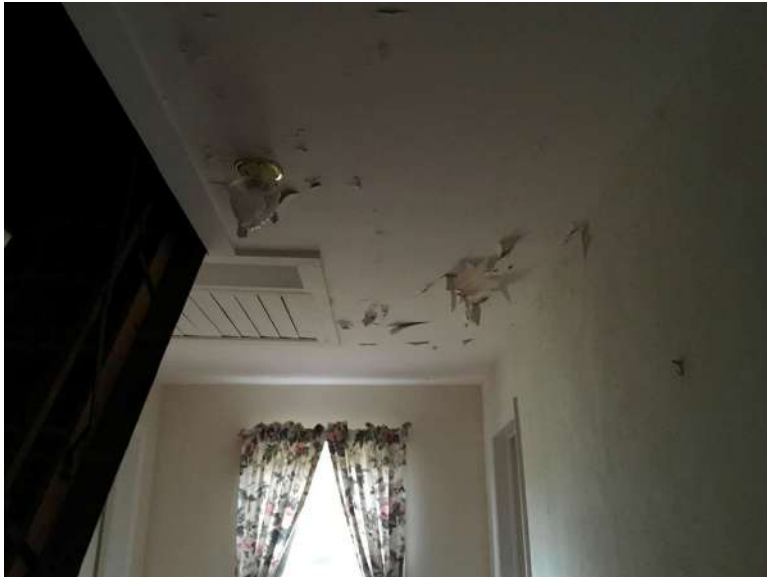
Peeling paint typical throughout building.

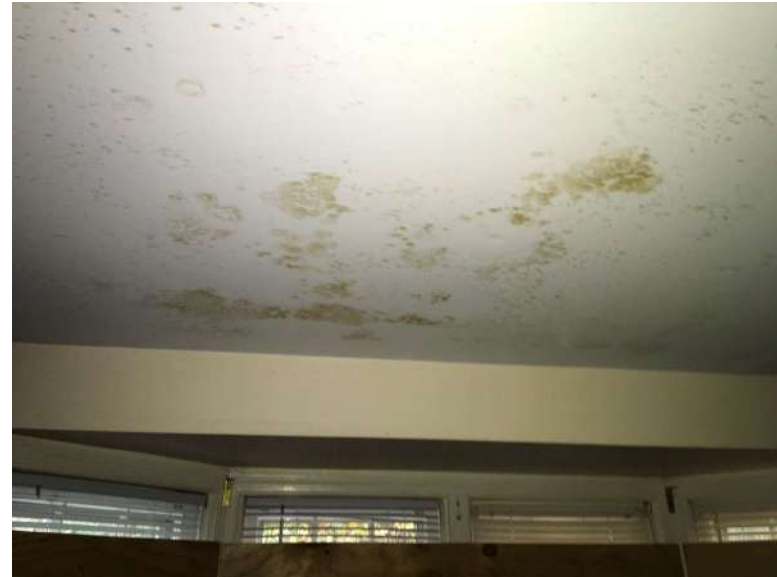
Peeling paint and mold growth.

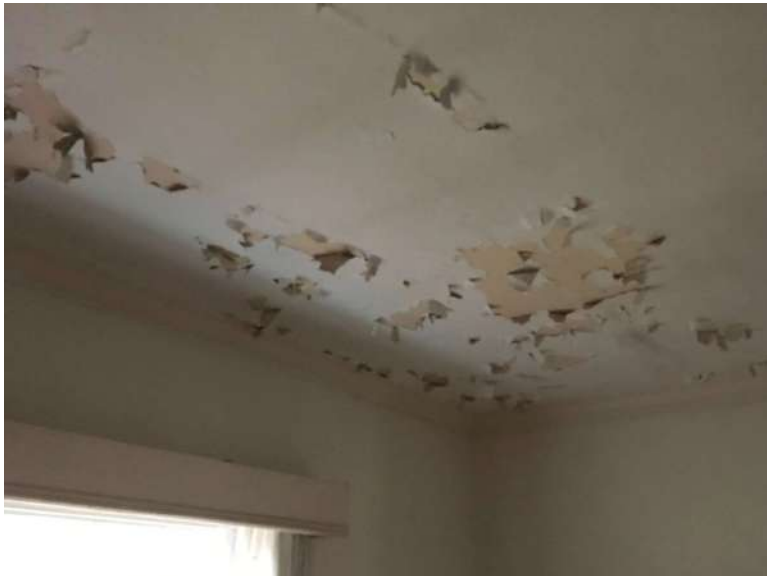
Peeling paint typical throughout building.

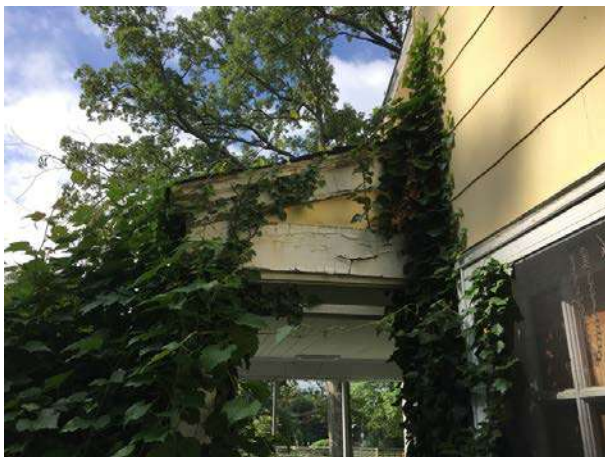
Growth on side porch

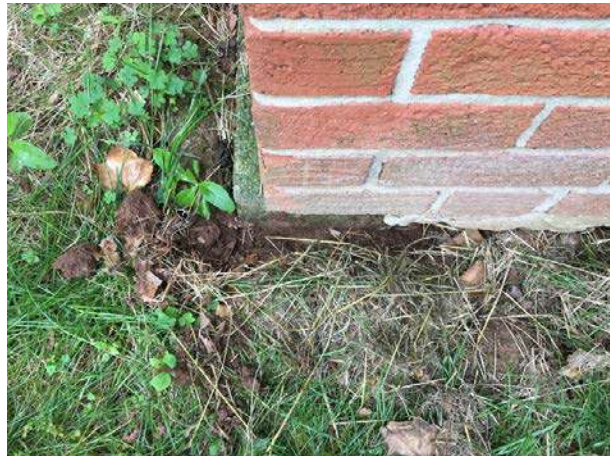
**4. Soil Erosion.** Erosion of soil along the rear chimney and areas around the perimeter of the structure is present. It is typically recommended that exterior grades are sloped away from the structure to avoid excess water from damaging the building. Many low spots are present immediately against the structure and this condition has caused

deterioration of masonry and washout of grades, possibly undermining foundations. Long-term, these conditions will typically cause settlement cracking. We could not observe enough of the exterior walls to determine if settlement cracking has occurred due to the present of the wood siding.

Rear chimney bottom

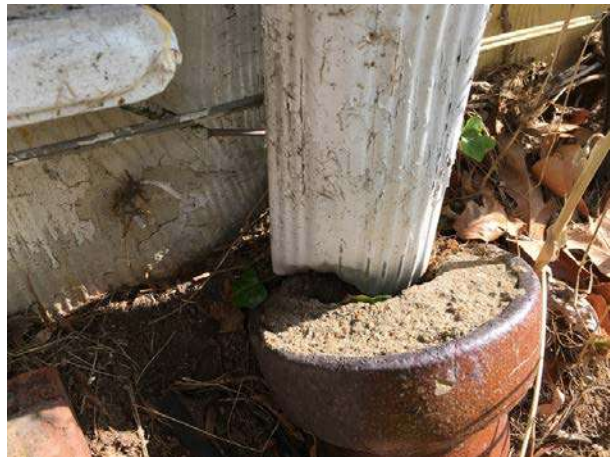
Downspout path blocked

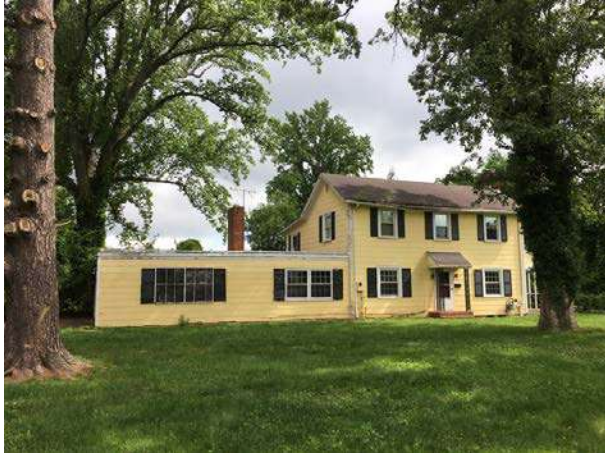
Gutters at the front

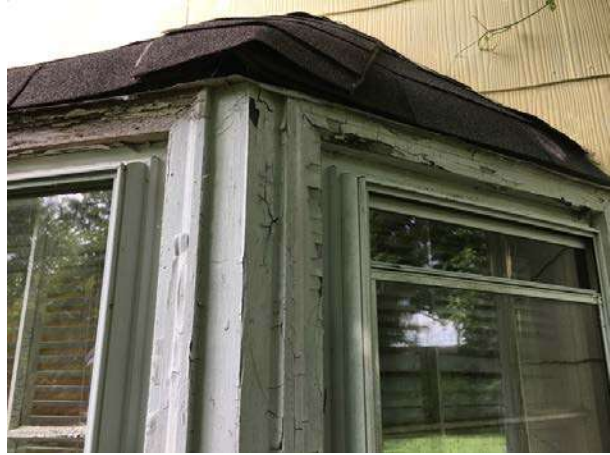
Shingles over bay window

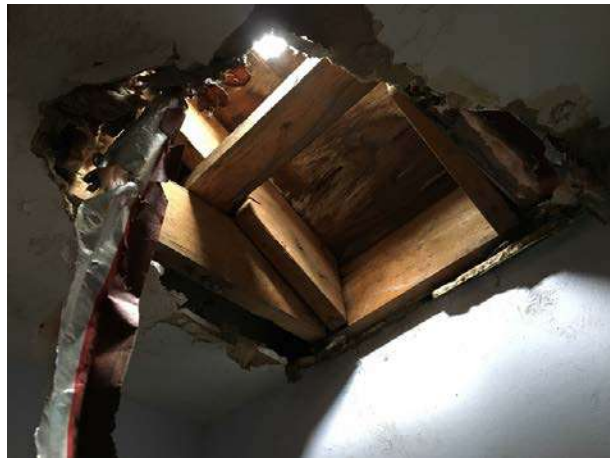
Hole in Roof

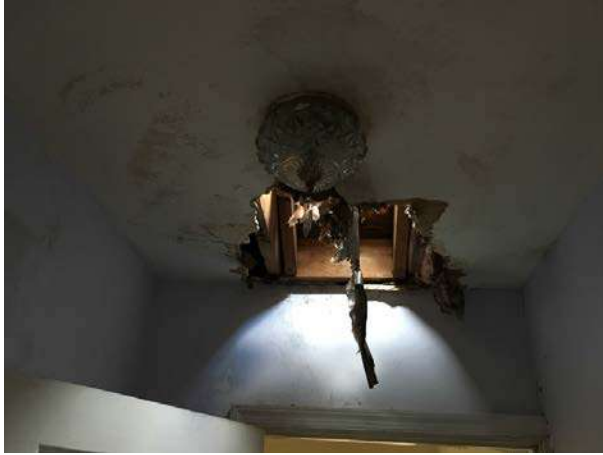
Hole in Roof

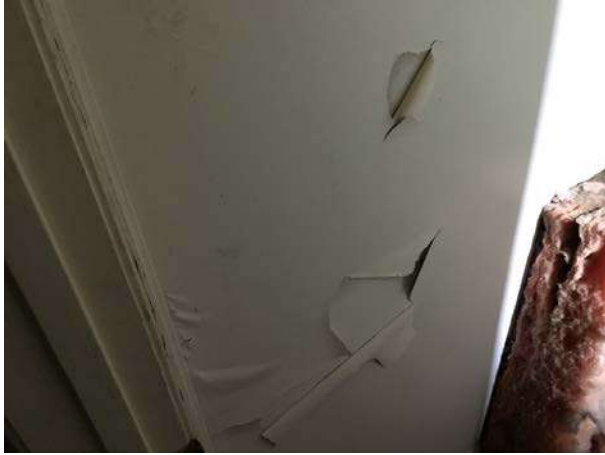
Most of the rooms throughout the building have paint peeling from the ceilings and walls. This is most likely due to moisture exposure that causes the paint to de-bond from the substrate. Some water pockets were observed to have formed in the ceiling of various rooms. Water in this amount is typically the result of leaks, either in the building envelope or from plumbing.

Paint peeling from wall in laundry room

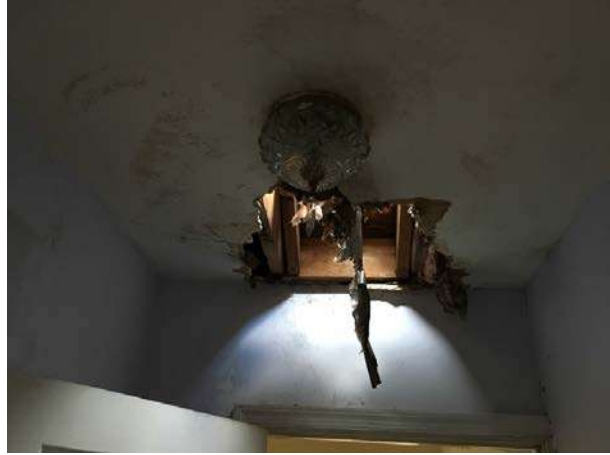
Hole penetrating from roof

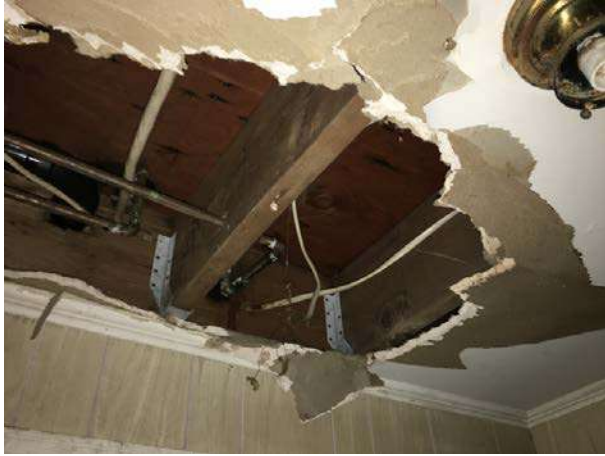
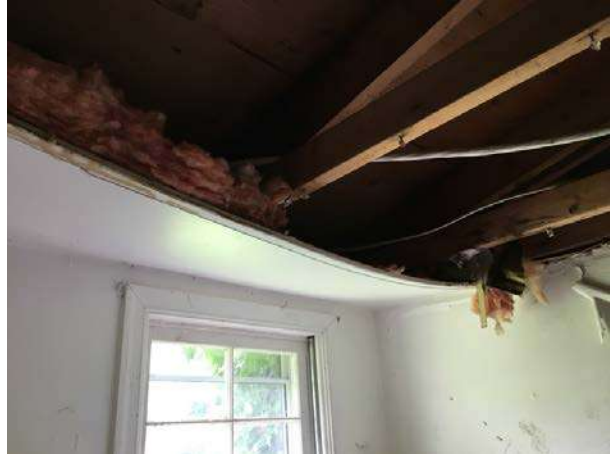
Hole in Laundry Room

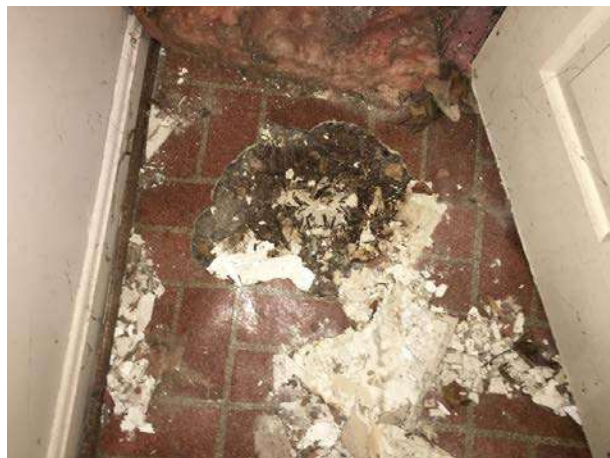
Flooring in the laundry room

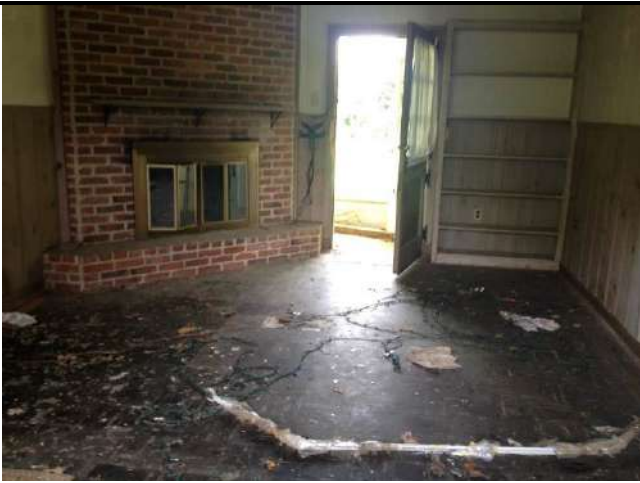
1. View of the den with 9" x 9" black floor tiles (ACM), Samples 1-2.

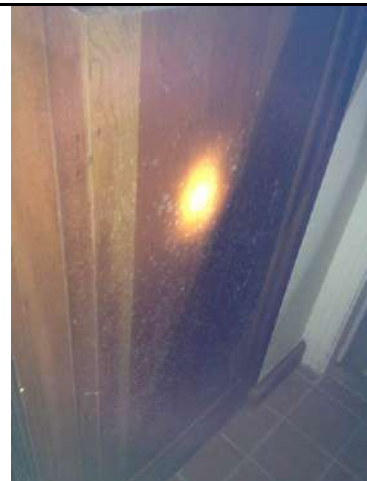
6. View of visible mold on kitchen cabinets.

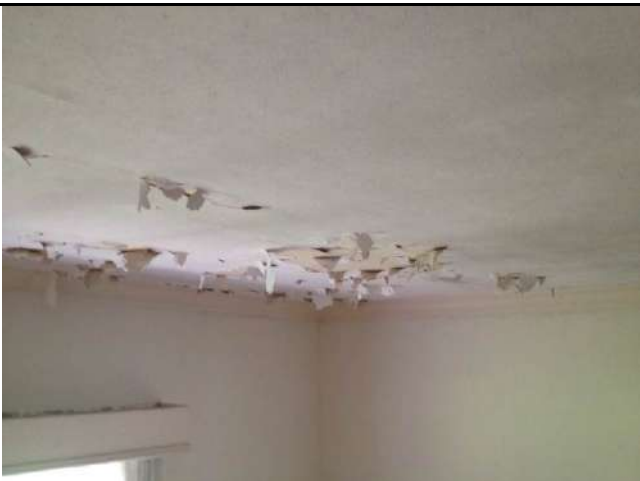
11. View of peeling paint in the dining room with mold on the ceiling.

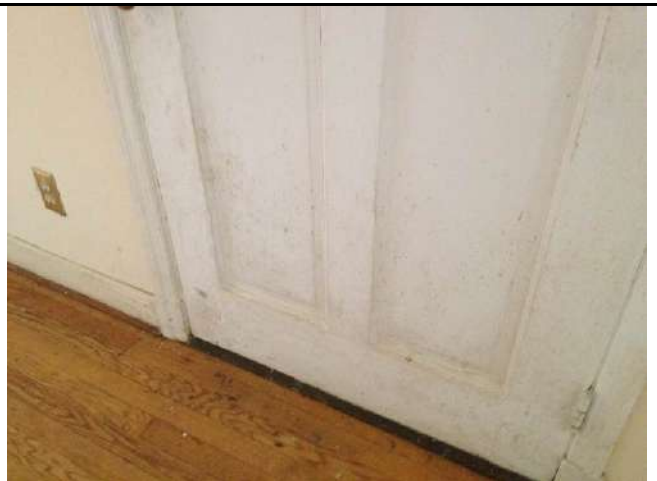
12. View of visible mold on the doors in the living room area.

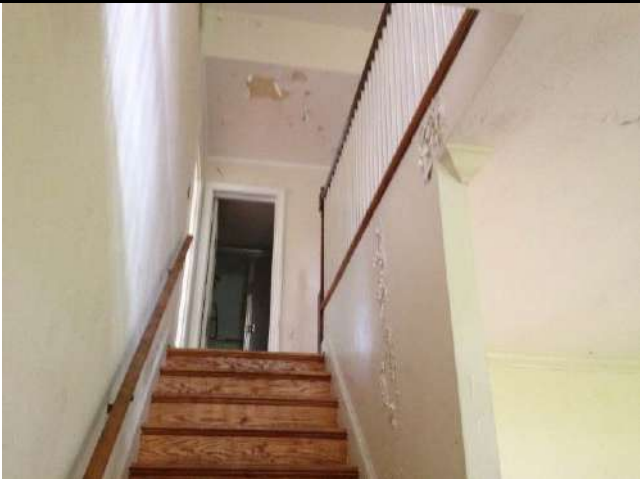
13. View of peeling paint on the walls and ceiling.

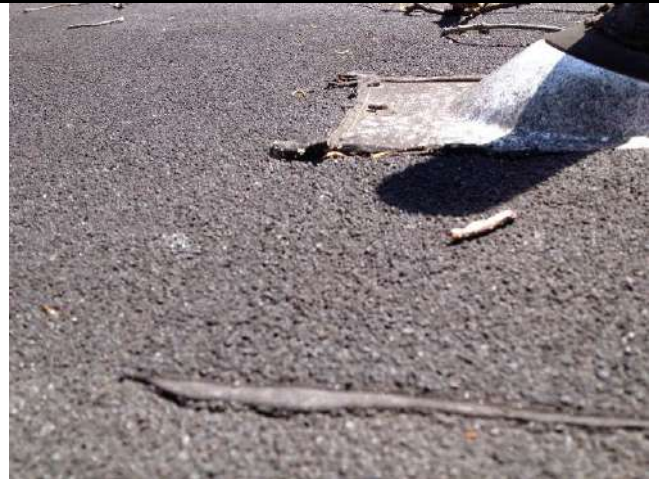
20. View of the black seam sealant (ACM), Samples 63-64.

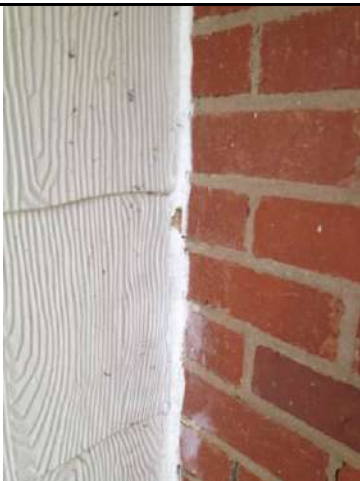
23. View of the tan caulk (ACM) on the chimney of the patio.

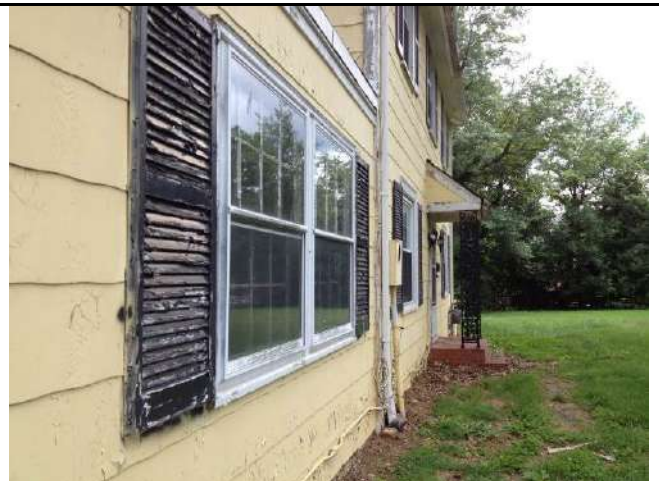
24. View of peeling paint (LBP) on the exterior of the house.
