## Board of Architectural Review

DATE: December 20, 2017  
TO: Board of Architectural Review Chair and Members  
THROUGH: Jason Sutphin, Community Development Division Chief (JDS)  
FROM: Tommy Scibilia, BAR Liaison (TS)  
SUBJECT: Paul VI Redevelopment – Work Session

HAZARDOUS MATERIALS AND STRUCTURAL SURVEY

YELLOW HOUSE AT 10606 CEDAR AVENUE

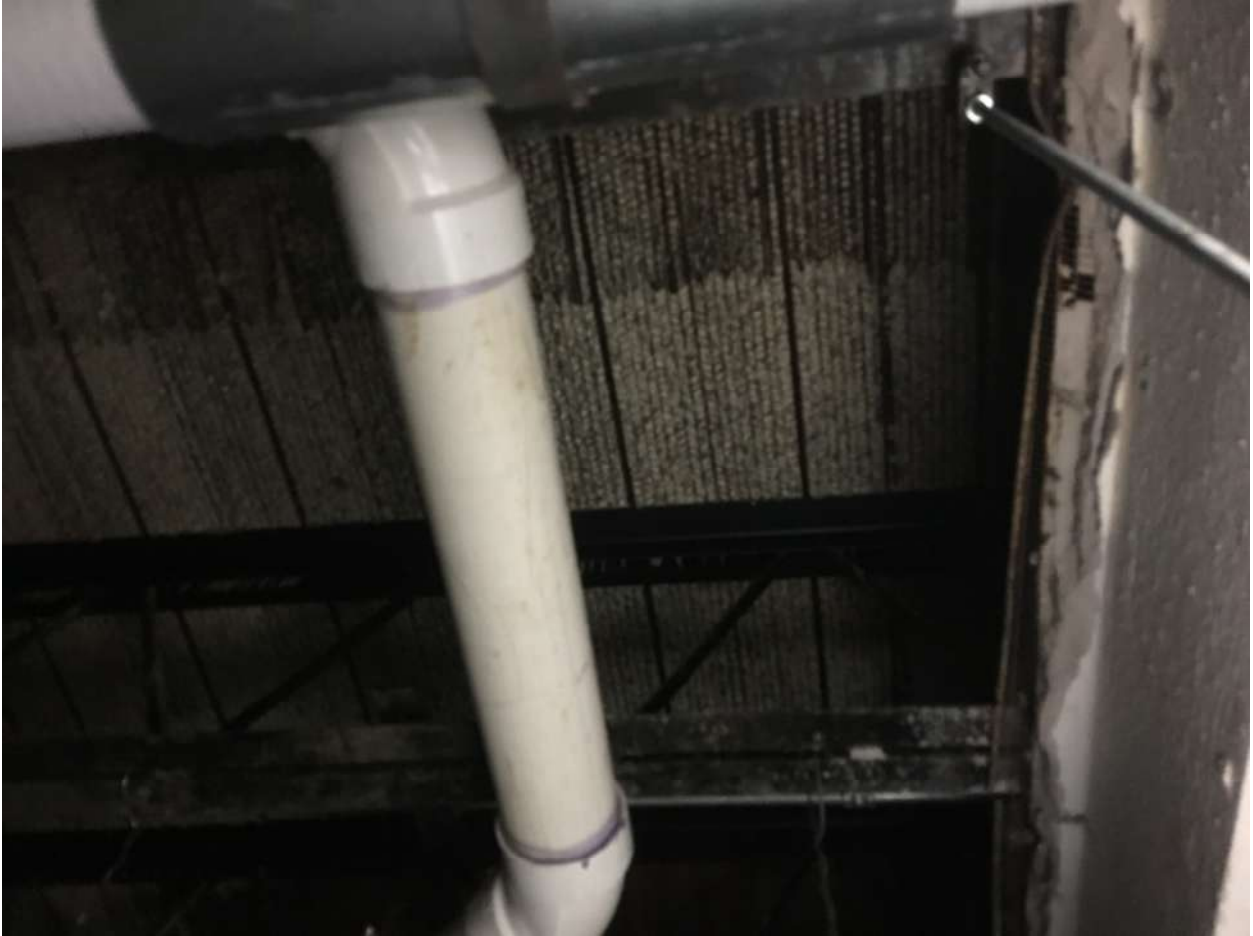
**Photo #1: Underside of 2<sup>nd</sup> floor joists with metal lath decking**

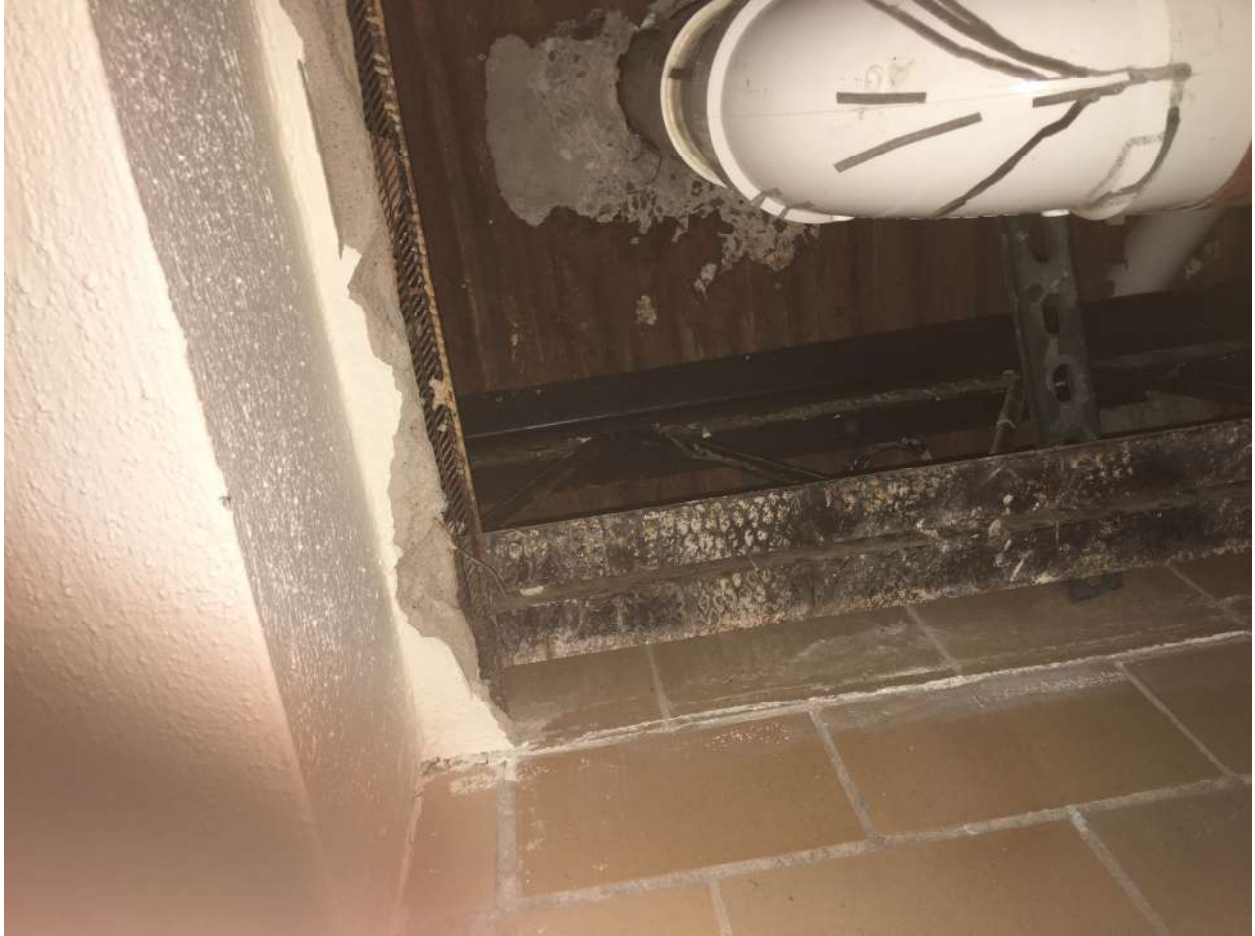
**Photo #2: Underside of 2<sup>nd</sup> floor joists with steel form decking**

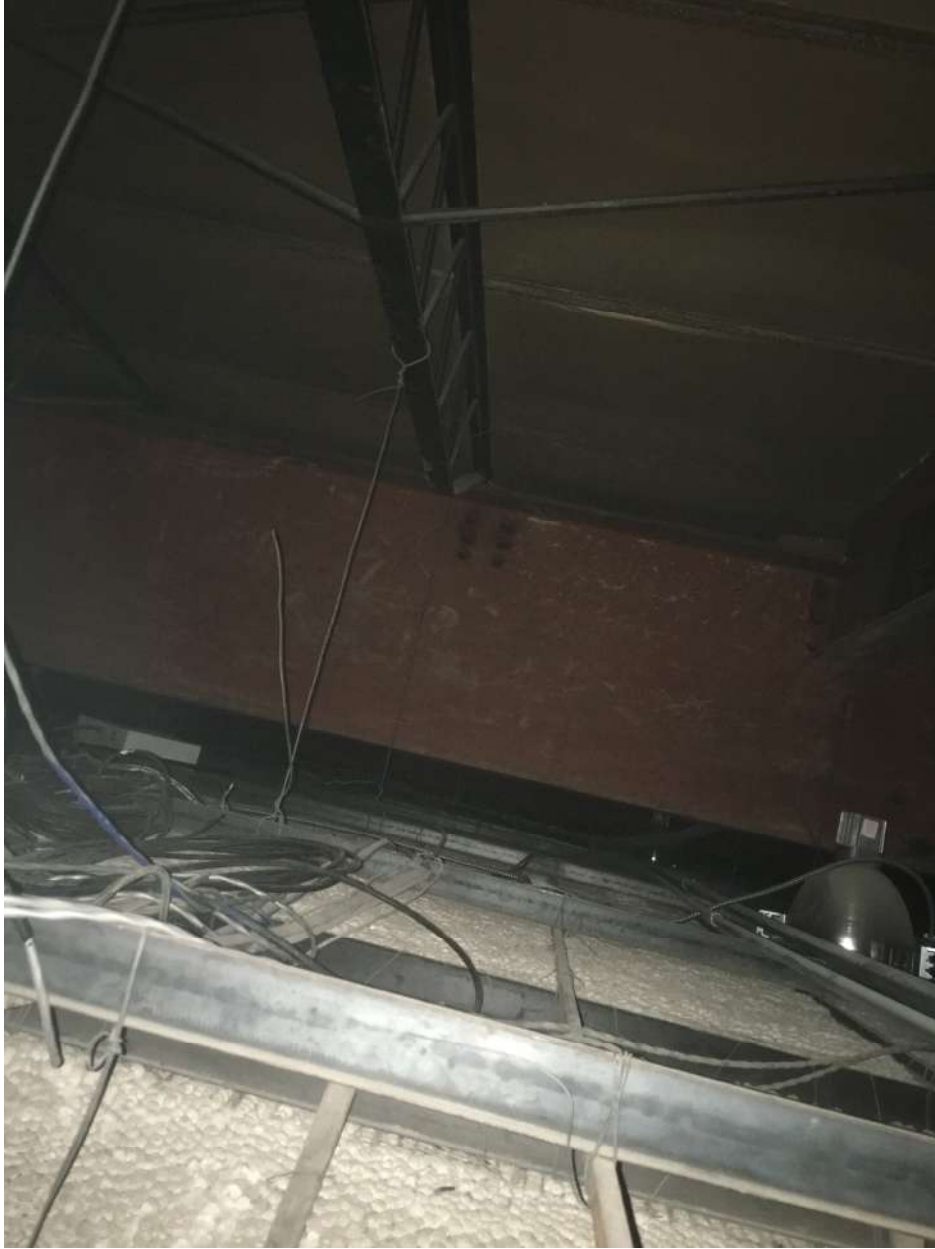
**Photo #4: Steel beam supporting roof joists at corridor bearing line**

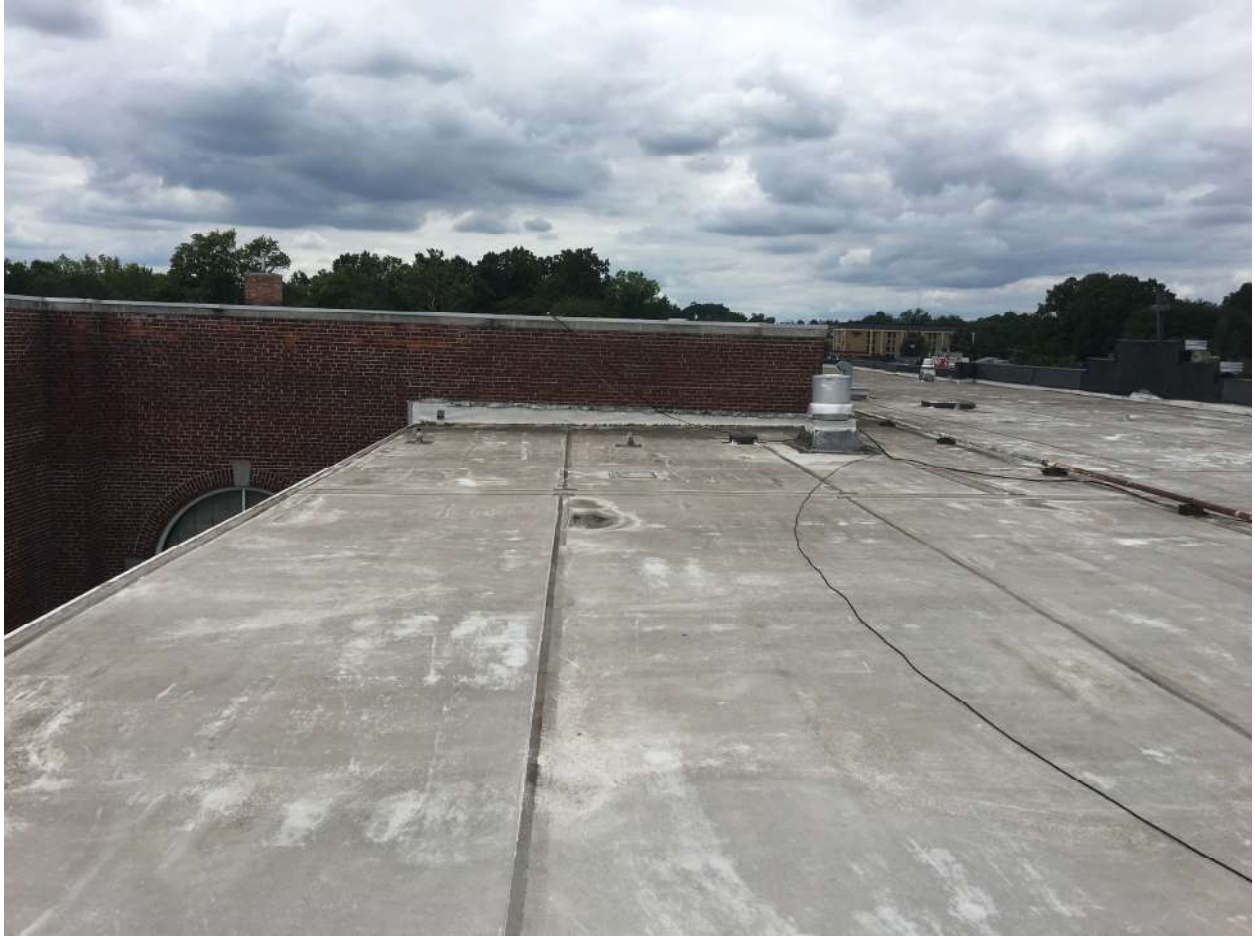
<b>PROJECT:</b> Paul VI	<b>PROJECT NUMBER:</b> 17-124	<b>PAGE:</b> 1
<b>REPORT DATE:</b> 09-01-2017	<b>REPORT NUMBER:</b> 1	<b>DATE OF SITE VISIT:</b> 07-25-2017
<b>TO:</b> Patrick Rhodes – IDI Group		<b>TIME OF SITE VISIT:</b> 1:00 pm
<b>WEATHER/TEMP:</b> SUNNY/85		
<p><b>PROJECT:</b> Paul VI - Condition Assessment Study of Original School Section</p> <p><b>LOCATION:</b> 10675 Fairfax Blvd. Fairfax, VA</p> <p><b>SITE VISIT BY:</b> D. Linton - LE</p> <p><b>PRESENT:</b> P. Rhodes - IDI</p>		
<p><b>OBSERVATIONS/DISCUSSIONS:</b> The following observations were made of the original 24,000 SF circa 1935 portion of the existing school building. All findings are based upon the visually accessible portions of the existing structure. The existing building is two stories above grade and appears to have been constructed with open web steel joists spanning to masonry bearing walls at the exterior and at the two corridor wall locations. A utility tunnel occurs below the first-floor corridor.</p> <p><b><u>Second Floor Level:</u></b></p> <p>The 2<sup>nd</sup> floor structure is framed with open web steel joists spanning front to back. See Photo #1. The joists are supported by the existing brick walls at the sides of the corridor and at the exterior walls. At some locations, the corridor walls are discontinuous and steel beams are likely present to support the floor joists. See Photo #2. Two different types of floor deck construction were observed. At some locations a steel form deck was used to span between the joists and at other locations a floor deck consisting of a wire mesh with concrete fill that was draped between the existing joists. In each case, the joists were spaced at approximately 2-feet on center. No structural defects were observed at any of the visually accessible second floor areas.</p> <p><b><u>Roof Framing:</u></b></p> <p>The framing for the roof also consists of open web steel joists spanning front to back between the brick walls at the exterior and to the interior brick walls or steel beams occurring at the interior corridor lines. See Photos #3 and #4. The joists support a roof deck system that appears to be tectum type roofing consisting of a steel “T” spanning between the joists with the tectum panels located between the tees. No structural defects were observed at any of the visually accessible roof areas.</p> <p>In looking at the various parapet conditions at the top of the roof, it was observed that parapet walls appear to align directly above the original 1935 building wall location. There are clear delineations between the existing original portion of the building and adjacent roof structures that occur where the existing Library, Cafeteria and Auditorium join to the classroom wing. See Photo #5.</p>

**Photo #5: Parapet walls pop-up at Library and Cafeteria wings**

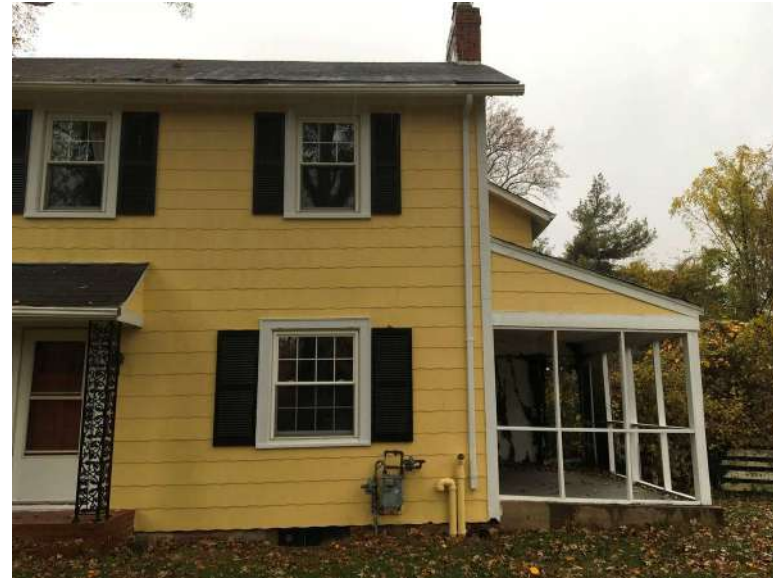
South elevation of property.

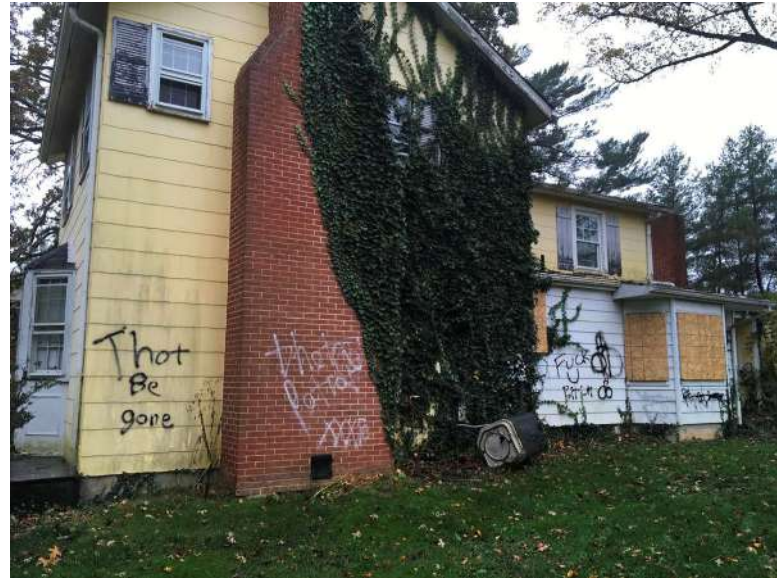
North elevation of property.

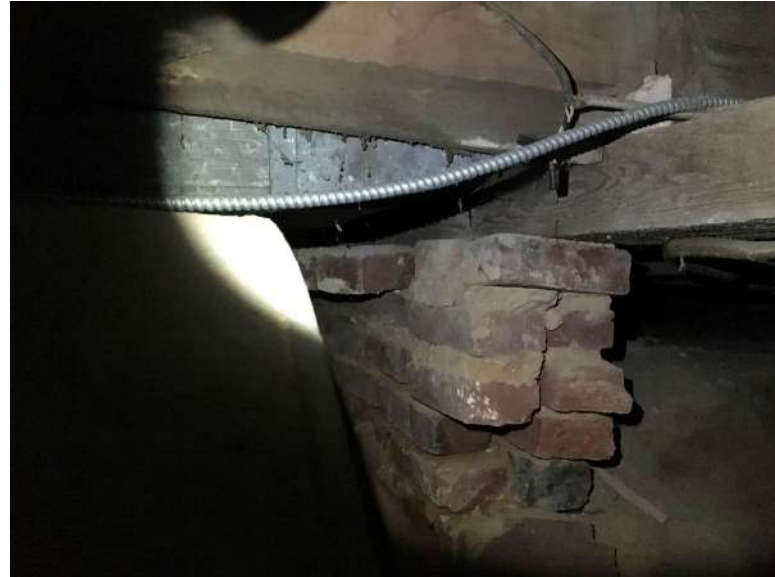
Significant deterioration of masonry foundation.

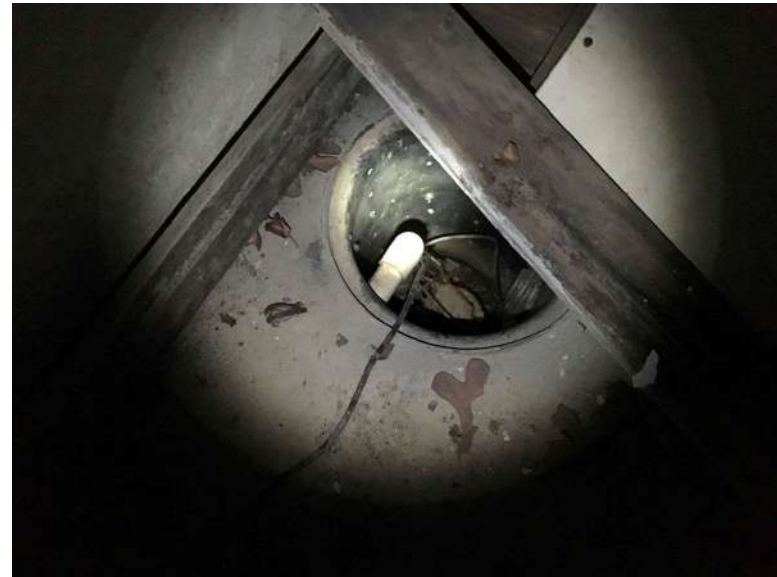
Sump pit within Cellar level. Pit was dry.

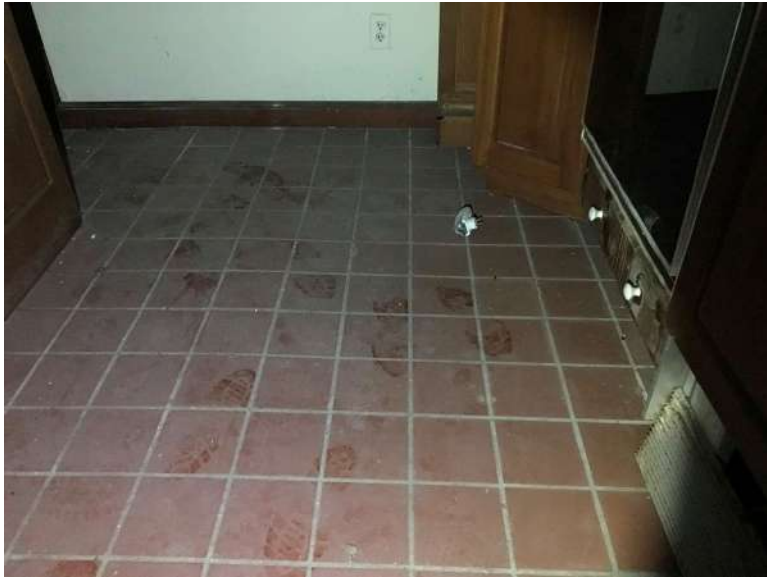
Significant displacement of floor structure within kitchen. Estimated 1.5" within five feet.

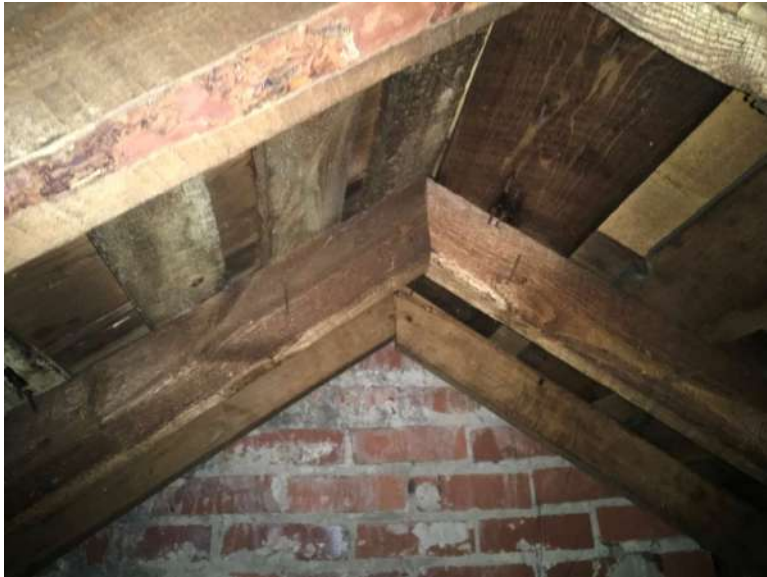
Typical main building gable roof framing.

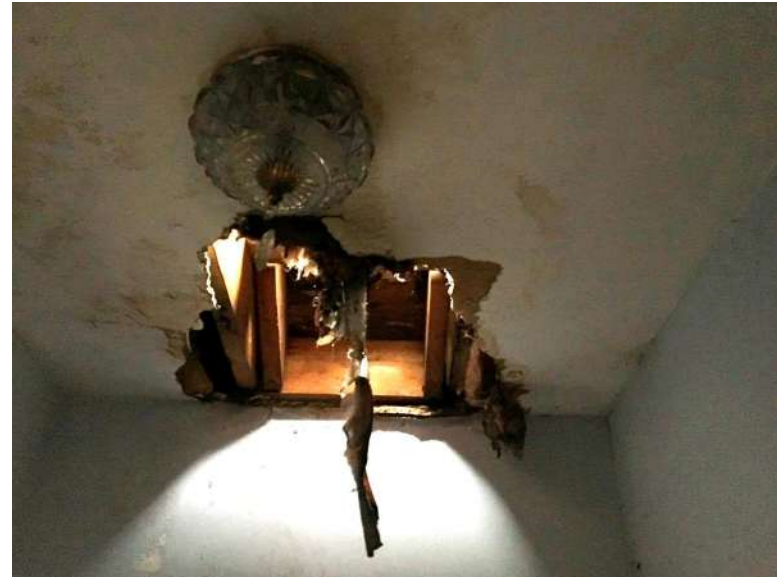
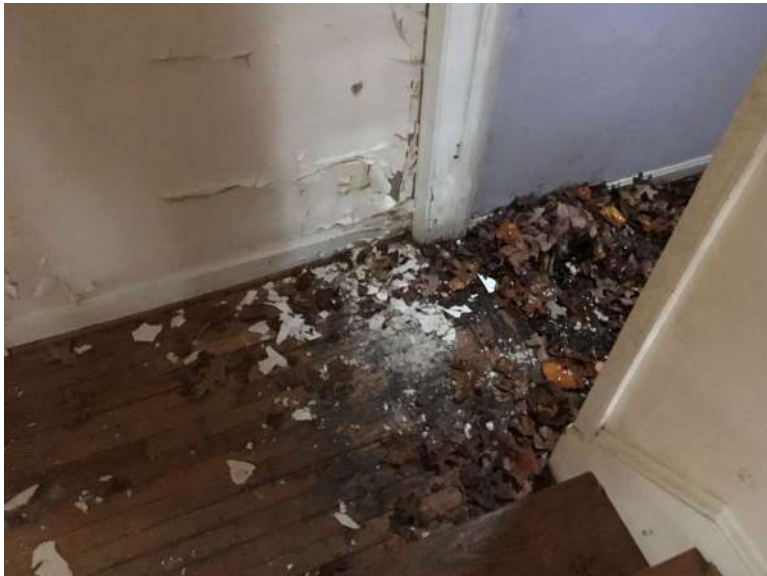
Floor debris at partial collapse of roof structure.

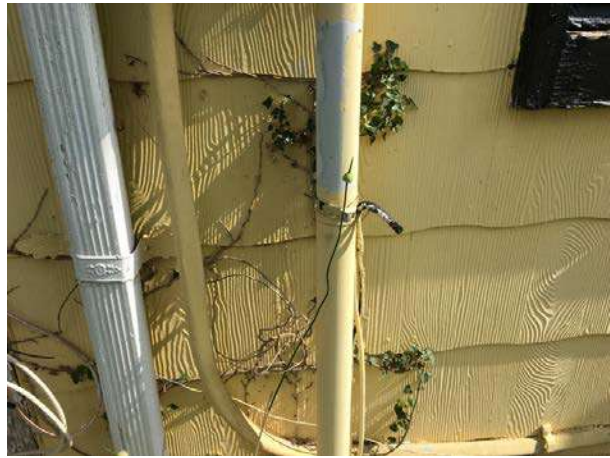
Organic on the wall

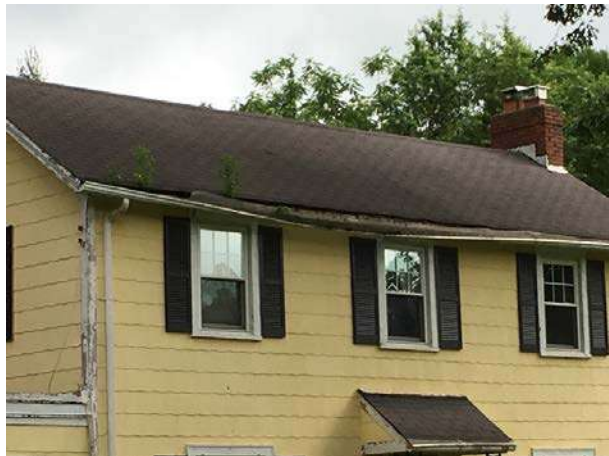
Gutter sagging

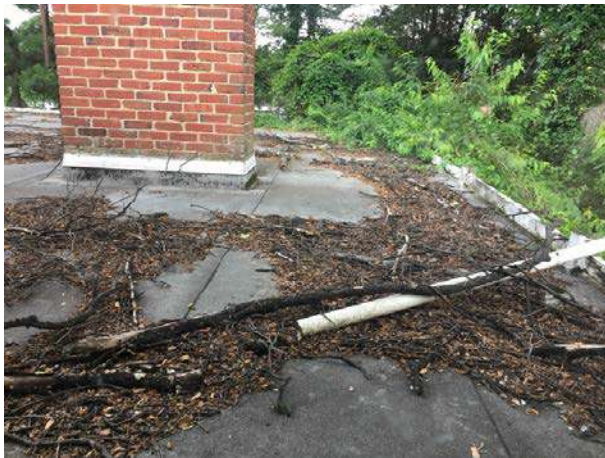
Garage roof

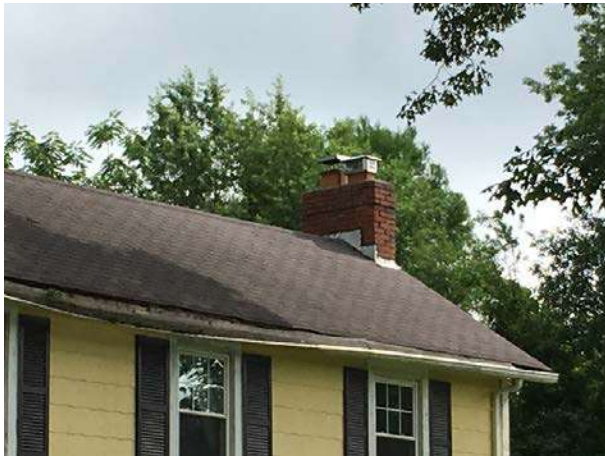
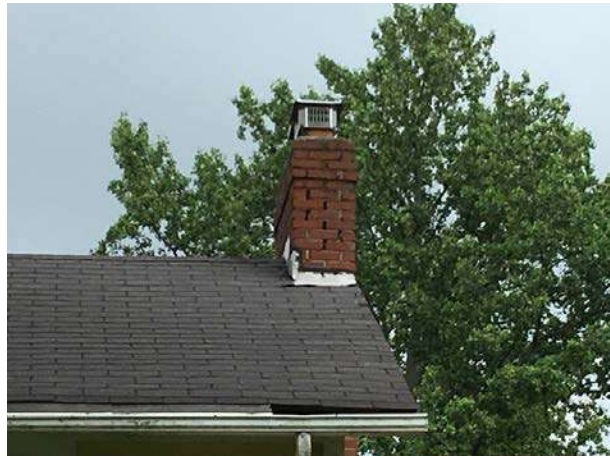
The east chimney was in poor condition. The east chimney of the building was observed to have extensive mortar loss. Mortar loss (loss of the binder material) appears to have resulted in movement and dislocation of the bricks. In particular large voids between bricks were observed along the mortar joints.

Loss of mortar may result in instabilities of the chimneys and lead to eventually collapse.

East chimney

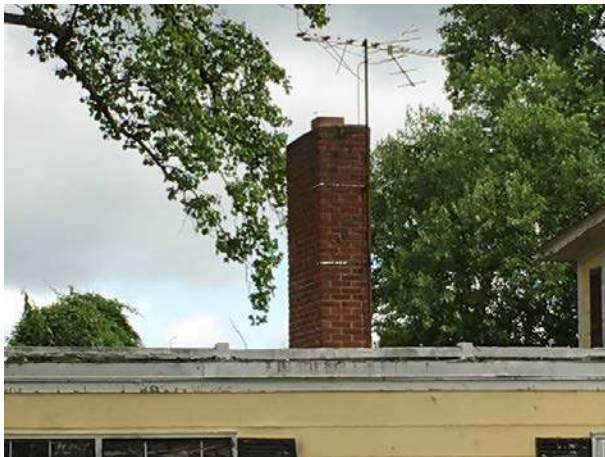
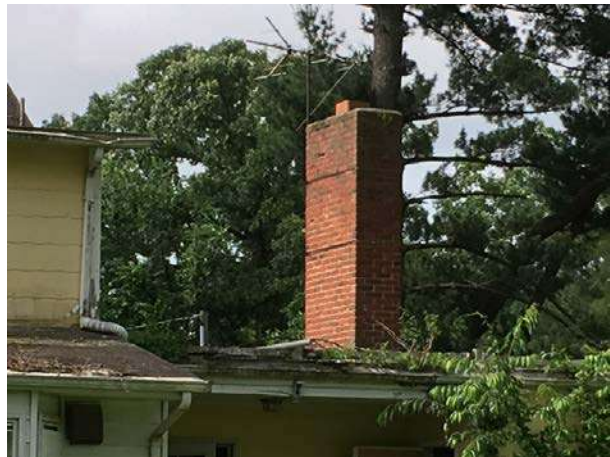
The north and west chimneys were in fair condition. There appeared to be mortar loss in the joints at the upper half of the chimneys.

West chimney

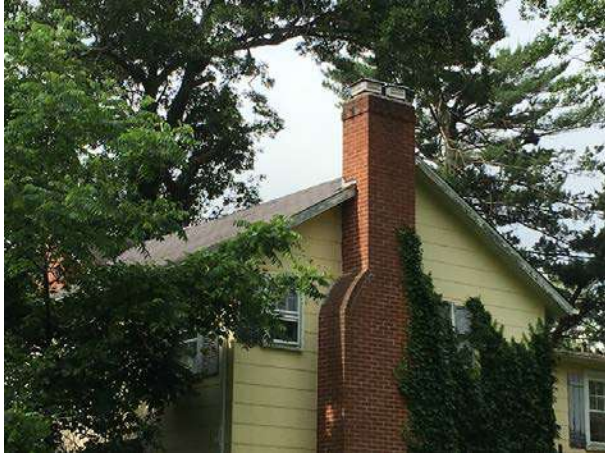
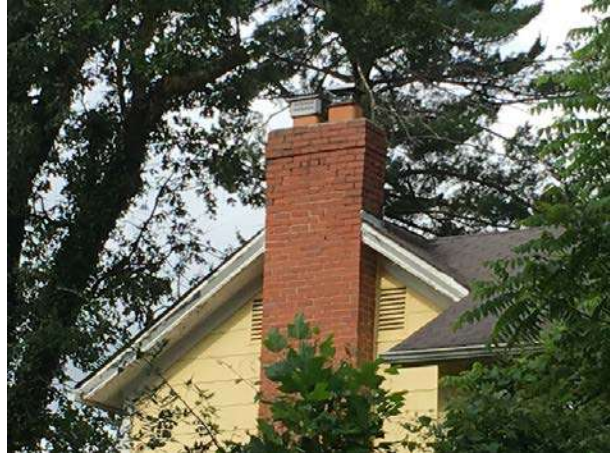
North chimney

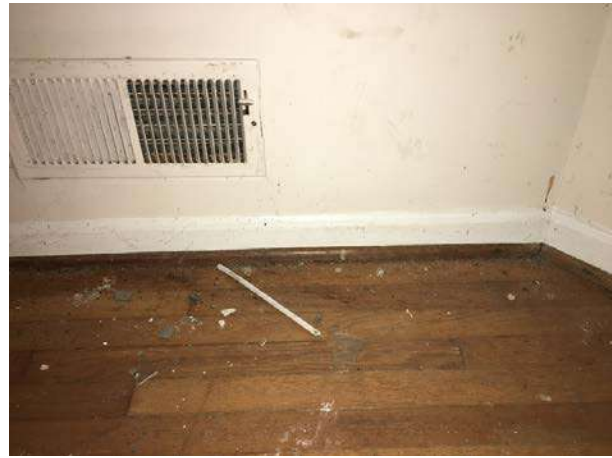
Dry wall with hardwood floor

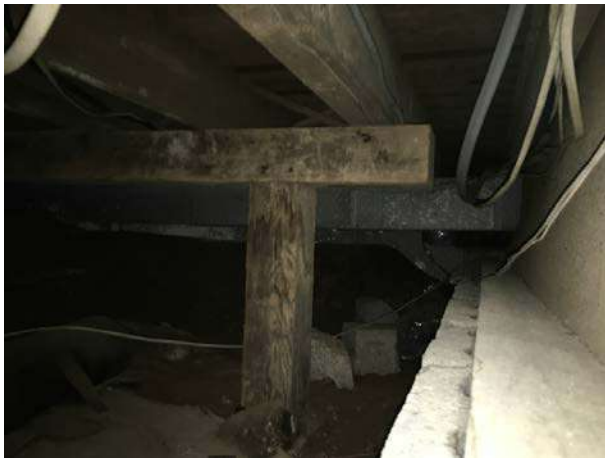
Crawl space

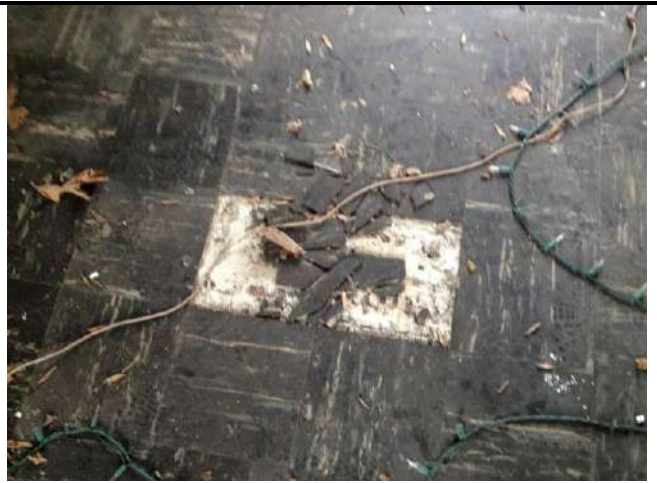
2. View of the 9" x 9" black floor tiles (ACM), Samples 1-2.

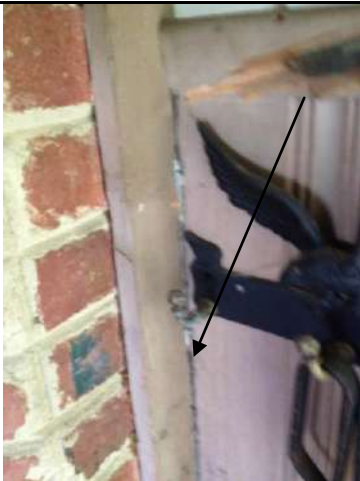
3. View of the light gray wall caulk, Samples 5-6.

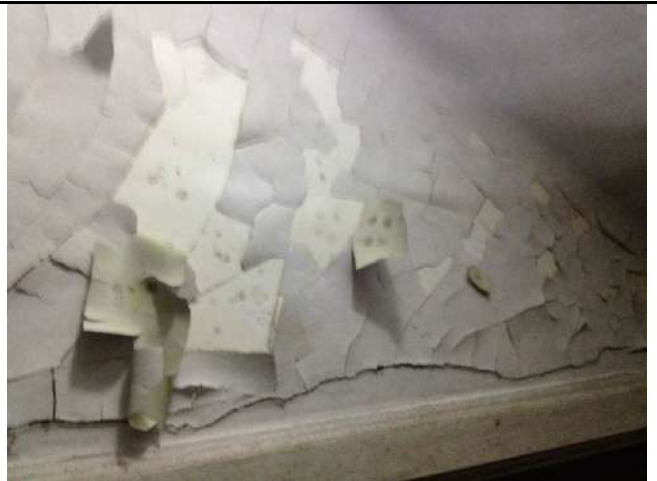
4. View of peeling paint with mold in the basement stairwell.

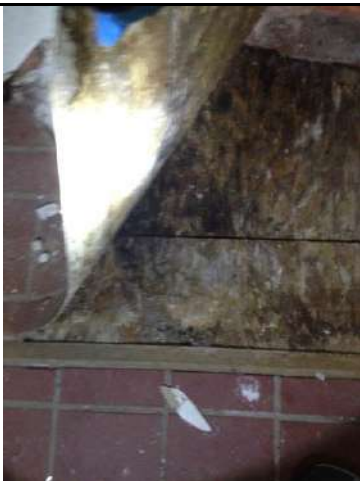
5. View of water impacts and mold beneath the sheet flooring in the laundry hallway.

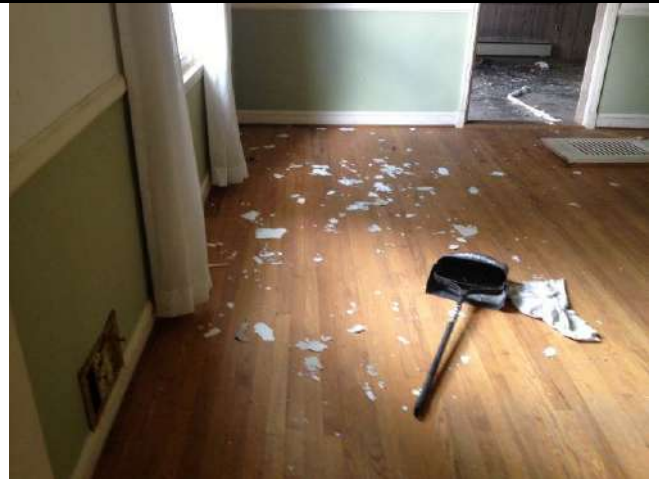
14. View of peeling paint on the floor surfaces.

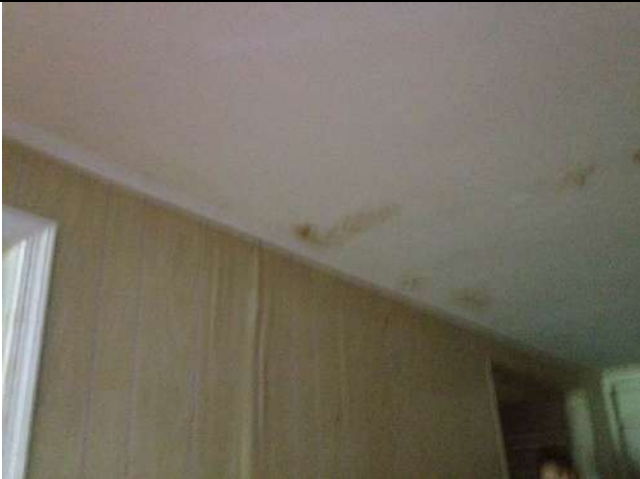
15. View of water impacted walls and ceiling in the northeast living room.

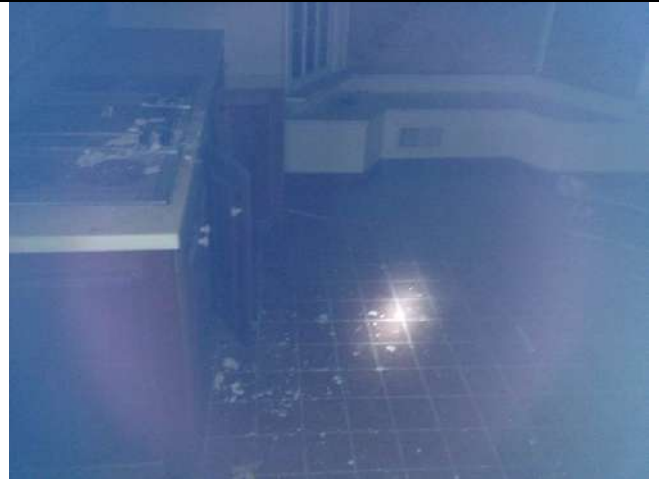
16. View of ceiling debris (with asbestos) on the floor in the kitchen.

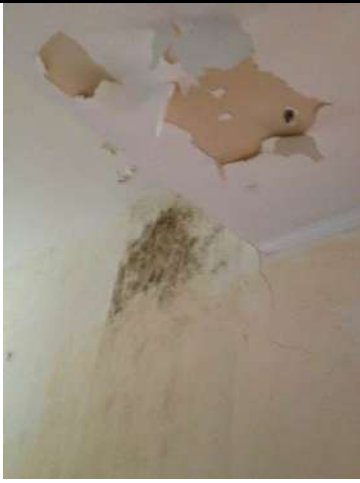
19. View of visible mold and peeling paint in the upstairs hallway.

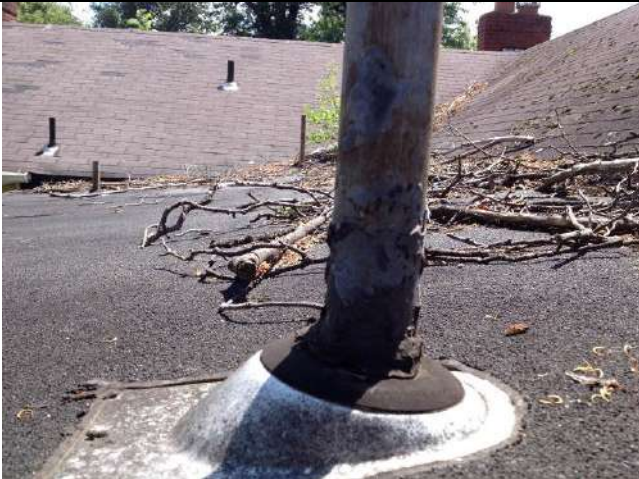
21. View of the cement (ACM) on the roof vent, Samples 67-68

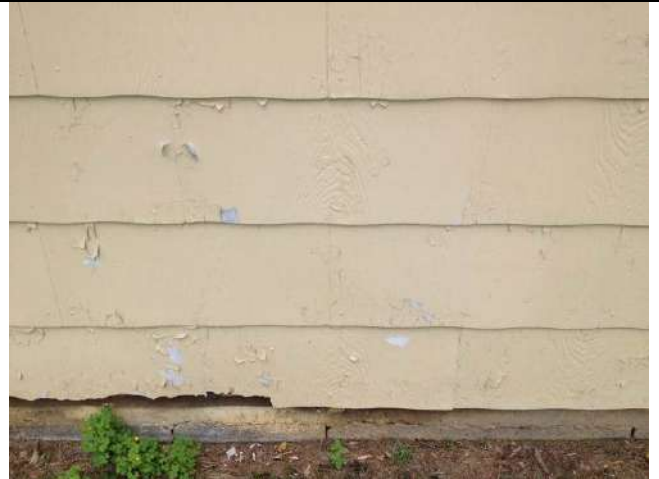
22. View of the cement board siding (ACM), Samples 73-74, and paint chips in the drip line.
